Eightmile Lake Storage Restoration – Feasibility Study

David Rice, P.E. – Anchor QEA, LLC

April 27, 2017

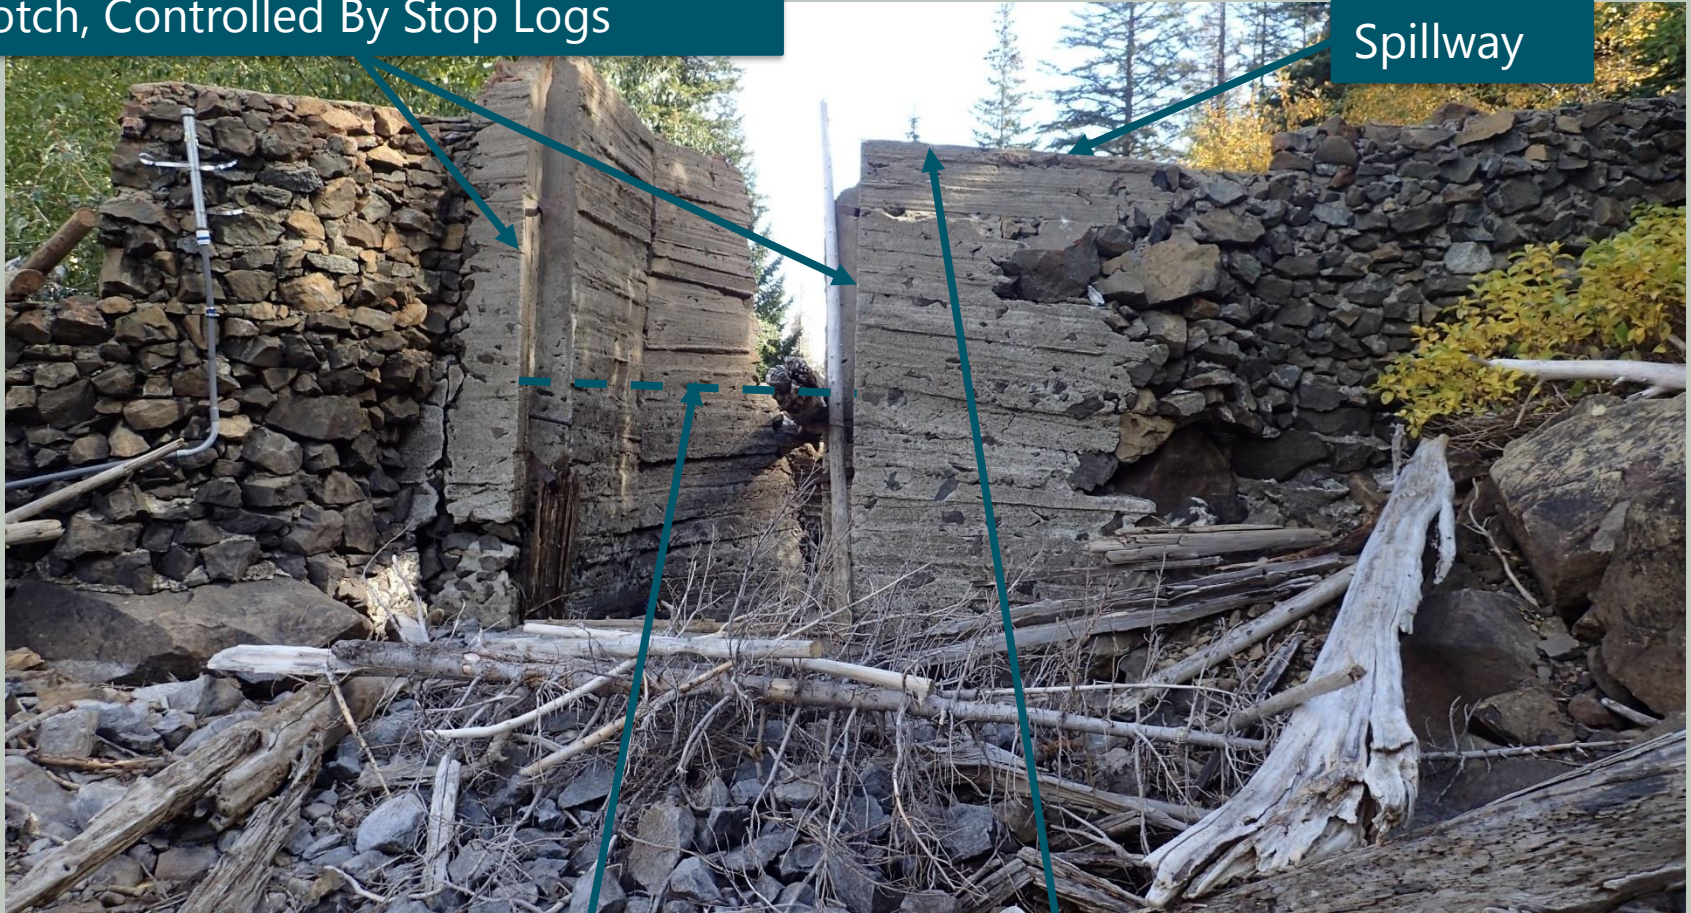
Existing Dam and Spillway

Notch, Controlled By Stop Logs

Spillway

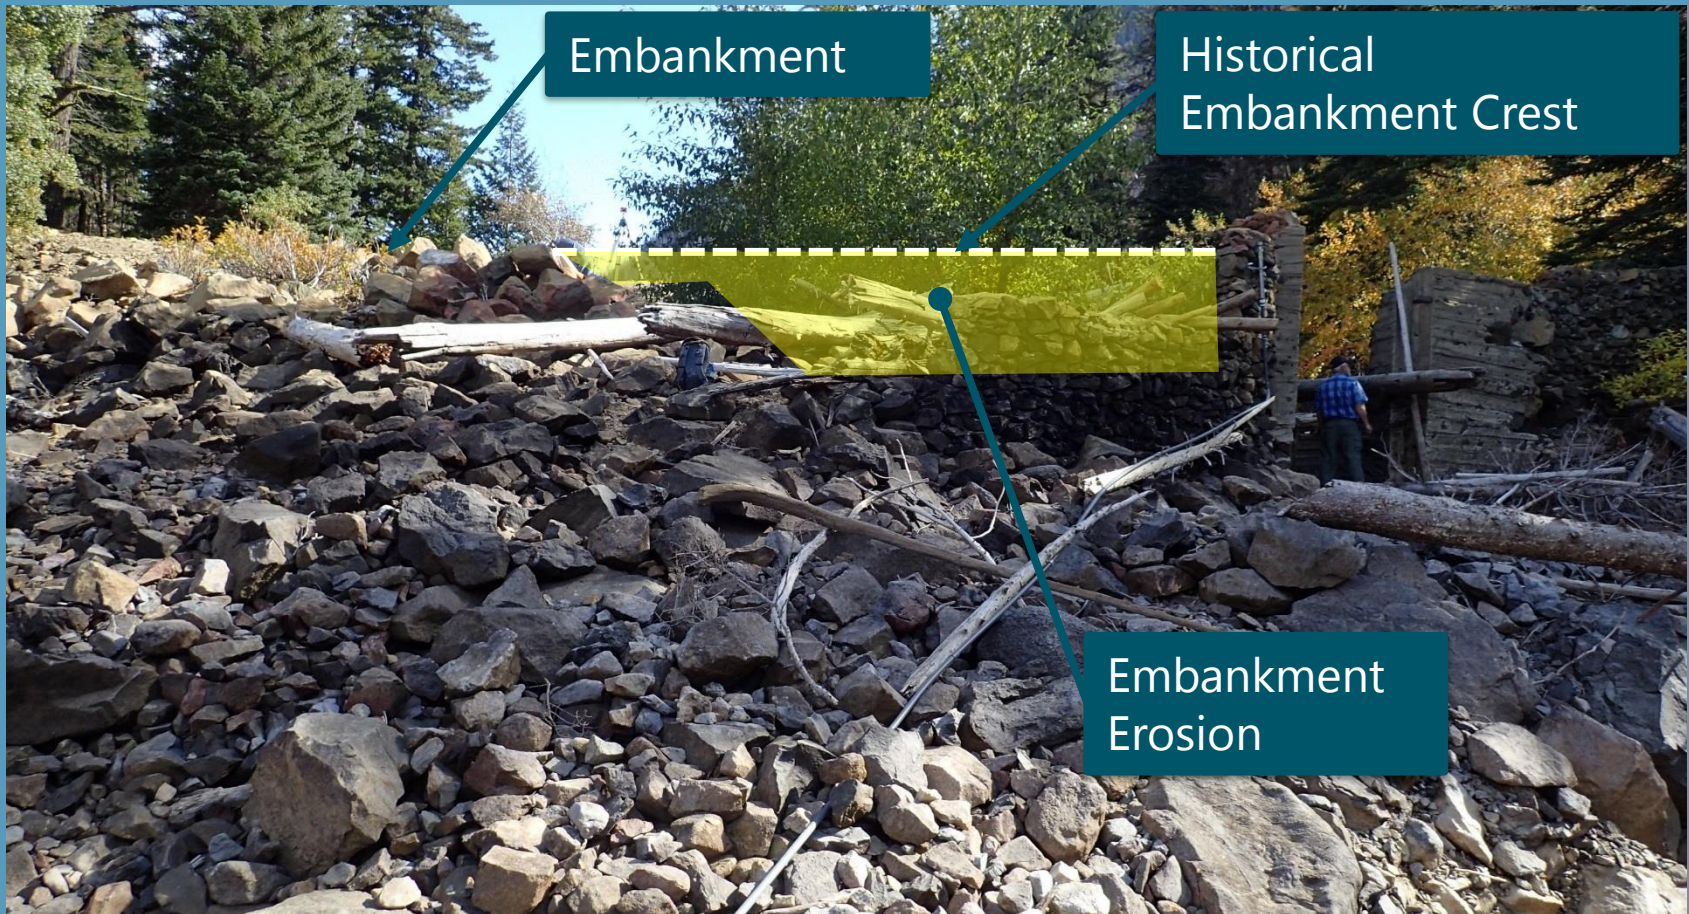
Current High Water Surface
Elevation ~ 4,667 Feet

Historical High Water Surface
Elevation ~ 4,671 Feet

Existing Embankment

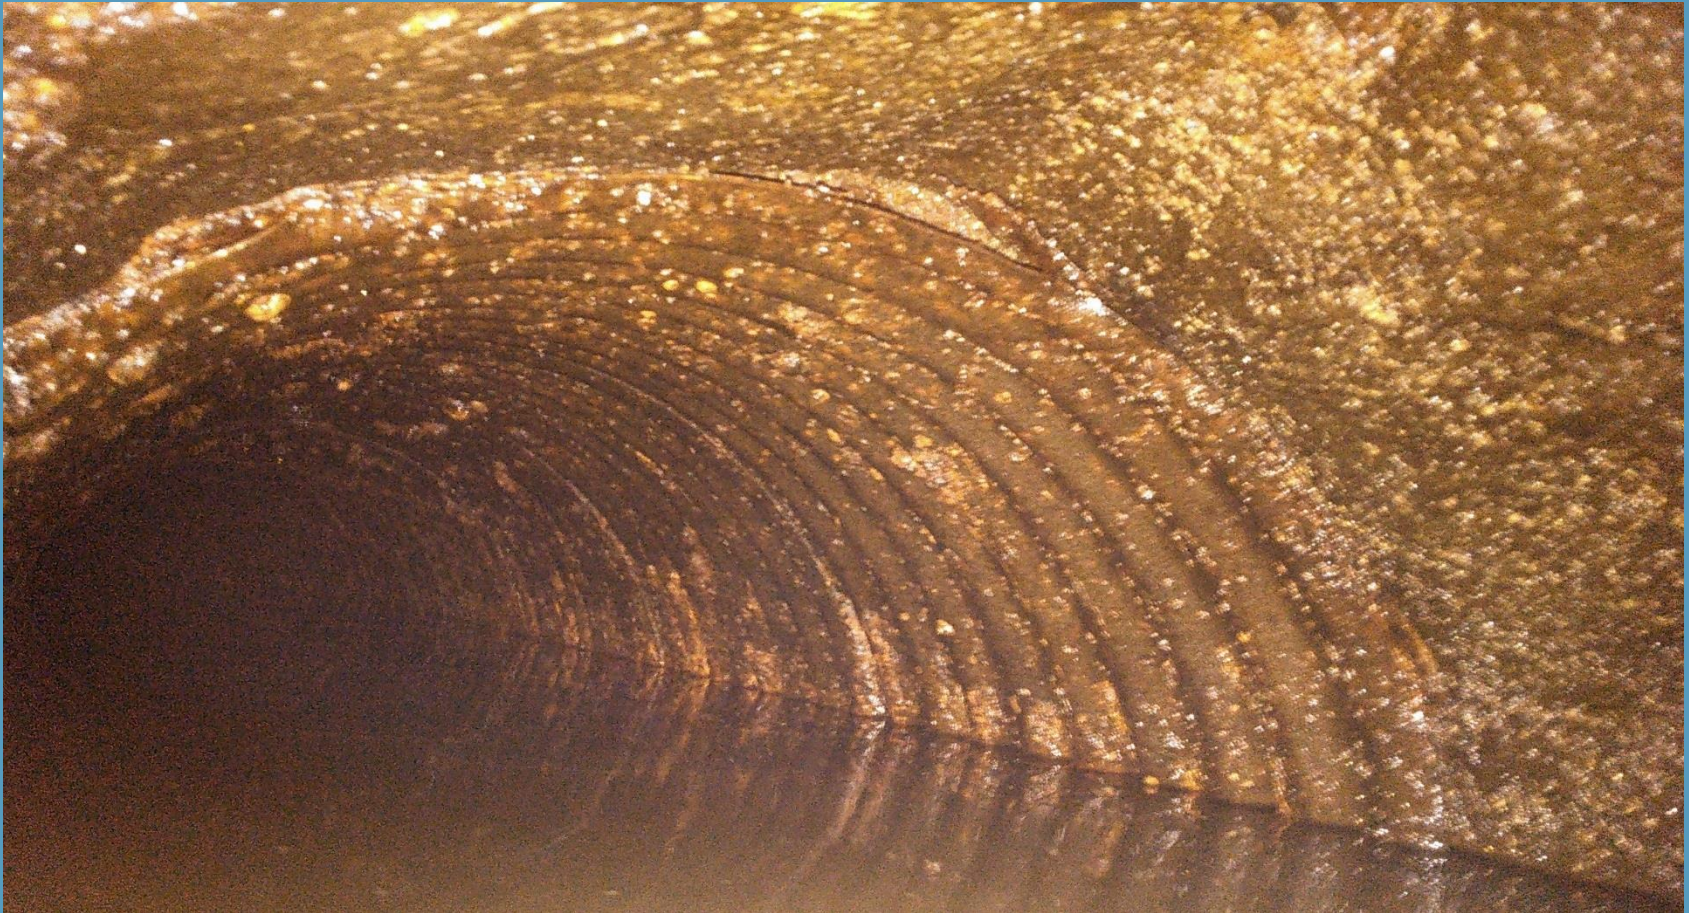
Low-Level Outlet Pipe, Near Pipe Inlet

Gate Stem

Come Along

30" Pipe Inlet

30" Slide Gate

Debris Rack

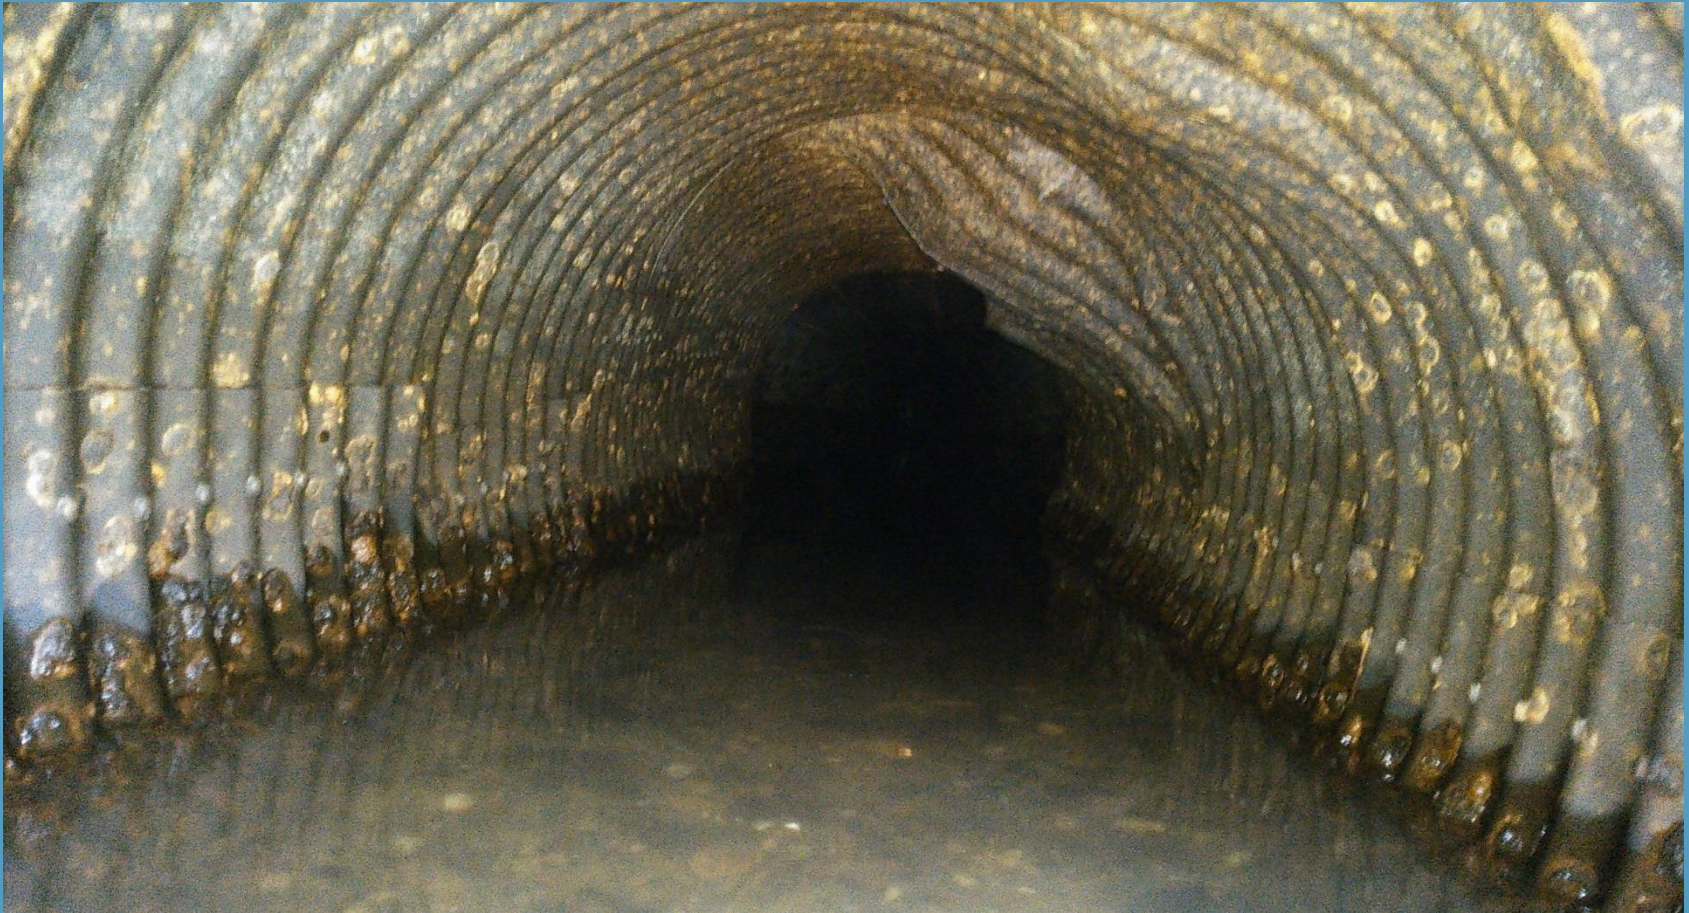
Low-Level Outlet Pipe, Near Pipe Outlet

- Gate Operation
 - Requires come along to open and close gate
 - Rocks/debris make operation challenging
- Dam Condition and Level Control
 - Embankment erosion, reduced water storage
 - <1,400 acre-feet available without pumping/siphoning
- Low-Level Outlet Pipe
 - Multiple materials, some in poor condition
 - Pipe collapse has recently reduced capacity
- Storage releases are critical to IPID late summer water supply, especially during dry years
