Lower Icicle Creek Reach Level Assessment

Prepared for:

Icicle Valley Chapter of Trout Unlimited
8158 East Leavenworth Road
Leavenworth, WA 98826

26 January 2005

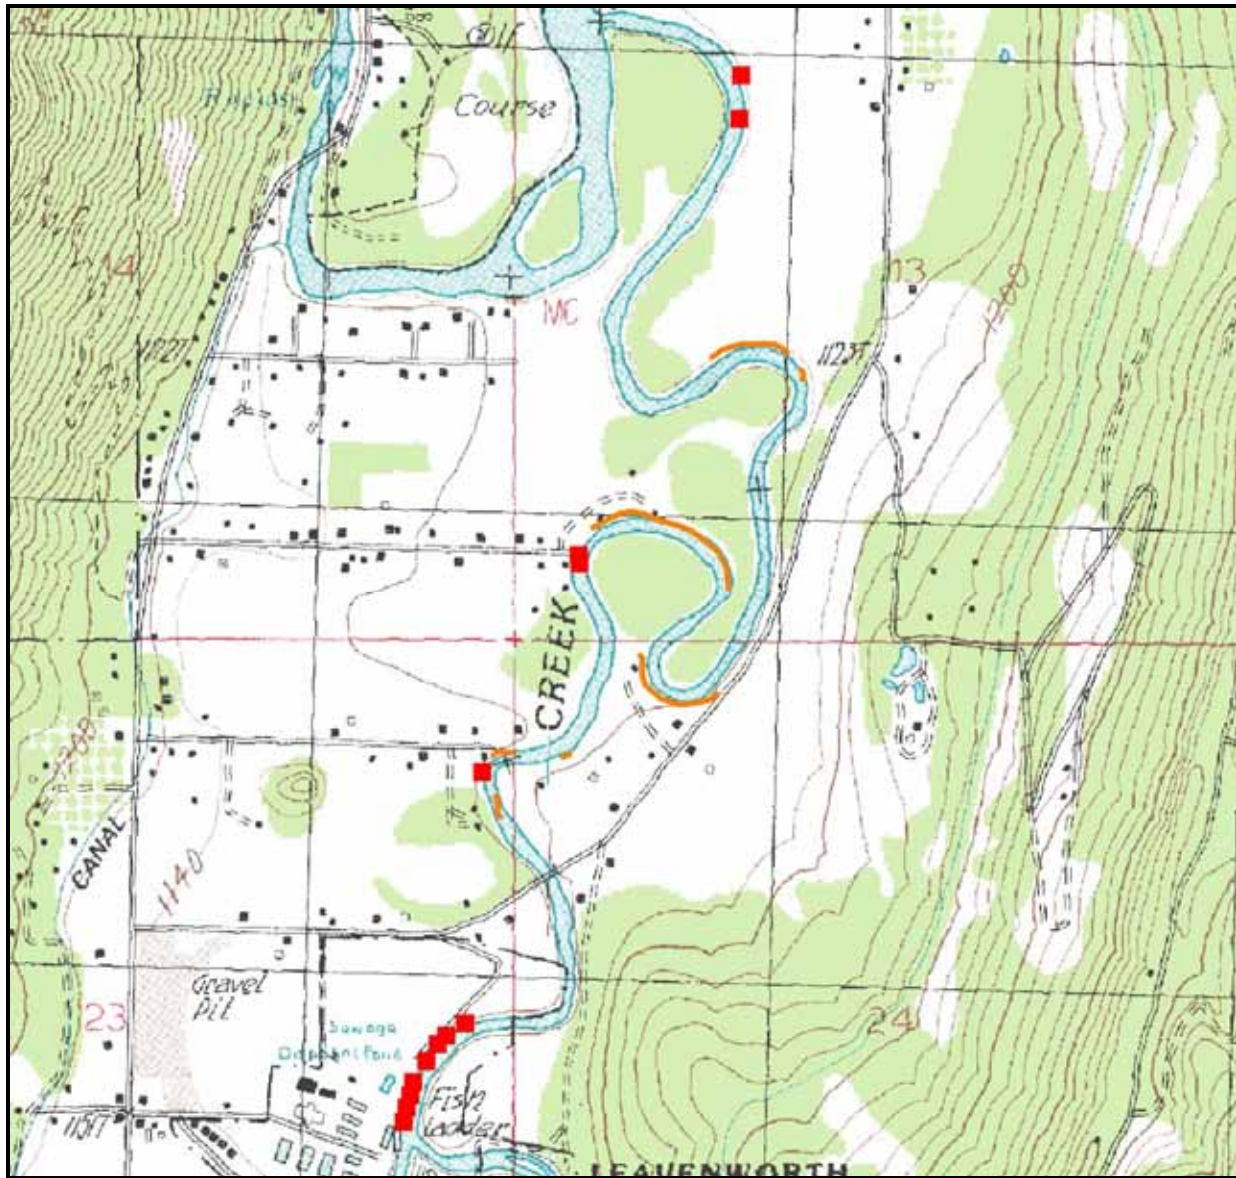
Figure 5. Shoreline modifications (after Jones & Stokes 2003).

Historically, landowners have protected their property by installing a variety of bank protection measures, including rip-rap armoring and barbs. In 1972, a flood caused a meander to be cut off near RM 1.5. The eroded banks causing the cut-off were later repaired with rip-rap. Figure 5 shows the locations of bank protection projects.

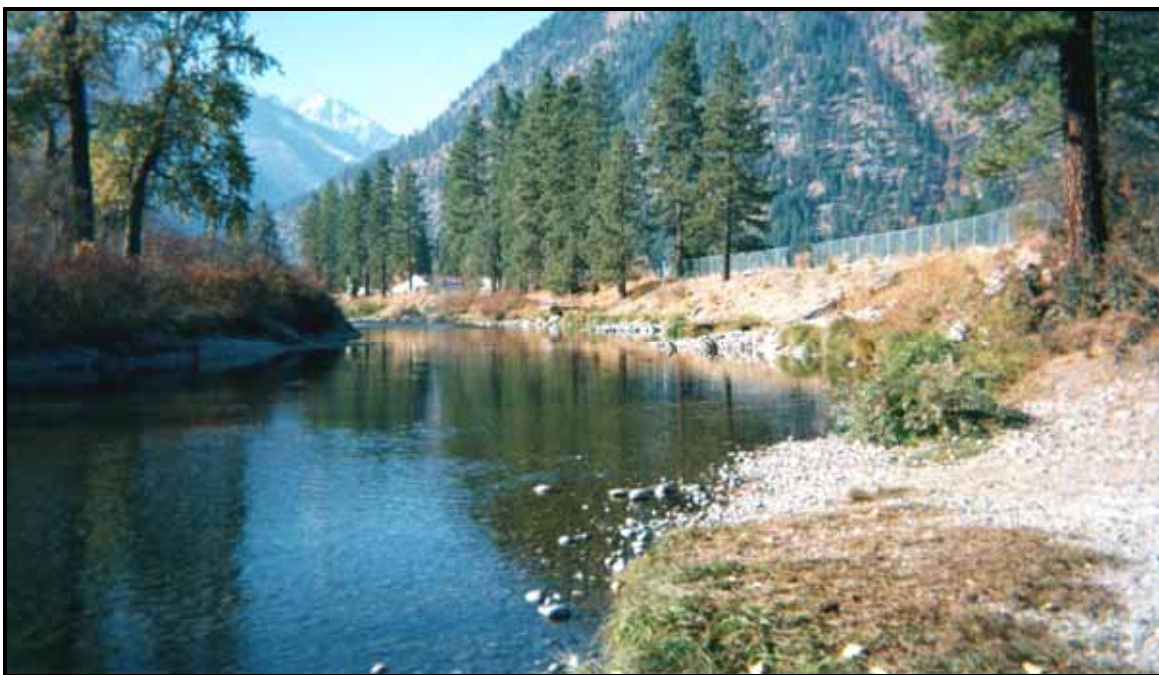
with some mid-channel bars. In other words, the only difference in deposition pattern relates to how well the side- or mid-channel bars connect to the banks, which is a matter of degree. Both patterns generally indicate excess sediment. Bank stability at CS1 was rated higher than at the reference reach, indicating more stable banks at CS1 than at White Upper. However, the BEHI results were somewhat contradictory, indicating the erosion hazard at CS1 is higher than at White Upper. Figures 11 and 12 are photographs of Icicle CS1 and White Upper cross-sections.

Figure 12. Icicle CS1 looking upstream towards the Hatchery

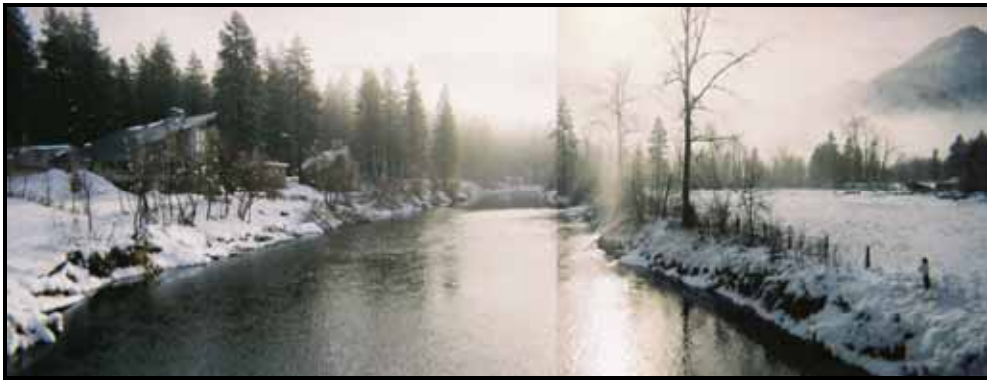
Figure 13. Composite of Icicle CS2 looking upstream. Note hill on right bank (left side of photo).

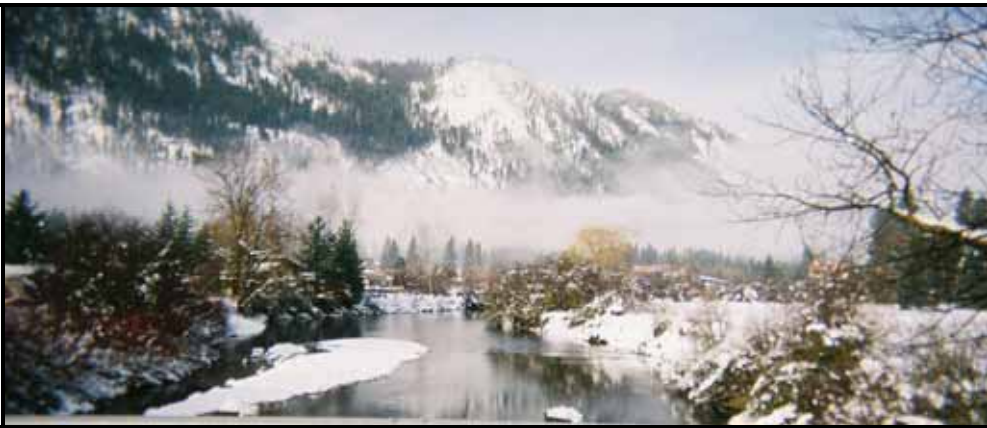
Figure 14. Looking downstream of Icicle CS2 towards Icicle CS3. Note broad floodplain on both banks.

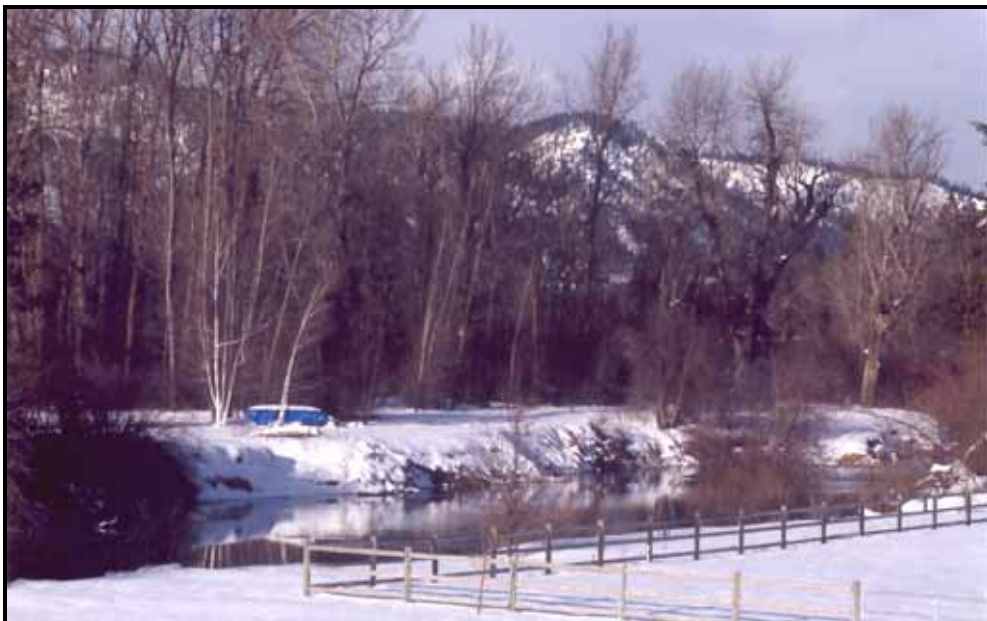
Icicle CS3 is located in a residential area of the creek, with broad floodplain flats on either bank. The width/depth ratio at this reach was exceptionally high, nearly three times that of the reference reach. Bed material was somewhat larger than the reference reach, and debris in the channel was very sparse. Riparian vegetation in this reach was much less mature and dense than on the reference reach, dominated by grass lawns and pasture with few woody species with deep-penetrating roots. Bank stability was rated comparable to, and slightly better than the reference reach, and the erosion hazard index was somewhat lower than on the reference reach. Figure 15 is a photograph of the Icicle CS3 cross-section.

Figure 15. Icicle CS3, looking downstream.

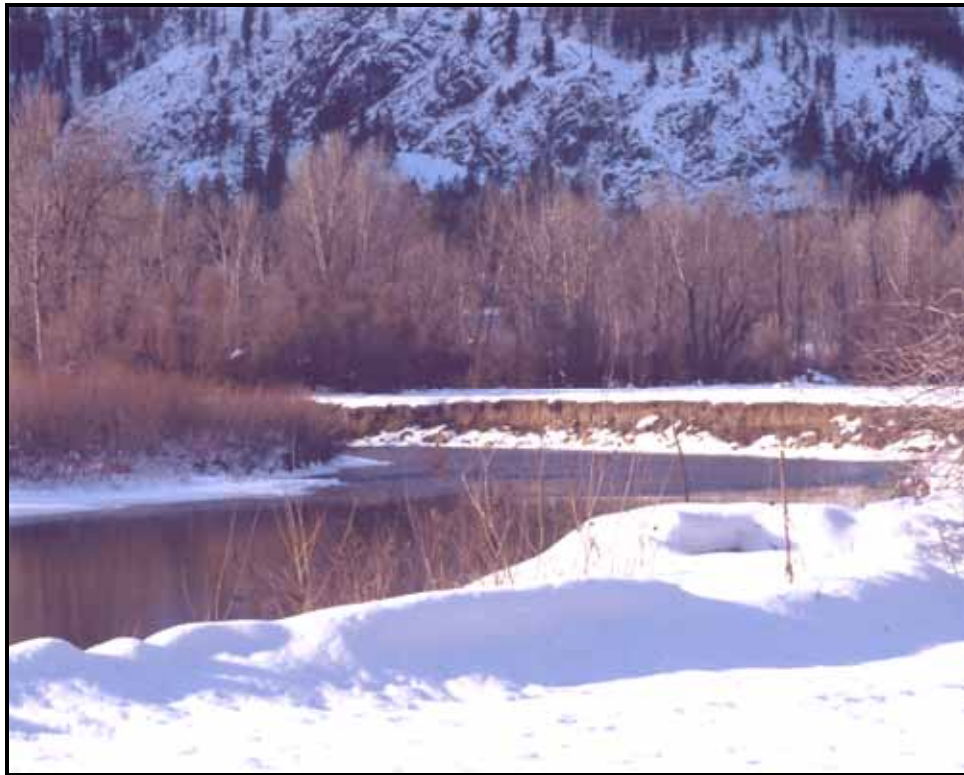
Icicle CS5 is located near the confluence with the Wenatchee. Both banks are formed in floodplain deposits. The width/depth ratio of this reach is the same as that of the reference reach, as is the bed material size. The riparian vegetation on this reach is comparable to that of the reference reach on the left bank, dominated by mature deciduous trees, but is immature and sparse on the right bank, dominated by pasture grasses. The deposition pattern of this reach is comparable to the reference reach. Bank stability was rated lower on this reach than the reference reach, but the erosion hazard for the two reaches was nearly identical. Figures 16 and 17 are photograph of the Icicle CS5 cross-section.

Figure 16. Icicle CS5, looking downstream.

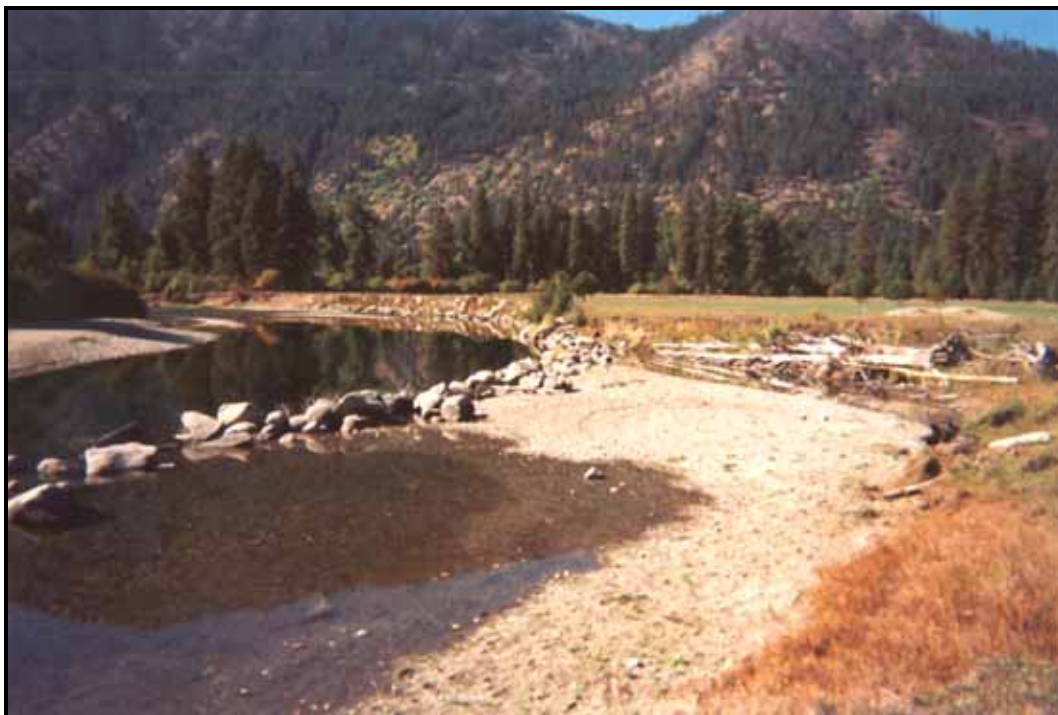
Figure 17. Icicle CS5 looking downstream. Note erosion on right bank (right side of picture). Rip-rap in channel indicates a previous toe of bank.

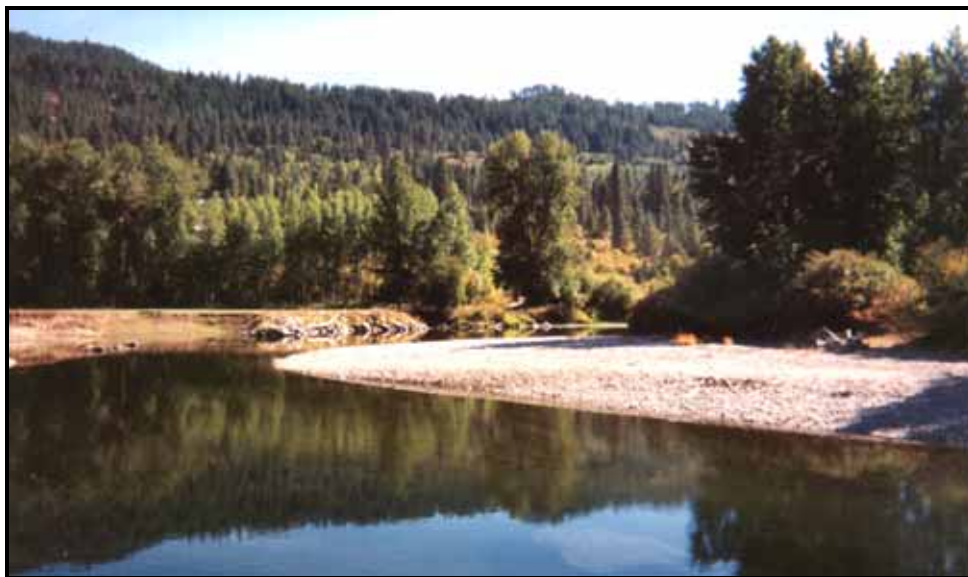
Figure 19. Icicle CS4 looking upstream. Note large bar developed on left bank (right side of photo).

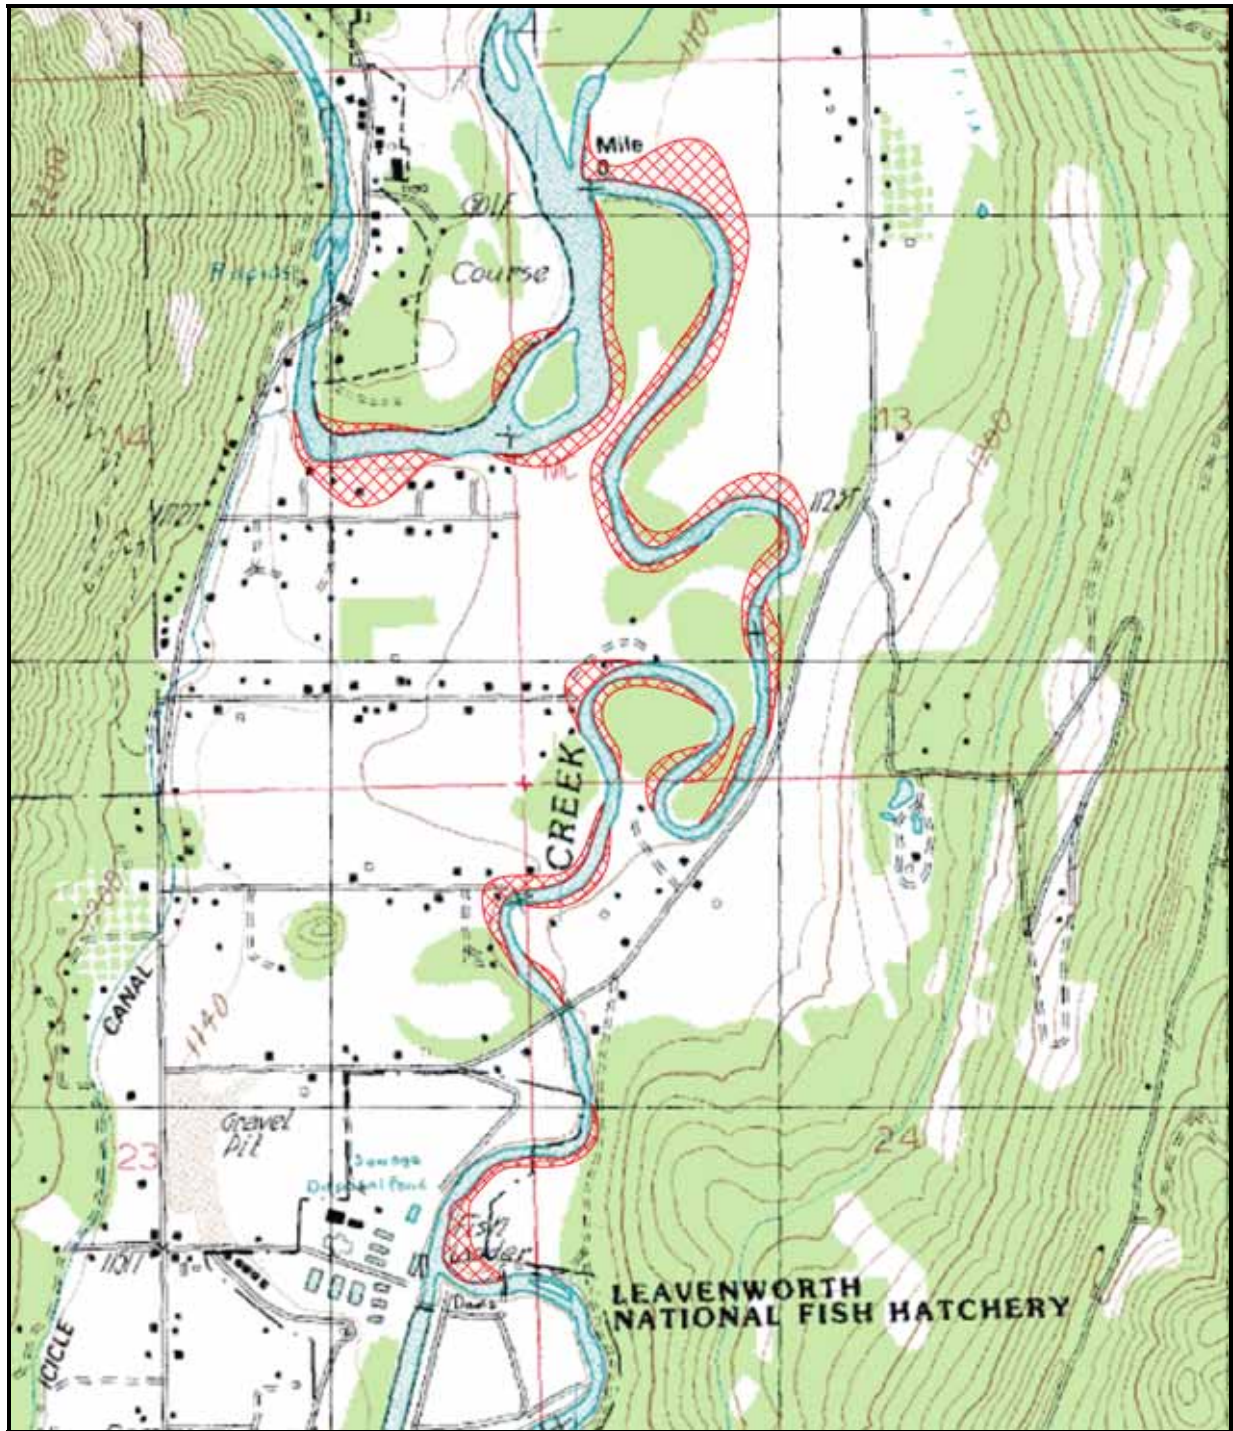
Figure 20. Erosion areas on Icicle Creek (Jones & Stokes 2003).

Bank erosion on the Icicle has been a problem for some time. Figure 5 indicates where bank erosion problems have been sufficiently detrimental that projects were undertaken to protect the banks. Presently there are some large areas of bank erosion that are still problematic, or where the bank protection has failed, likely increasing the volume of fine sediment in the Icicle and downstream receiving waters.

An earlier study (Jones & Stokes 2003) identified the erosion hazard areas of the lower Icicle (Figure 20). These areas should be targeted for bank preservation and restoration. Revegetation in these areas can help slow the erosion rate in the long term and also provide woody debris for future stream stability and habitat. It will often be helpful in these areas to combine revegetation with temporary or deformable bank protection in order to stabilize the banks long enough for the vegetation to grow sufficiently to be effective. Complex large woody debris structures should be particularly encouraged in association with bank revegetation.
