Project No.: 170566

August 29, 2018

Re: Section 16 and 17 Upper Wheeler Road Reconnaissance and Planning-Level Geotechnical Considerations—Revised

Re: **Slope Stability Reconnaissance**

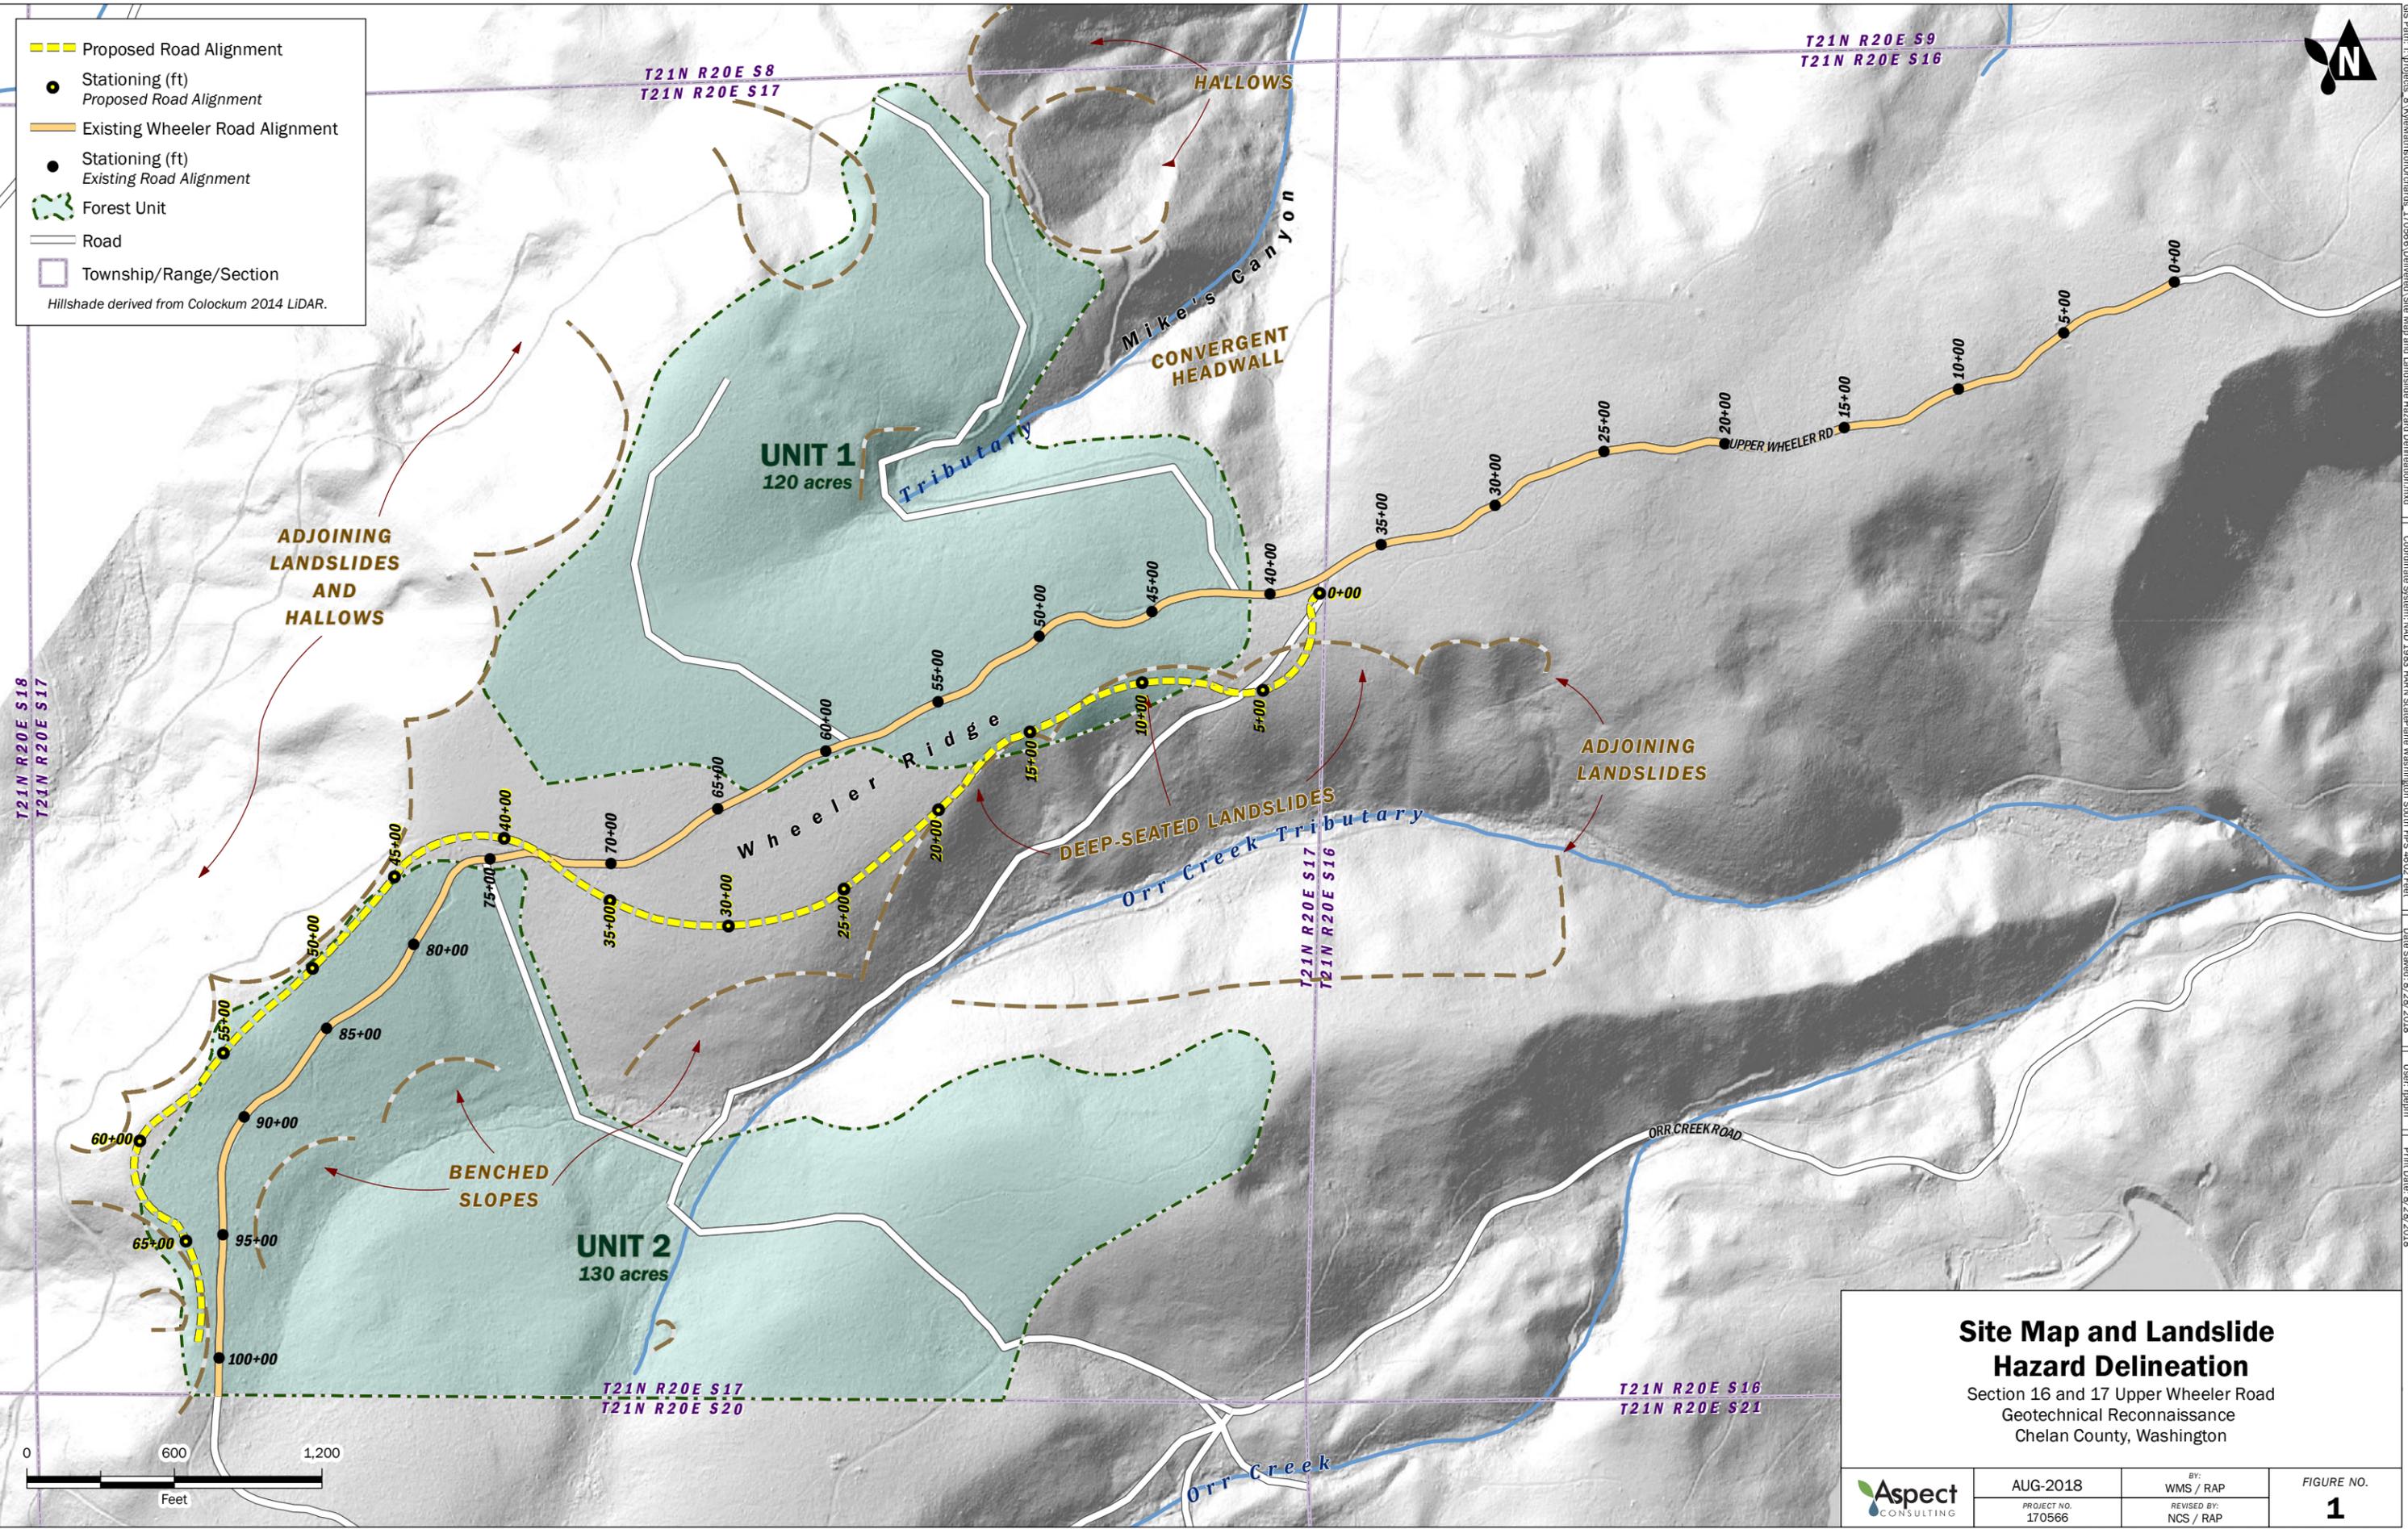
<h3>Site Map and Landslide Hazard Delineation</h3> <p>Section 16 and 17 Upper Wheeler Road Geotechnical Reconnaissance Chelan County, Washington</p>		
	AUG-2018 PROJECT NO. 170566	BY: WMS / RAP REVISED BY: NCS / RAP
		FIGURE NO. 1

In addition to the landslide feature delineation presented in the Slope Stability Reconnaissance (Aspect, 2017), we also observed some additional surficial indications that past landslide activity or slow ground creep may have occurred to the north of delineated Deep-Seated Landslides shown on Figure 1, and between Proposed Road Alignment Station 2+00 to 25+00. These indications consist of tilted or pistol-butted evergreen trees and areas of depressed or hummocky terrain. These surface features in our opinion, indicates landslide activity or ground creep has occurred consistent with those described in the Slope Stability Reconnaissance (Aspect, 2017).

Due to the proximity to delineated landslide activity, it is our opinion that there is an increased, moderate likelihood that landslide activity will negatively affect the Proposed Road Alignment

from approximately Station 0+00 (start) to 30+00, and 42+00 to 69+00 (end) over the design life of the road.

We estimate landslide or ground creep-induced movement could manifest as tension cracks and depressed/sagging areas, or as vertical movements causing offsets of the roadway. For these small movements, we anticipate that the roadway and drainages can be repaired/re-leveled with ongoing maintenance by WR after it occurs. A more extreme, but less likely, scenario is large-scale roadway movement on the order of several feet or more such that it might be most economical to WR to abandon the roadway and realign it further away from landslide activity.

We recommend WR frequently inspect the roadway alignment to identify areas and drainages that might require repair or re-leveling.

Similarly, we recommend the roadway realignment aim to limit the cuts and fills made to form a roadway prism to less than a few feet tall, with cut and fill slopes as flat as possible (our initial consideration is 2H:1V [horizontal:vertical] or flatter). This may not be possible in all areas, and slopes steeper than about 2H:1V should be addressed and evaluated in tandem with the project civil engineer (SCJ Alliance) on a case-by-case basis during the design-level phase.
