# MEMORANDUM

Project No. 180274

May 20, 2020

**Re:** Section 17 Geological Hazard Assessment

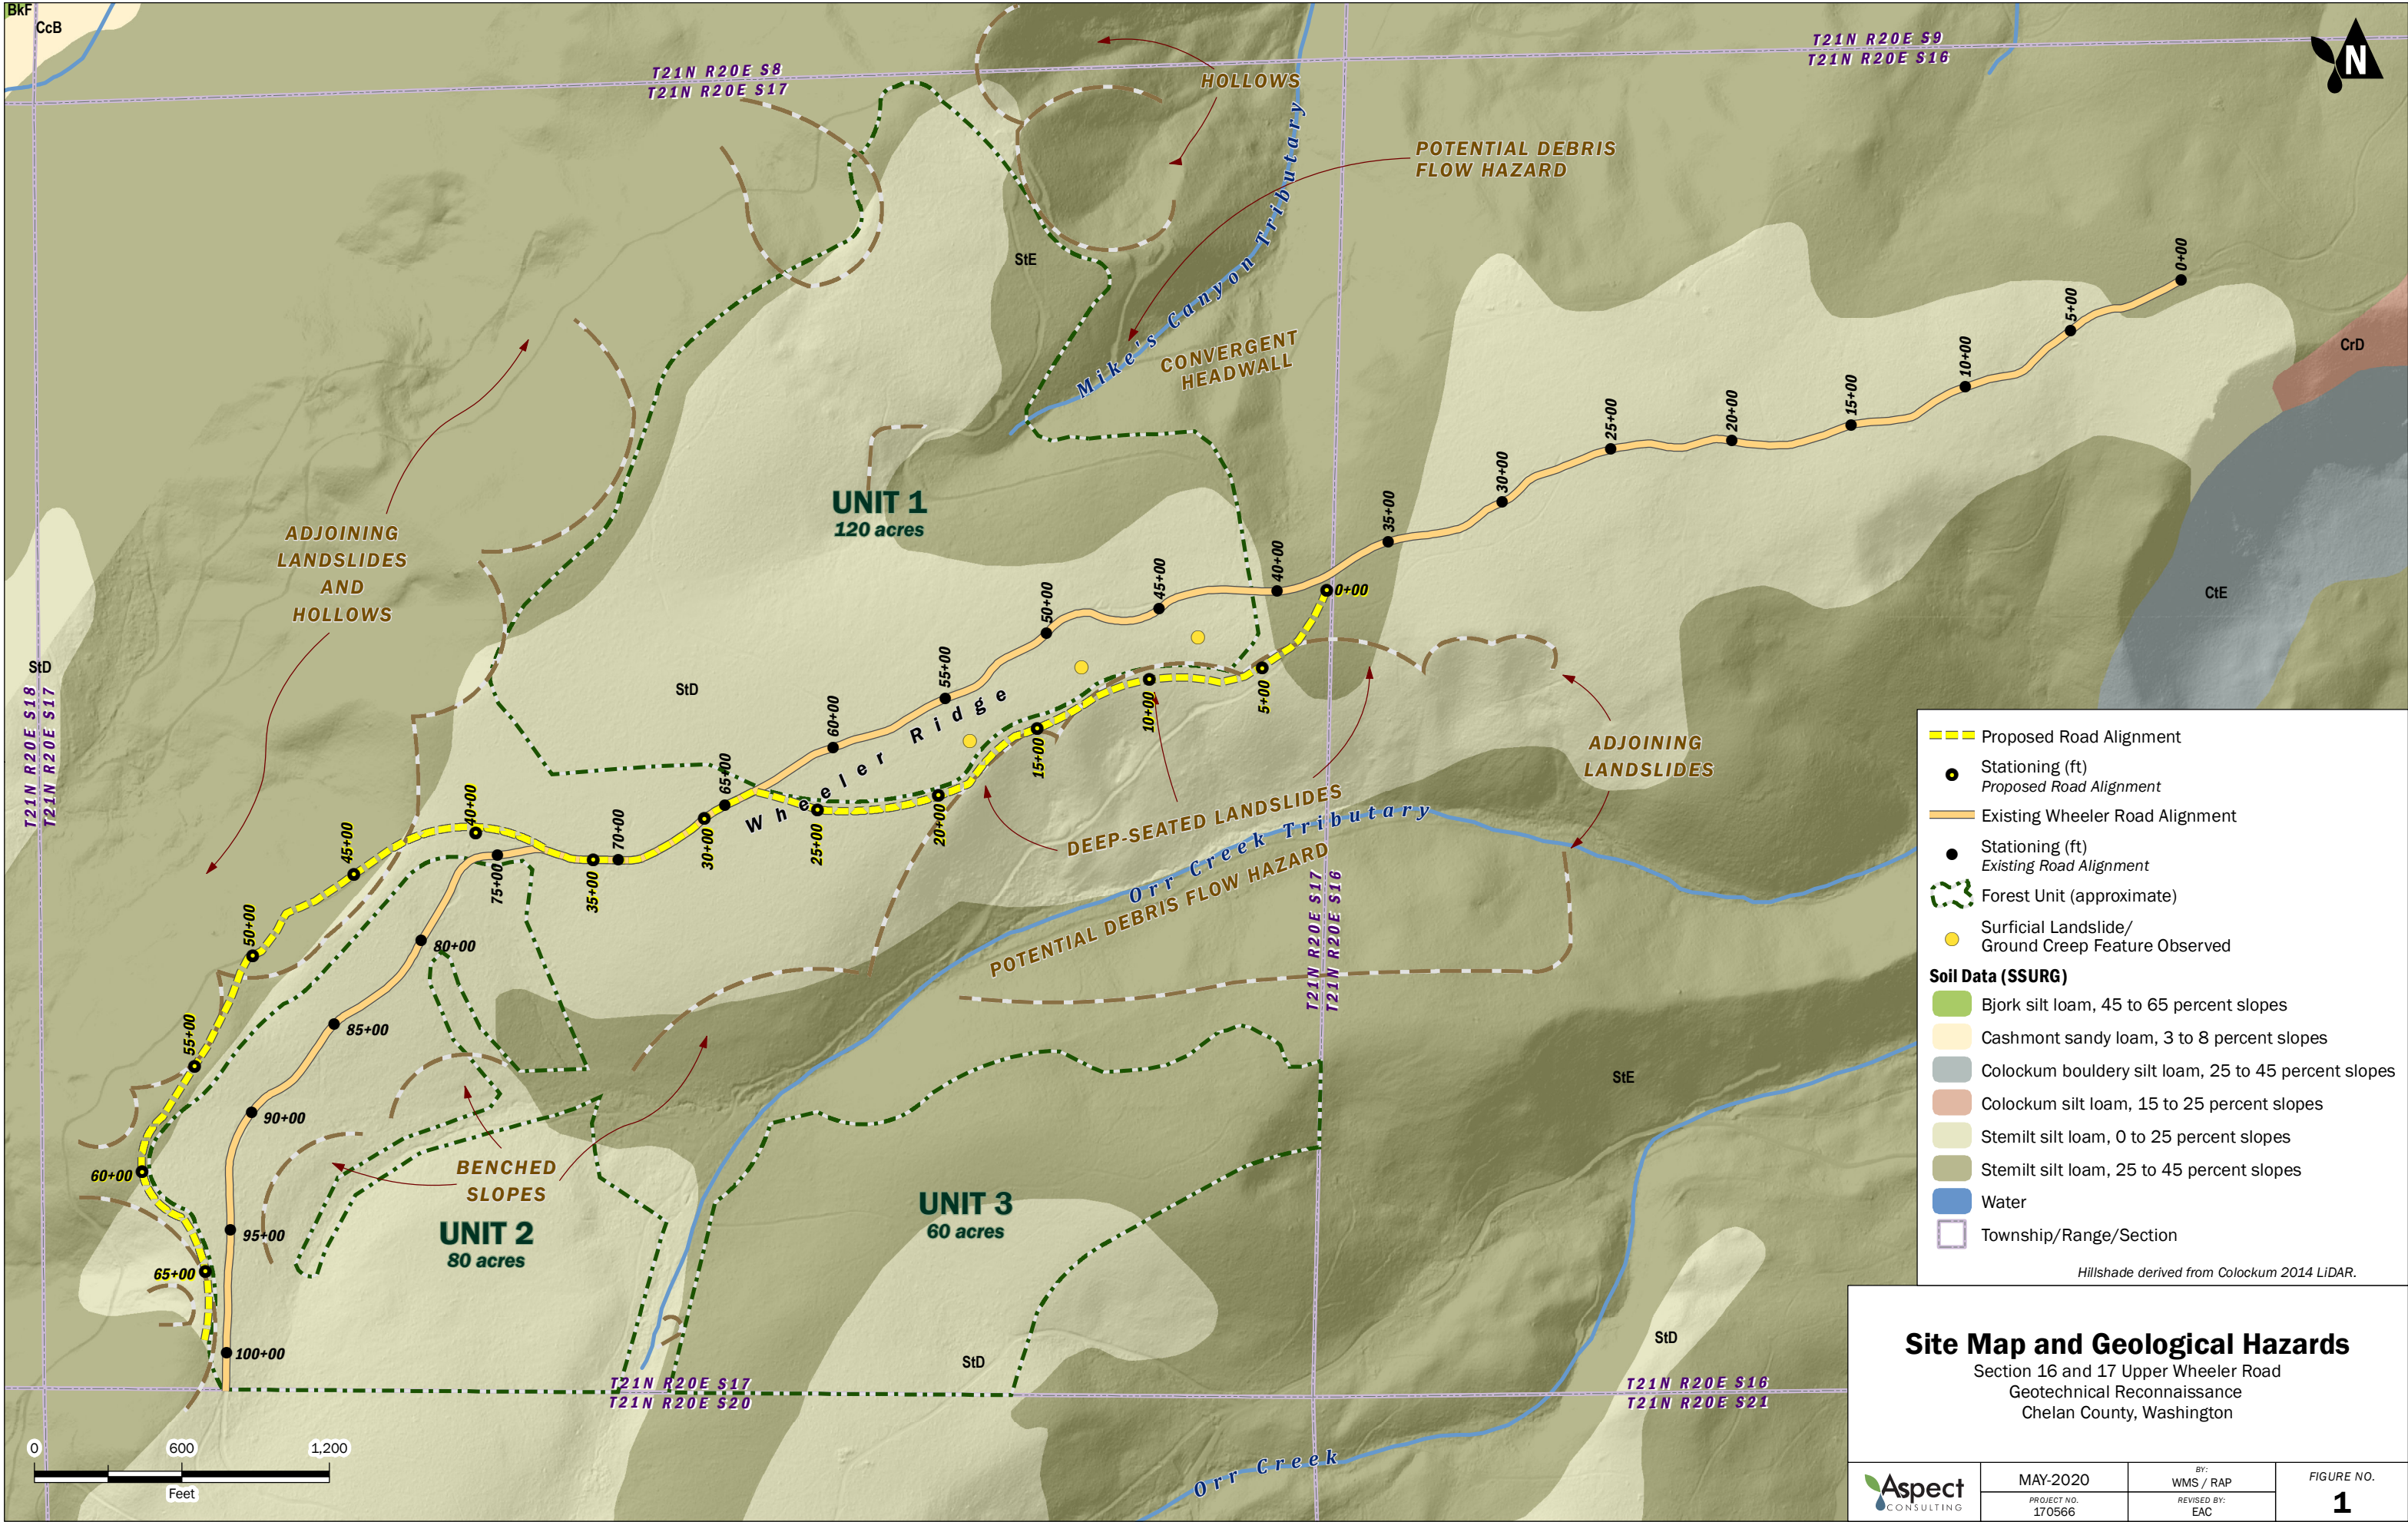
FIGURE NO.  
**1**

Geological hazards present at the Site vicinity include steep slopes, landslides, erodible soils, and debris flows. Figure 1 shows locations of geologic features and hazards discussed below. No project-specific geological hazards are present from snow avalanche activity. Geological hazards to the development can be mitigated by adhering to the recommendations listed below and in previous reports completed for the Site (Aspect, 2017; 2018a; 2018b) and for orchard development in Section 10 (Aspect, 2019). No offsite geological hazard impacts resulting from the development are anticipated.

- **Northeastern corner of Section 17.** Steep slopes exceeding 30 degrees (55 percent) are present adjacent to the eastern boundary of Unit 1. A convergent headwall measuring about 1,000 feet across and one or two hollows and inner gorges are present in the upper reaches of Mikes Canyon along the eastern boundary of Unit 1. Within Unit 1, there is evidence of a small landslide measuring about 50 feet across located on the northern sidewall of the tributary drainage to Mikes Canyon.
- **Northwestern third of Section 17.** Several adjoining landslides are present on steep slopes exceeding 30 degrees (55 percent) adjacent to the western boundaries of Units 1 and 2.

These slopes drop about 800 feet vertically from Wheeler Ridge to the bottom of the Squilchuck canyon. Several hollows up to between about 100 and 500 feet across are present in the upper portion of the canyon wall along the northwestern boundaries of Units 1 and 2. The upslope extent of these hollows terminates at or slightly within the boundaries of the Units 1 and 2.

- **Orr Creek Tributary.** Within Unit 2 in the upper reaches of the Orr Creek tributary, benched slopes suggesting slow moving creep processes were observed along the northern sidewalls of the drainage on slopes of about 20 degrees (35 percent). On the southern sidewall between Units 2 and 3, a small rotational landslide measured about 50 feet across. Further down the drainage in the region between Units 2 and 3, multiple adjoining slope failures were observed in the northern and southern sidewalls having slopes of 30 degrees (55 percent) or more. These adjoining landslides lie adjacent to the southern and northern boundaries of Units 1 and 2, respectively. At least two deep-seated rotational slides measuring about 200 feet across were observed with toes extending to the bottom of the drainage. Additionally, we observed surficial indications that past landslide activity or slow moving ground creep extends several hundred feet west from the headscarps of the adjoining landslides into Unit 1 (Figure 1). These indications consist of tilted or pistol-butted evergreen trees and areas of depressed or hummocky terrain.

- Limit timber harvest, land clearing, and orchard development to the proposed areas shown on Figure 1. Forest and orchard activities outside of this area could increase risk of slope instability, especially in areas having slopes greater than 35 percent.

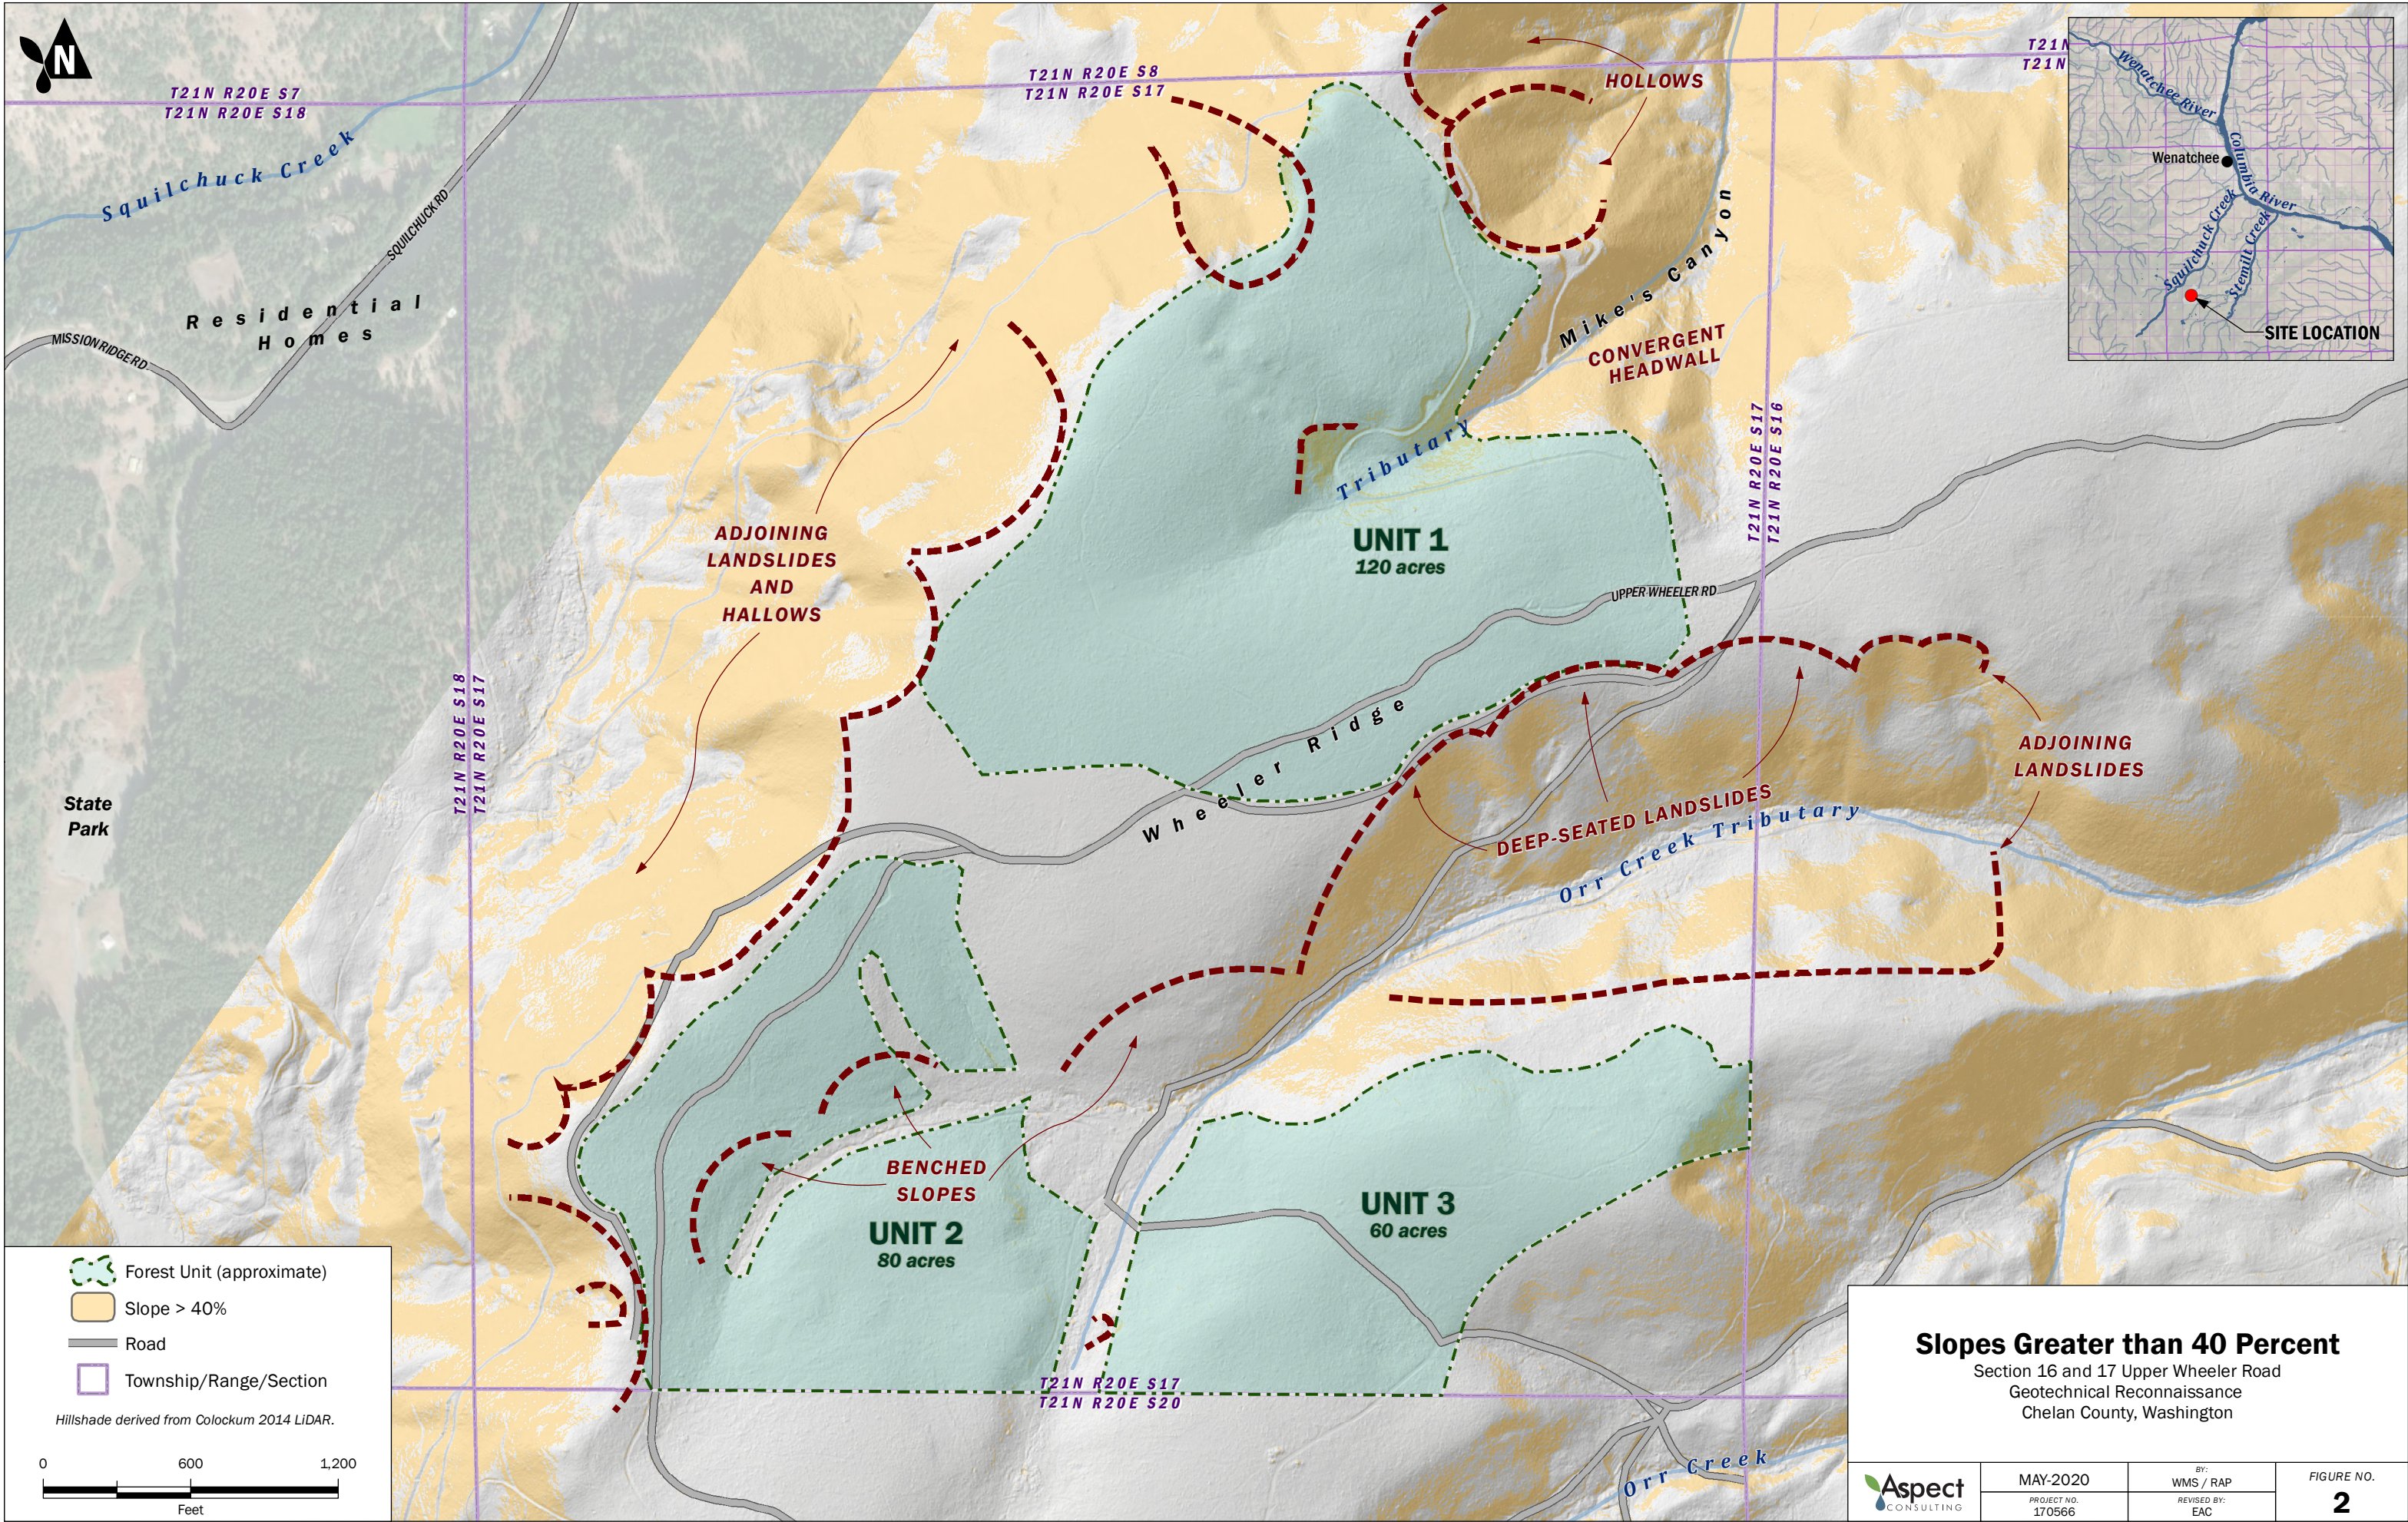
The Chelan County Code identifies slopes greater than 40 percent as presenting risk of erosion or landslide. Slopes on or near the Site greater than 40 percent are located along the walls of Squilchuck and Mikes Canyons in the northern portion of Section 17 and in the northern sidewall of the Orr Creek tributary separating Units 1 and 3. With one exception, no slopes exceeding 40 percent are present within the area proposed for development (Units 1, 2, and 3). The exception is in the western portion of Unit 1 where the existing primitive road makes a switchback as it traverses the tributary to Mikes Canyon. The slope angle of a small area in the northern sidewall and southern sidewall of this drainage ranges between 40 and 50 percent. Although this steep slope lies within Unit 1, we understand no development is proposed for the slope and we recommend avoiding clearing or altering the slope. Figure 2 shows areas having slopes of 40 percent or more; the angle most slope failures were observed to have occurred on (Aspect, 2017).

Clearing of native landcover on slopes of 35 percent or greater should be minimized. Where timber must be harvested to support adequate sunlight adjacent to orchard margins, we recommend maintaining native grass, shrubs, and soil to minimize runoff, erosion, and infiltration into the subsurface. Areas of disturbed groundcover should be replanted immediately after clearing.
