Table 6: Potential Project Areas Identified by the Nason Roads Assessment

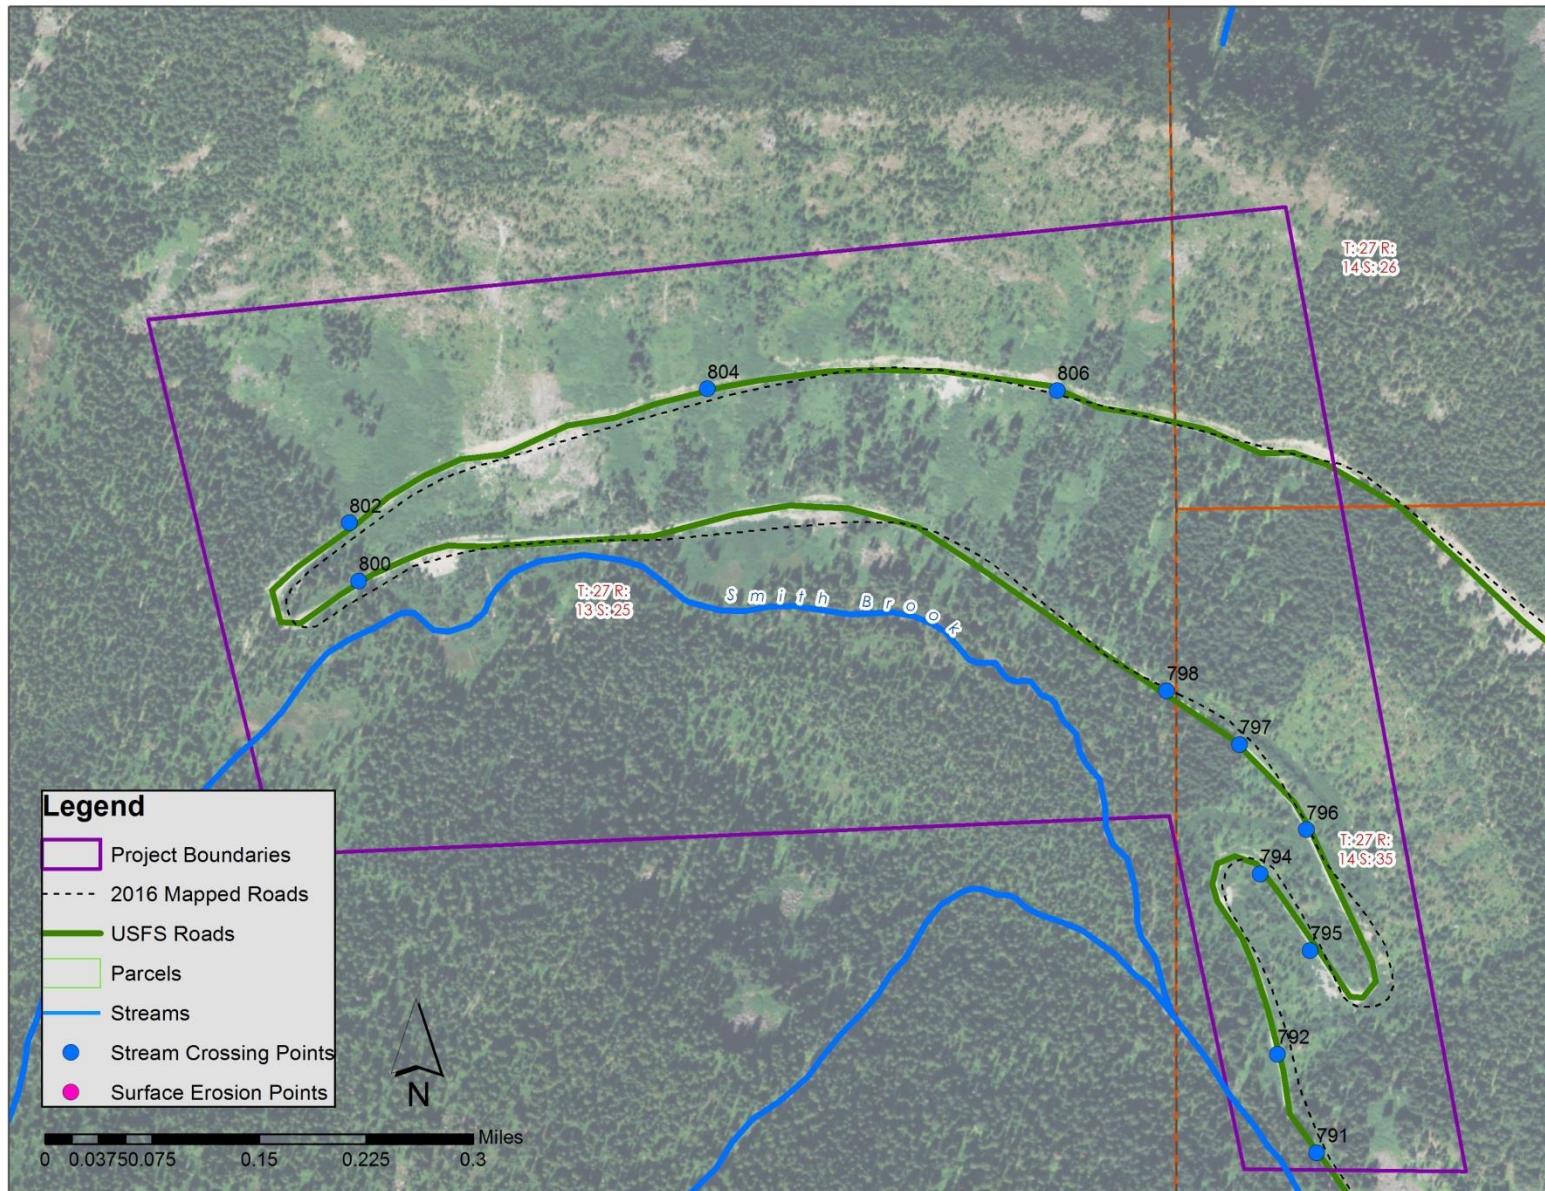
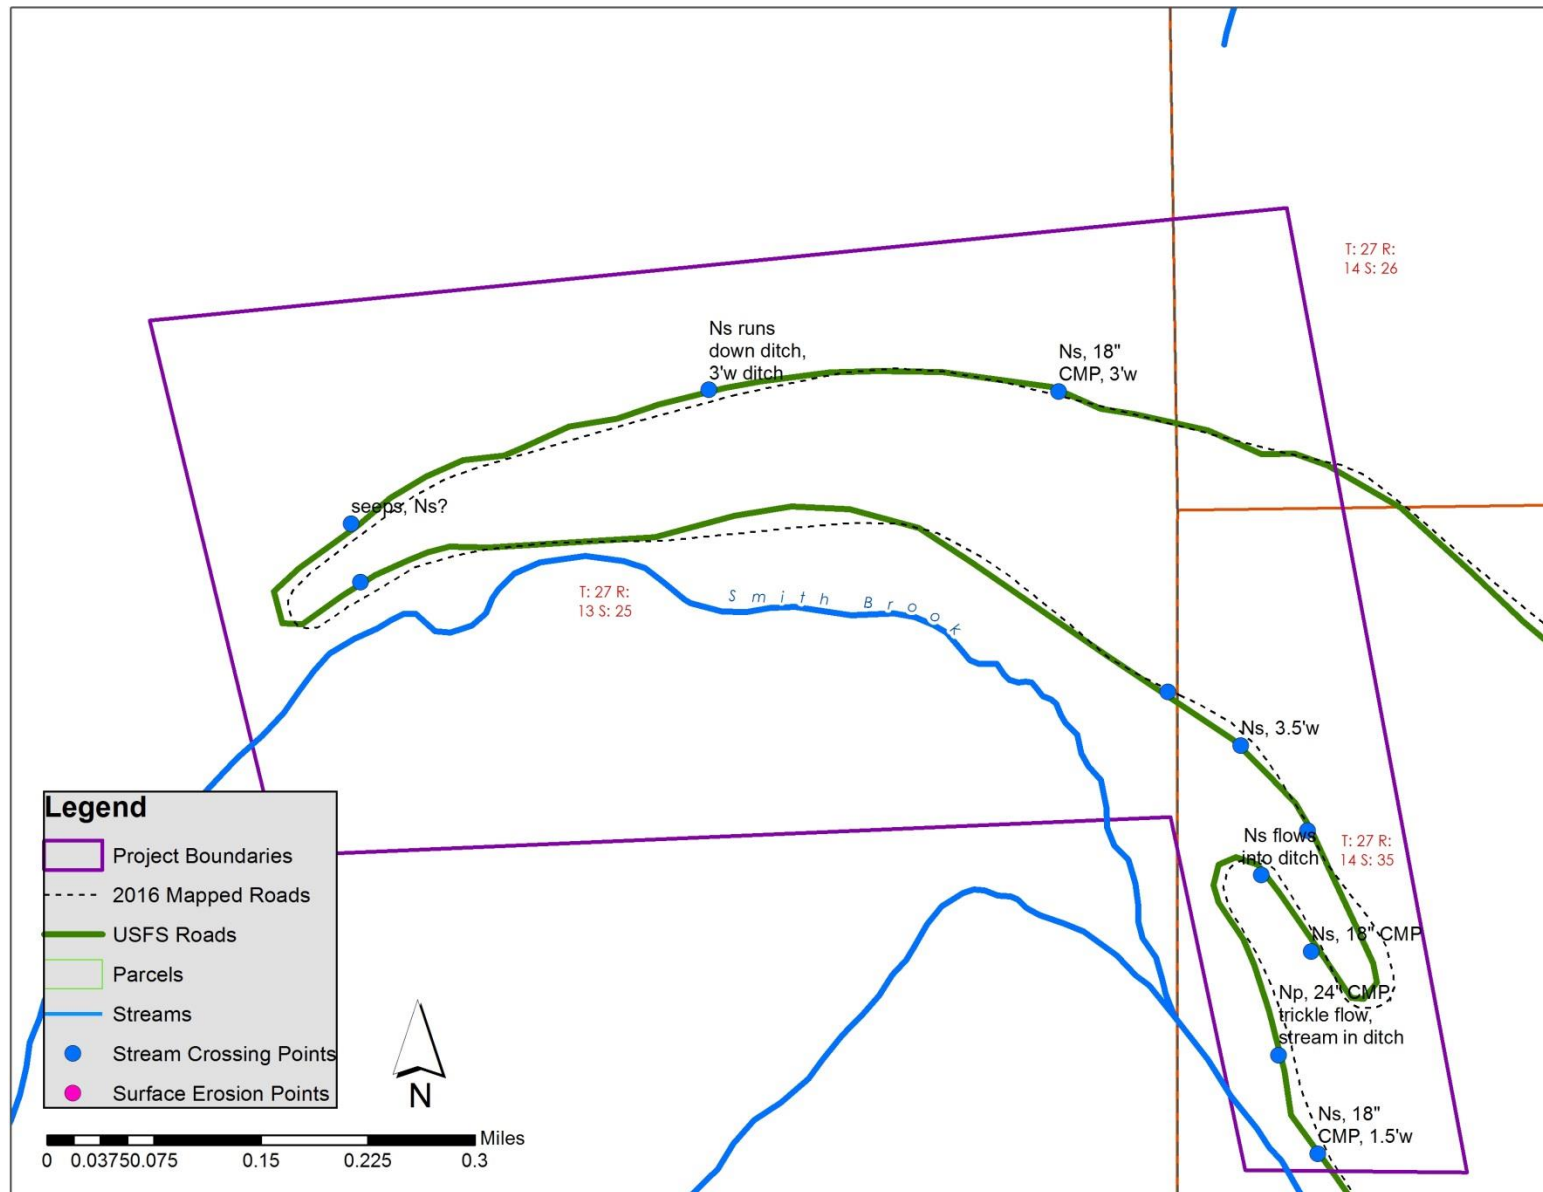
Project 1: Location of 2016 field inventory data overlaid on 2013 aerial photo

#	Location	GPS points	Name	Description	Notes
1		797, 798, 800, 802, 271325 804, 806	Rainy Creek Road	The upper switchback of Smithbrook road ranks moderate for general erosion potential delivery to streams and there is a high potential for sediment delivery near two of the stream crossings. Field inventory mapped 5 stream crossings with direct sediment delivery to streams.	Not likely to be able to de-commission this road as it provides recreation access and through access to the Little Wenatchee river
2	261401, 261402	85 points*	USFS road 6970	Across hwy 2 from Smithbrook this section of road has moderate erosion potential with several stream crossings with high erosion potential. Field inventory mapped 16 road surface erosion points and 41 stream crossings. This area is south of Hwy 2 and Nason creek is north of the Hwy.	This road is part of the Mill Creek Nordic Center special use system. Just past junction with 116, it is blocked by a rock berm. There are drainage issues. This road was partially decommissioned in 1994 past junction with 511.

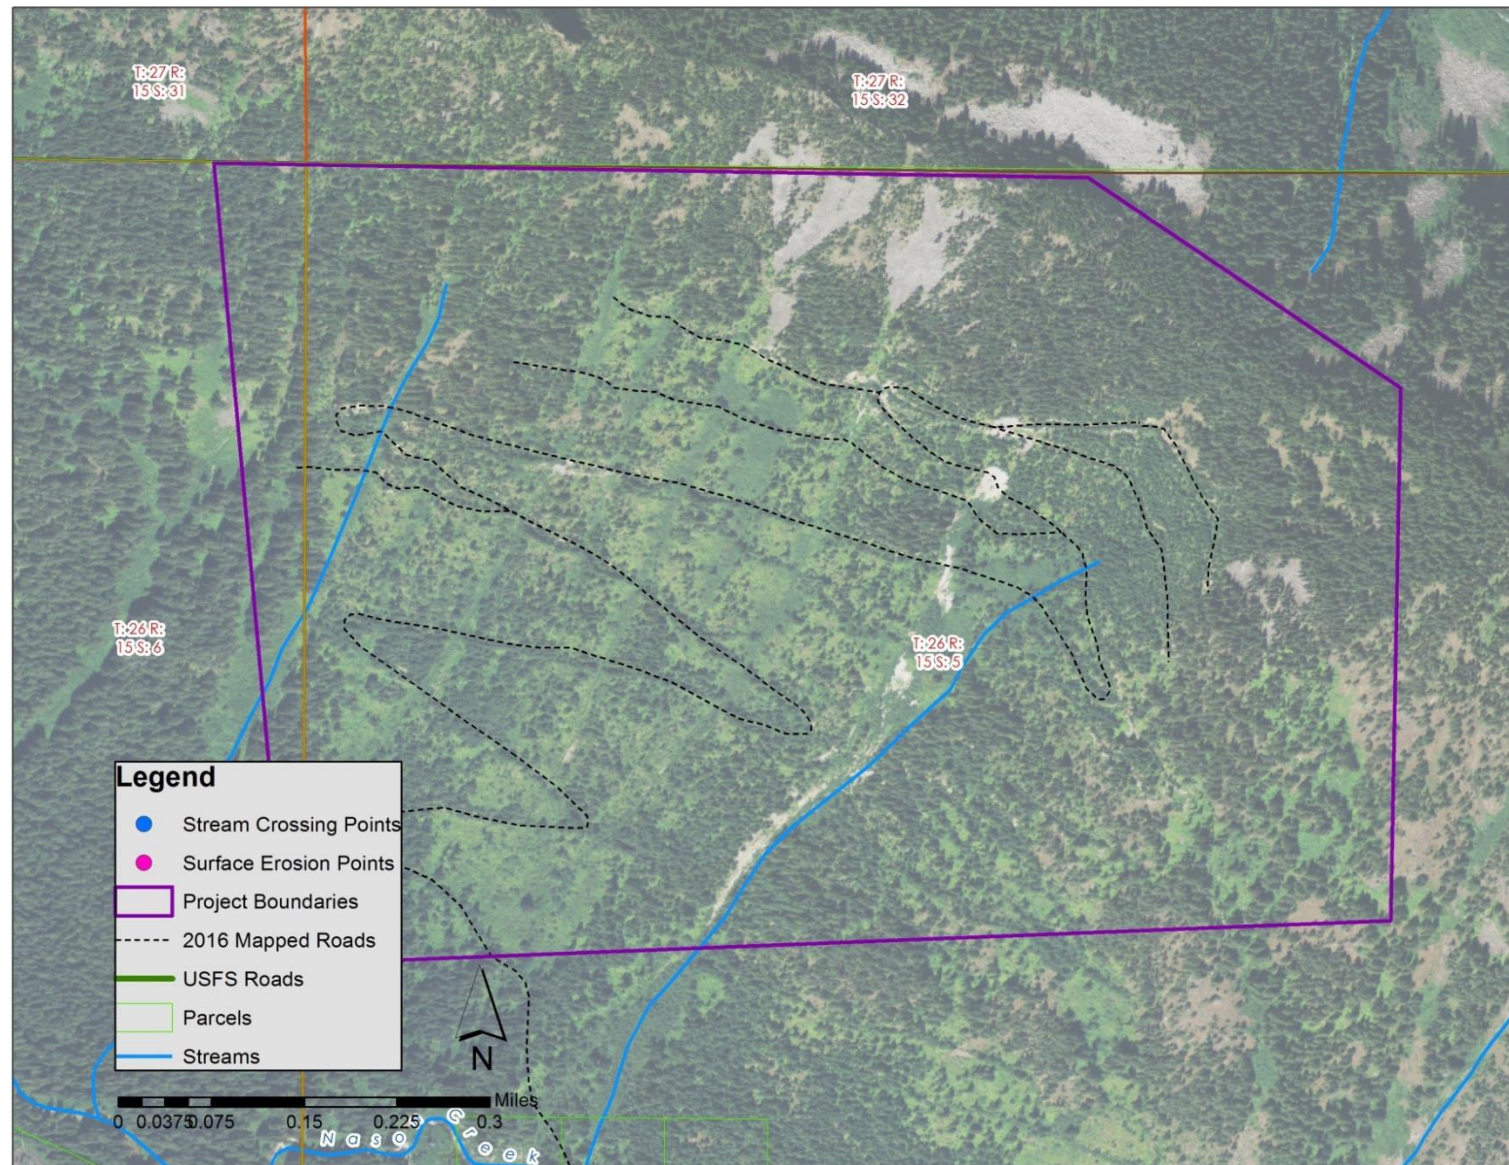
3	261505	None		This road system is not mapped as USFS roads and was missed during the field inventory. It was added based upon DNR maps and aerial photo interpretation. If this road system exists, it is within moderate to high erosion potential with ~30 stream crossings	Needs field verification
4	261507	464, 546, 550-555, 557-8, 560, 562	Mill Creek 1 (Spike and Switcher) USFS 6960	This project is a section of Mill Creek road plus a switchback up under the BPA powerlines with 3 surface erosion points and 6 stream crossings (5 fords). This section of road is ranked moderate for erosion potential to deliver to streams with 2-3 high potential for erosion stream crossings. The surface erosion points are described as follows: seep running across the road, water running across the road, erosion with cutslope failure and water running across the road.	Need to integrate information from the MRA
5	261513, 261518	468, 469, 472, 476	Mill Creek 2 (Guthrie Loop, Guthrie Heights) USFS 6960	This section of Mill Creek road and spur roads rank moderate for erosion potential to streams with 6 stream crossings that rank as high potential to deliver to streams. Field inventory mapped 4 stream crossings (2 fords).	The field inventory may not have covered the Guthrie heights part of this road which has ~7 stream crossings. Guthrie loop area looks like it may be wetland and a lot of roads/fill/disturbed areas.

Project 3: This road system was missed during the 2016 field inventory and will be walked in 2017 to collect stream crossing and surface erosion data. Roads mapping depicted was secured from the DNR roads layer.

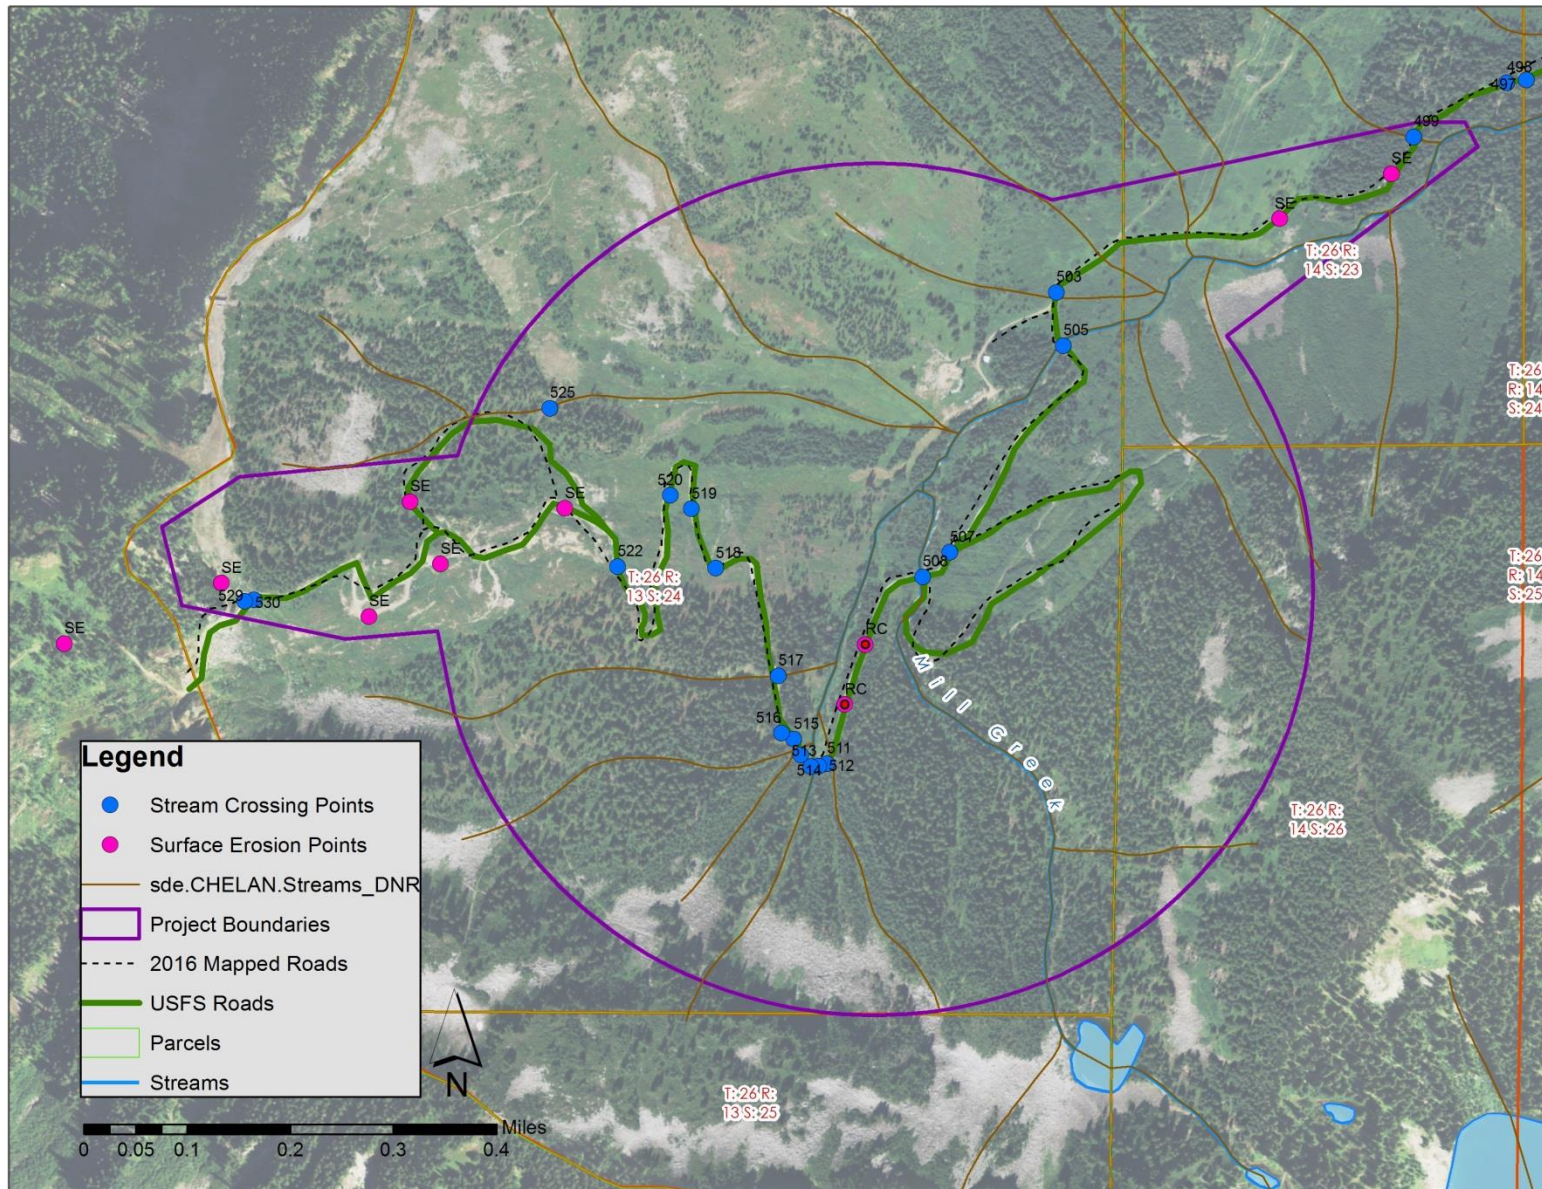
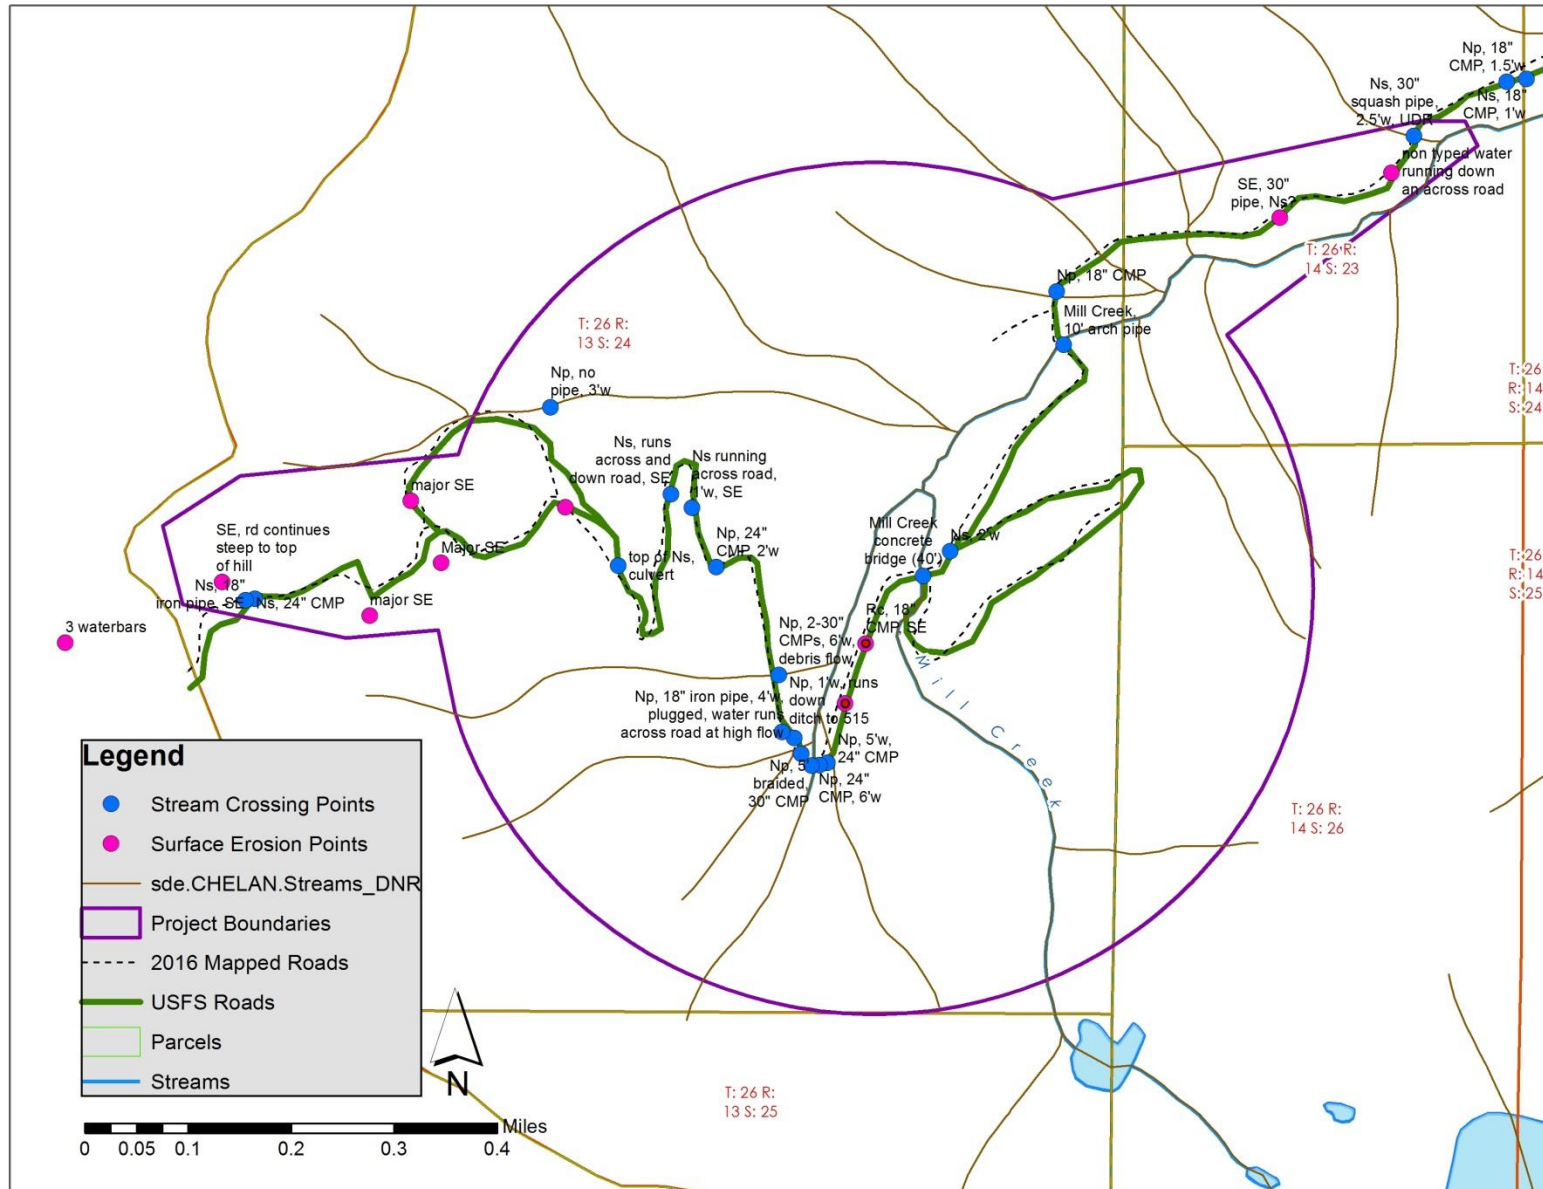
Project 6: Location of 2016 field inventory data overlaid on 2013 aerial photo

6	261324	499-501, 503, 505, 507-520, 522, 525, 527-530, 532, 542, 545	Mill Creek 3, Outer Limits USFS 6960	This is the last driveable switchback in Mill Creek road. It is mapped as moderate erosion potential with one area having high erosion potential for stream delivery. In the 350' of road that makes this switchback, the field inventory maps 6 stream crossings (2 with plugged pipe and water running across the road at high flow and one pipe where flows run down a ditch).	Provides access to the PCT and back side of Stevens Pass Ski area. The upper end of Mill creek road has so much water on it, that it lacks fines and consists of large cobble to boulders.
7	261503		Above DOT maintenance facility	This road system is not mapped as USFS roads and was missed during the field inventory. It was added based upon aerial photo interpretation. If this road system exists, it is within moderate erosion potential with high potential for erosion at 3 stream crossings. Aerial photo interp indicates there may be 5 stream crossings	Needs field verification

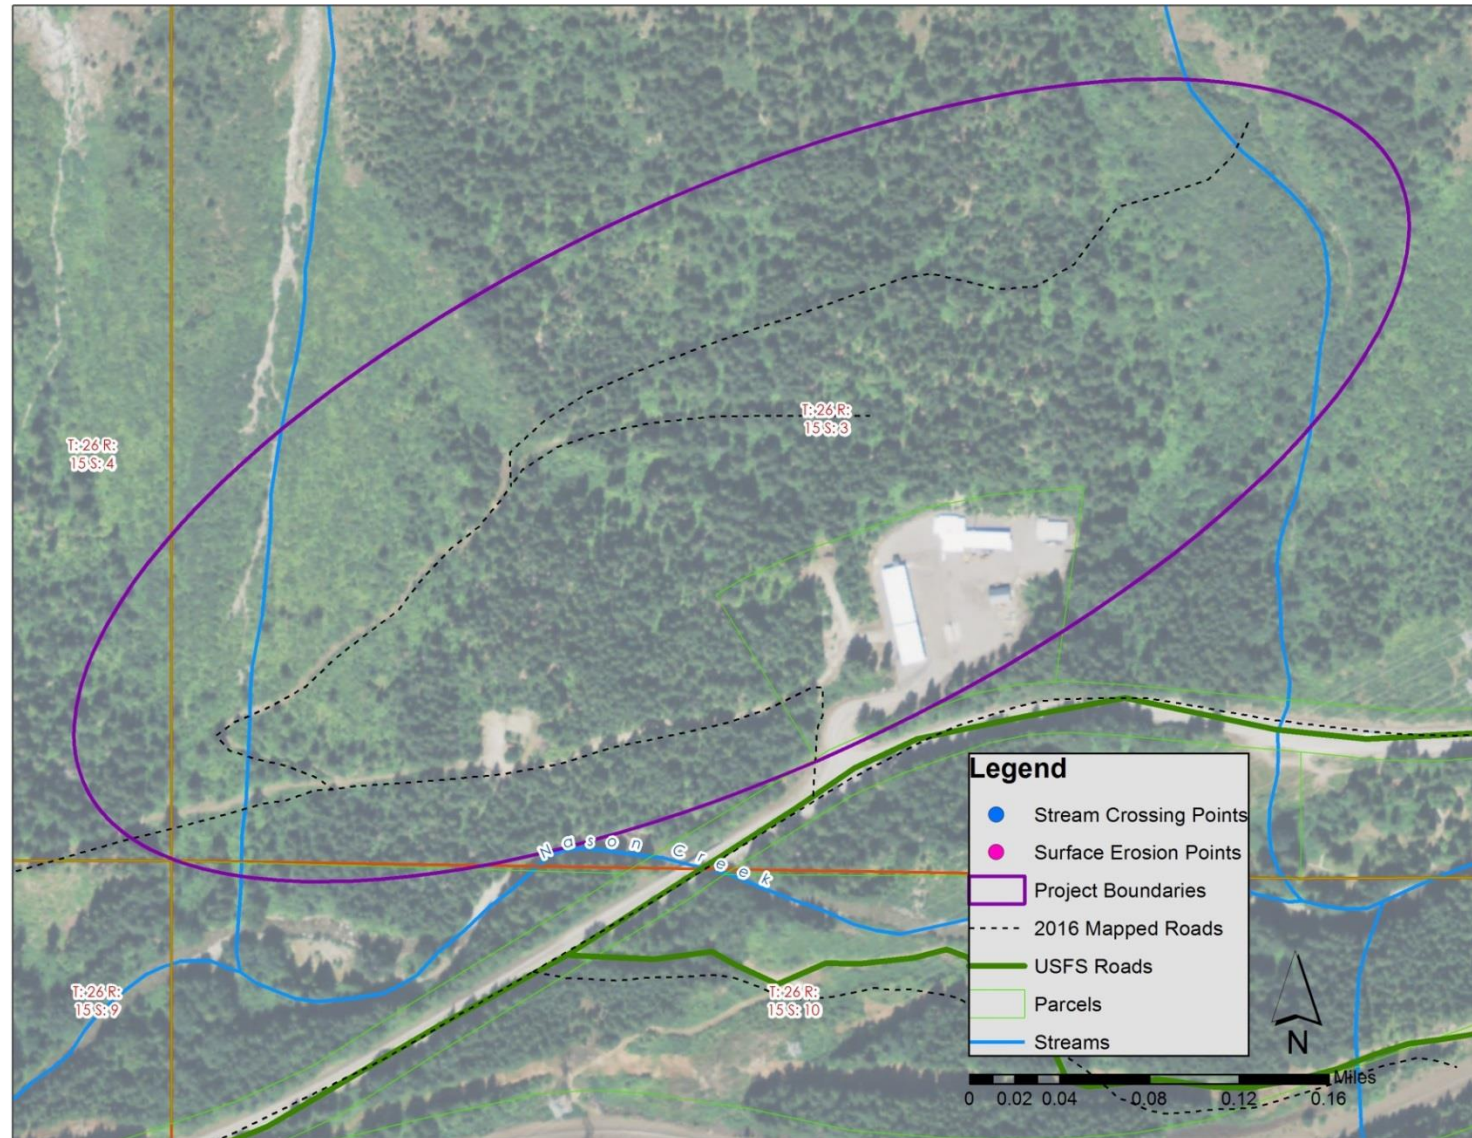
Project 7: This road system was missed during the 2016 field inventory and will be walked in 2017 to collect stream crossing and surface erosion data.

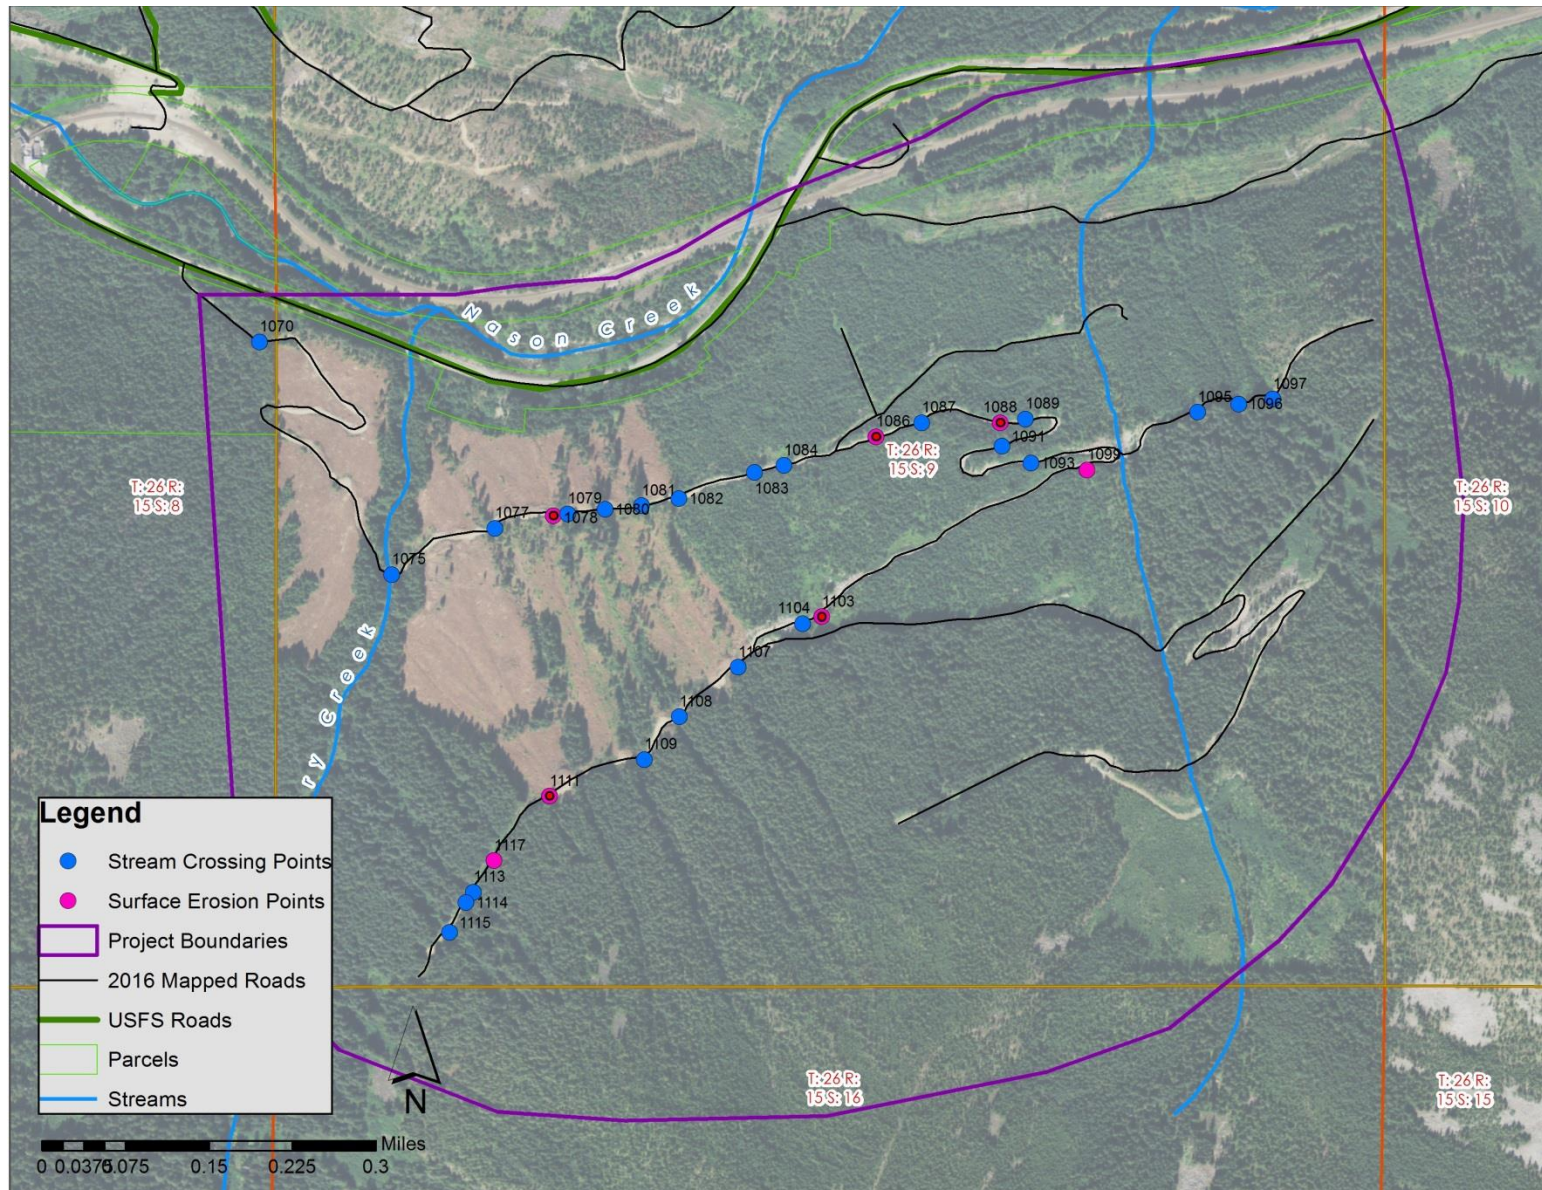
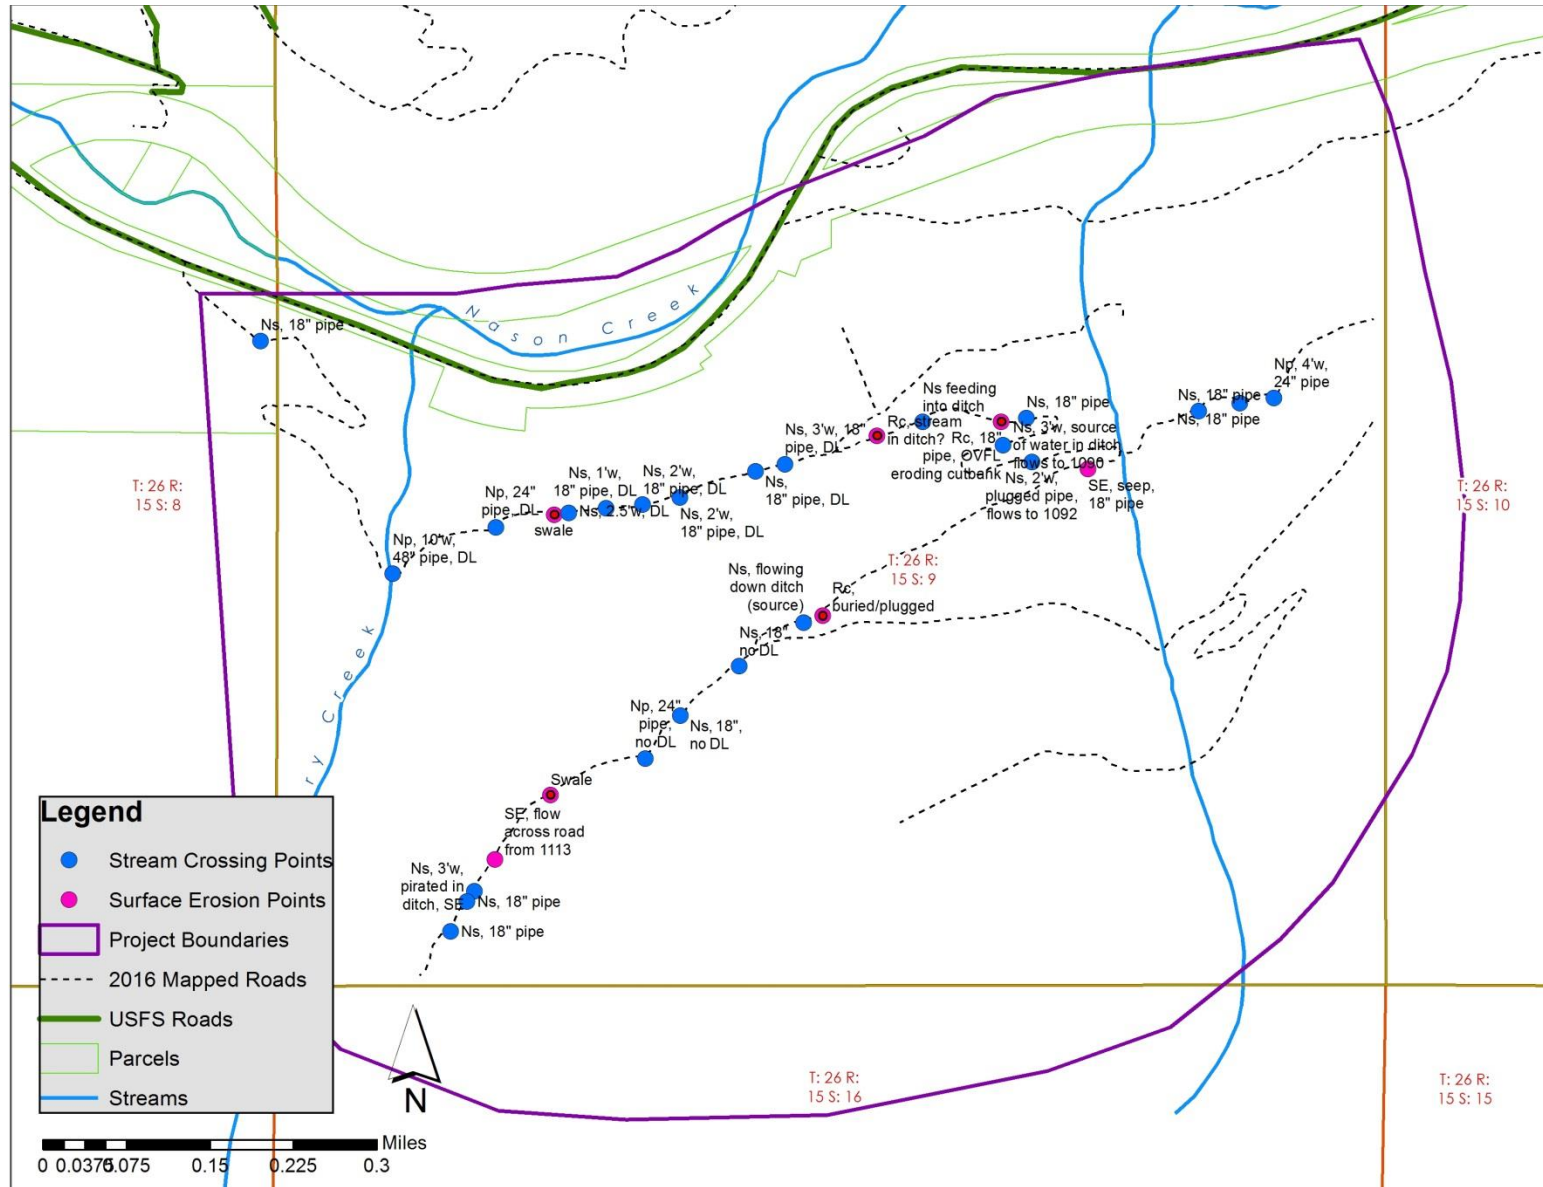
Project 8: Location of 2016 field inventory data overlaid on 2013 aerial photo

8	261509	1070, 1075, 1077-1084, 1086-1089, 1091, 1093, 1095-7, 1099, 1103, 1104, 1107-1109, 1111, 1113-1115, 1117	Arrowhead access	This parcel is owned by Weyerhaeuser. The road switchbacks up the hillside providing access to Arrowhead Mtn. Modeling indicates moderate to high erosion potential for delivery to streams. Field inventory mapped 2 surface erosion points (water flows across the road, seep with erosion) and 23 stream crossings (5 direct sediment delivery to stream, 1 plugged pipe, 4 have water source from ditch or stream flows in ditch).	
9	261501	420, 429, 430, 440, 441, 778		Moderate erosion potential with one area of high erosion potential. Field inventory maps 3 surface erosion points; one described as fill slope failure and one described as 500' long surface erosion. This area includes at least 1 perennial stream crossing.	
10	261607	737, 739, 752, 2352, 2353, 2355, 2357, 2358, 2369, 2370, 2376-2378, 2380, 2381, 2385, 2386, 2388, 2389, 2392-2395, 2398, 2399, 2402		This parcel was purchased by Western Rivers Conservancy and sold to USFS in 2012. The road switchbacks up a steep slope and crosses several drainages. Modeling indicates there is moderate to high potential for surface erosion throughout most of the 4 miles of roads. The field inventory mapped four surface erosion points and 17 stream crossings on the roads that switchback up the hillside.	Non-system road

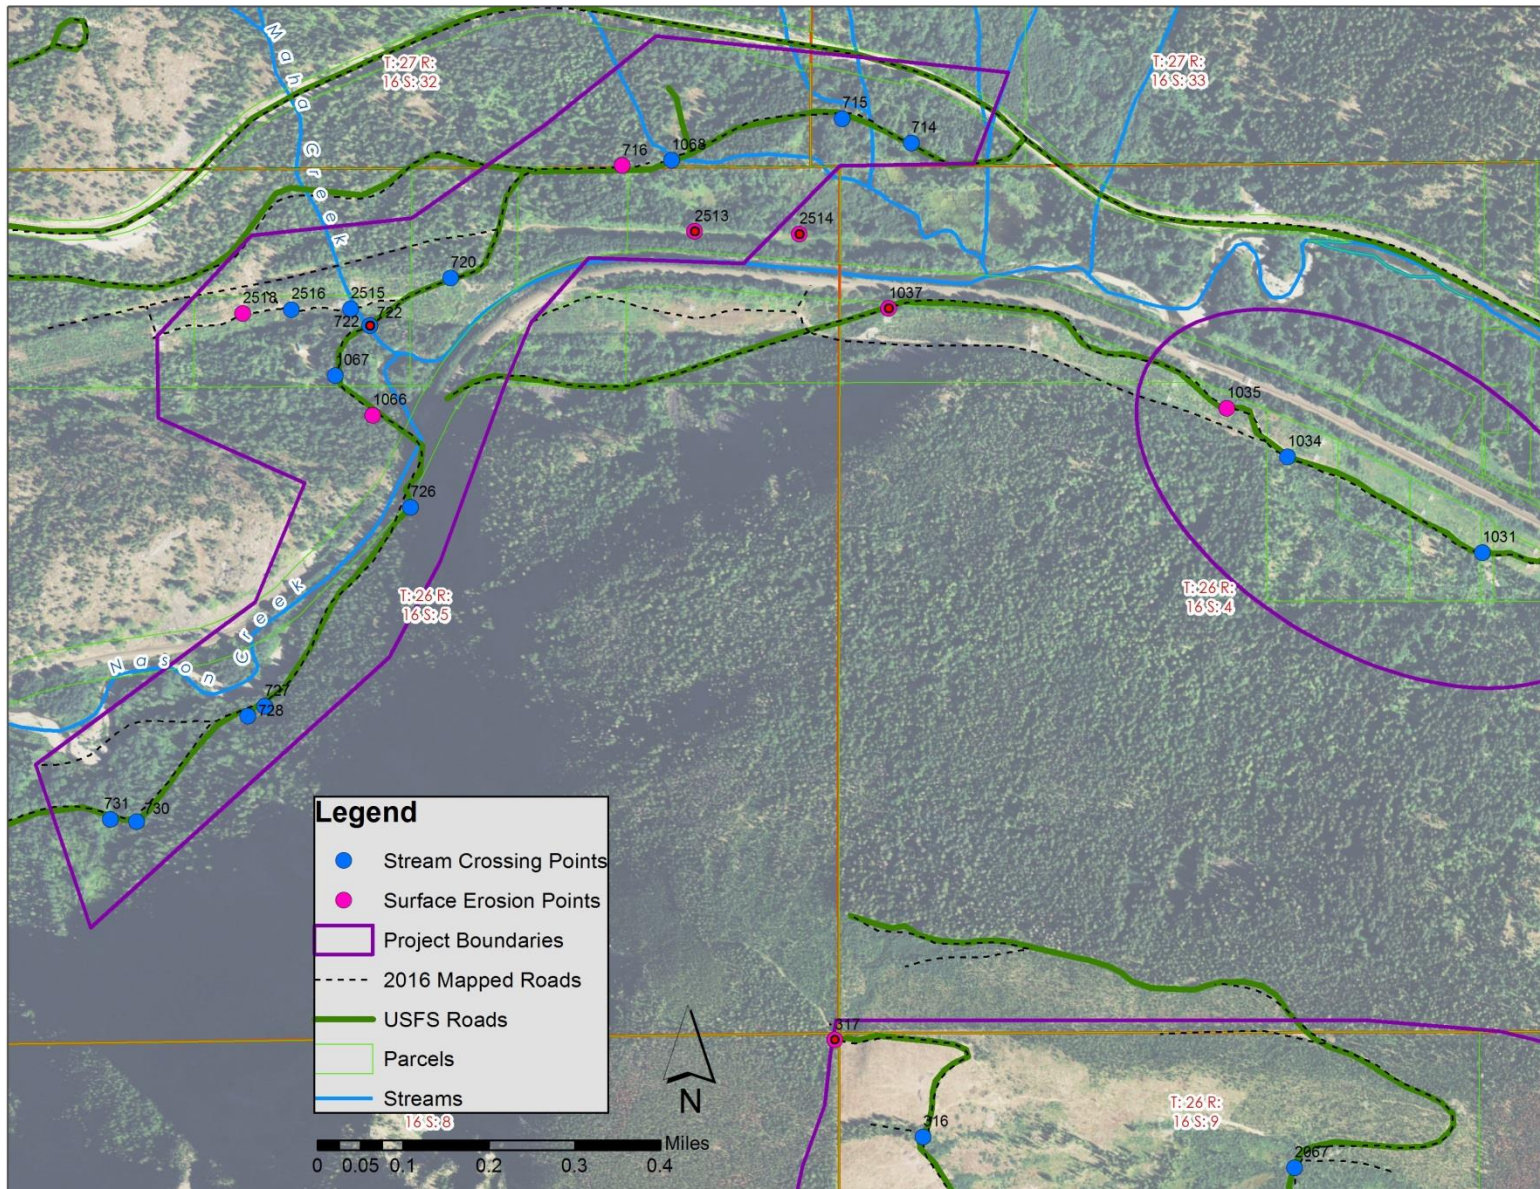
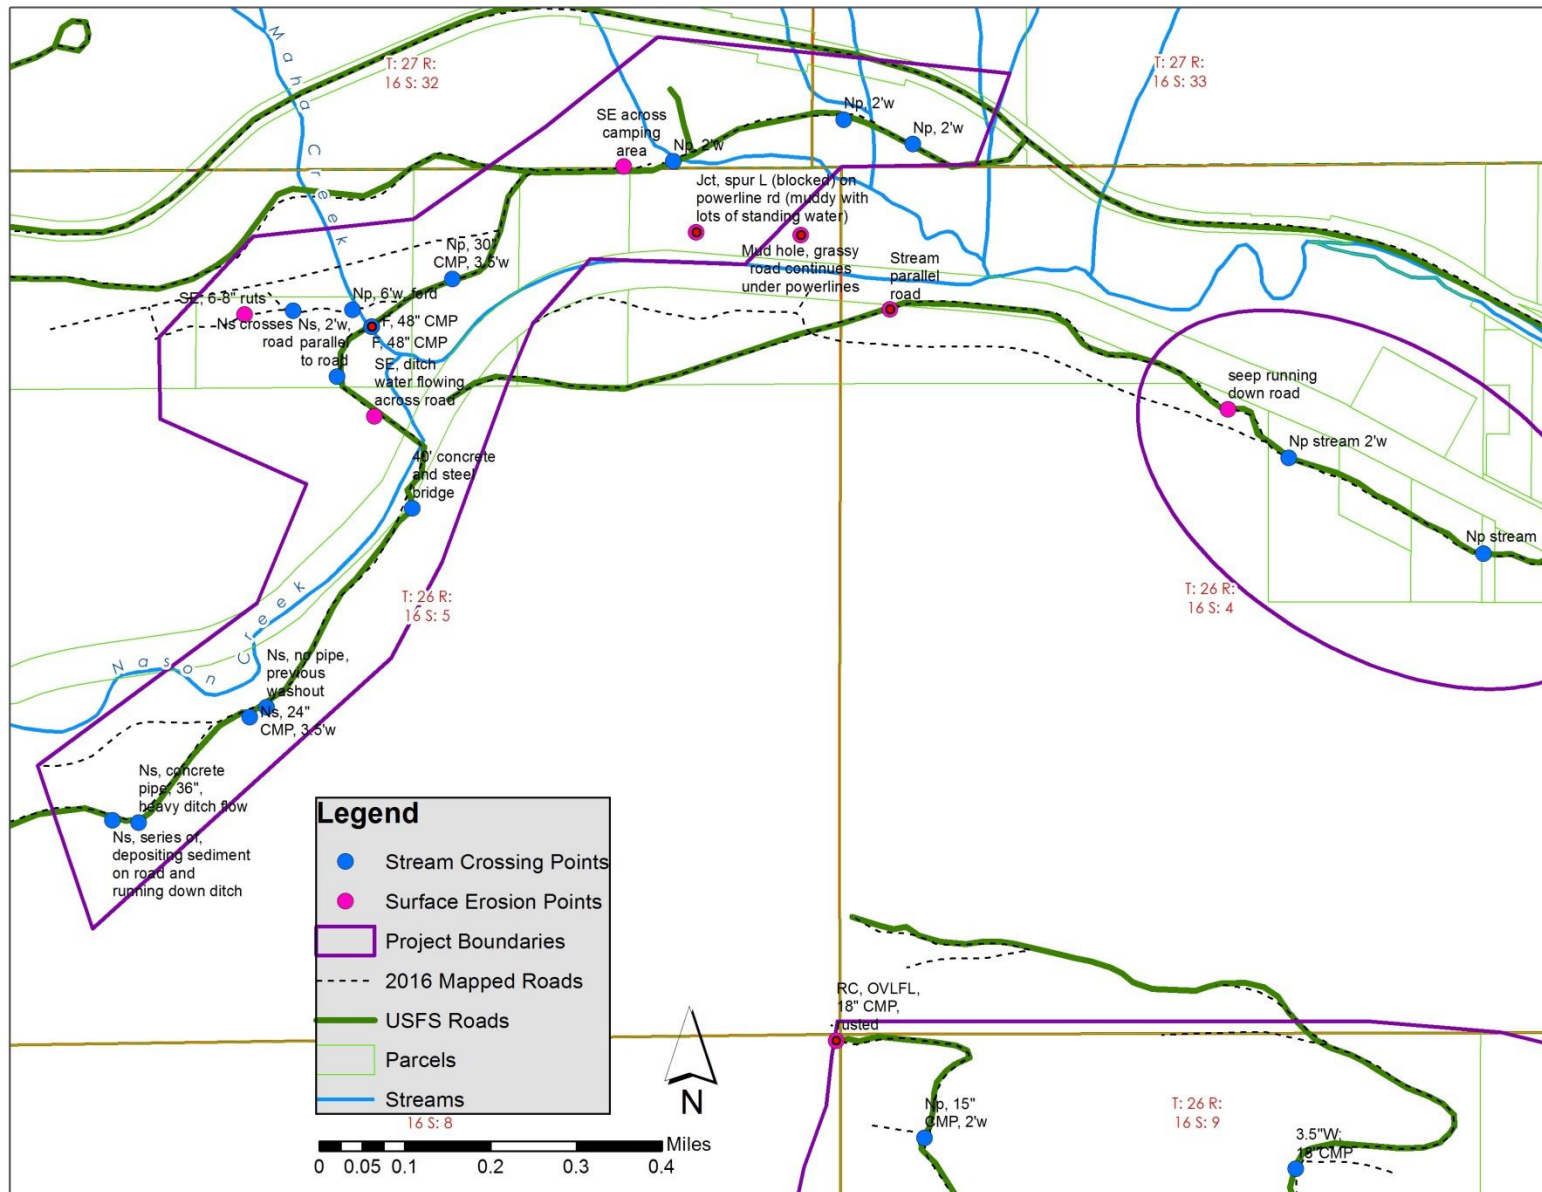
Project 11: Location of 2016 field inventory data overlaid on 2013 aerial photo

11	26164, 26165	BPA access 1031, 1034, 1035 and White Pine 714-716, 720, 722, 726-728, 730, 731, 1066-68, 2513, 2515, 2516, 2518	White Pine road (6950) and BPA access road through Merritt, USFS 6940-615	This project area could be divided into two project areas based upon land ownership. White Pine road is owned by USFS and it has evidence of surface erosion in a few areas, water ponds on the road near the BNSF bridge crossing, and there is one stream crossing that washes out the road frequently. The other area is south of Nason Creek and South of the BNSF road prism. Modeling depicts this entire road as moderate to high risk for surface erosion to streams. In reality, the BNSF prism is between the road and Nason Creek so I'm not sure how much surface erosion actually gets to Nason Creek. The field inventory mapped 2 surface erosion points and two stream crossings including a seep running down the road and a stream running parallel to the road.	White Pine road should be stormproofed; it provides access to private land and the White Pine trailhead. The road south of Nason Creek provides access to BPA towers and the MRA recommends changing the ML status to closed.
