Table 6: Potential Project Areas Identified by the Nason Roads Assessment

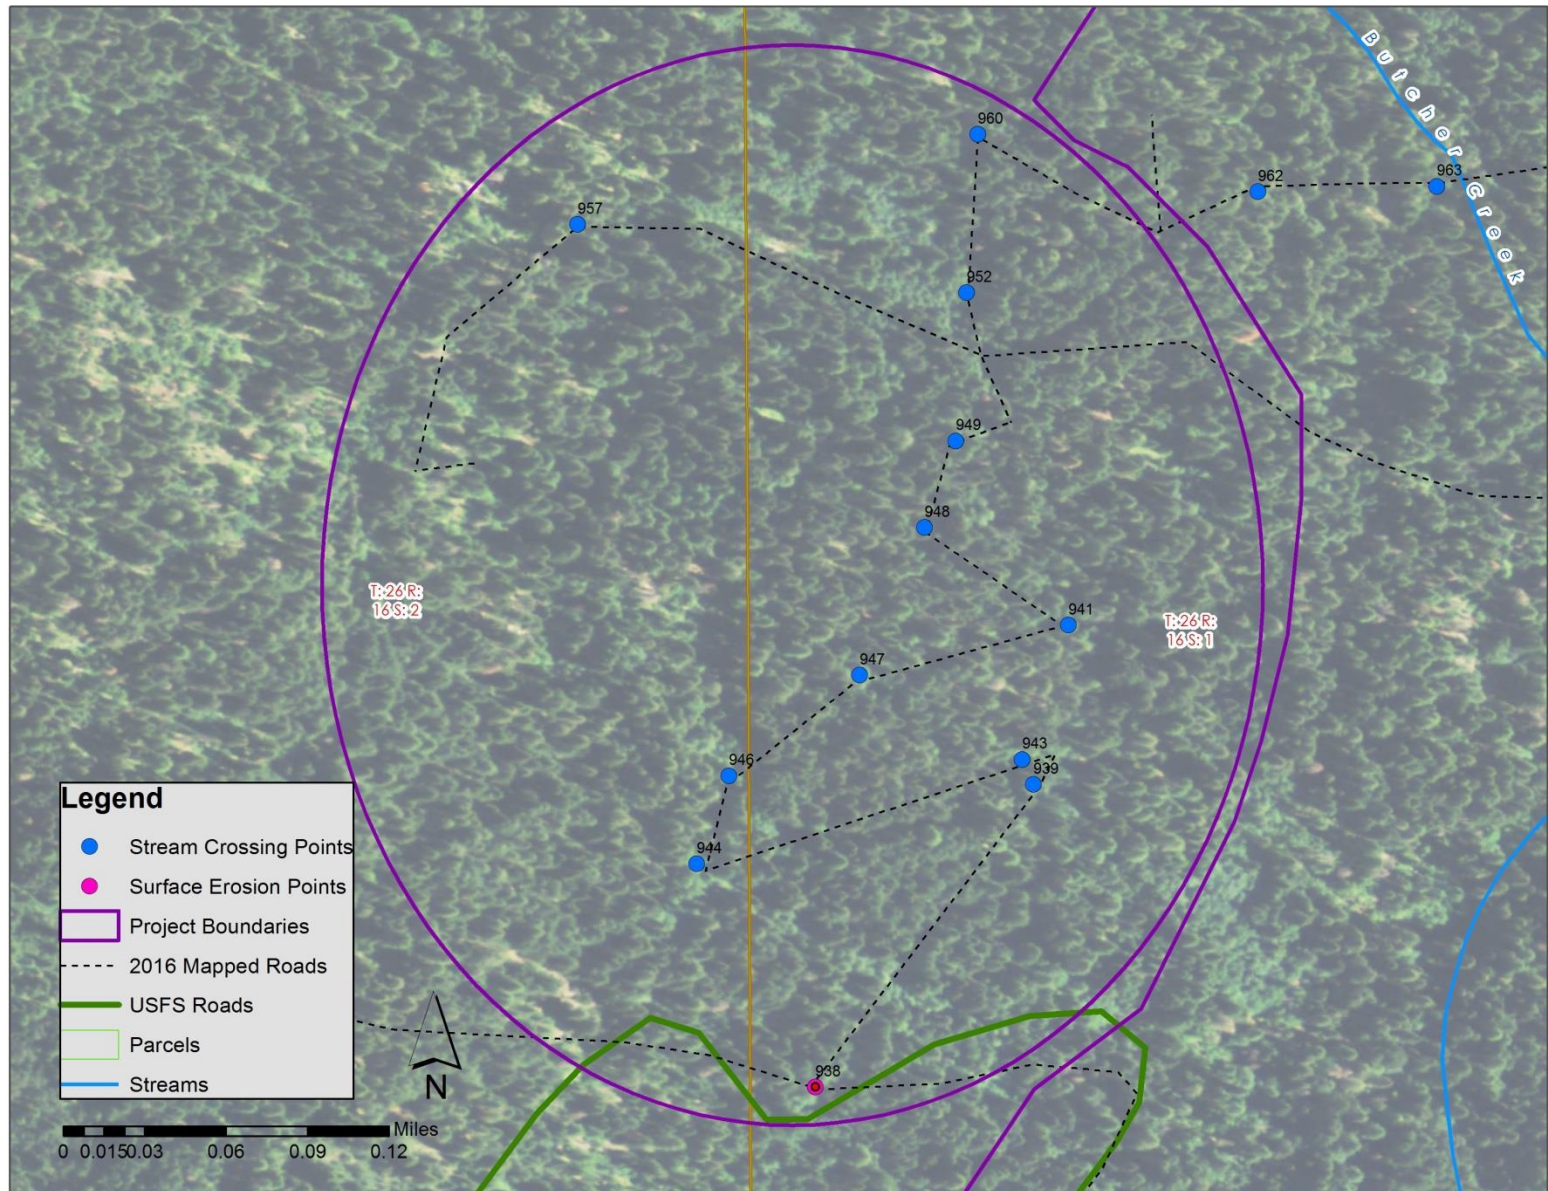
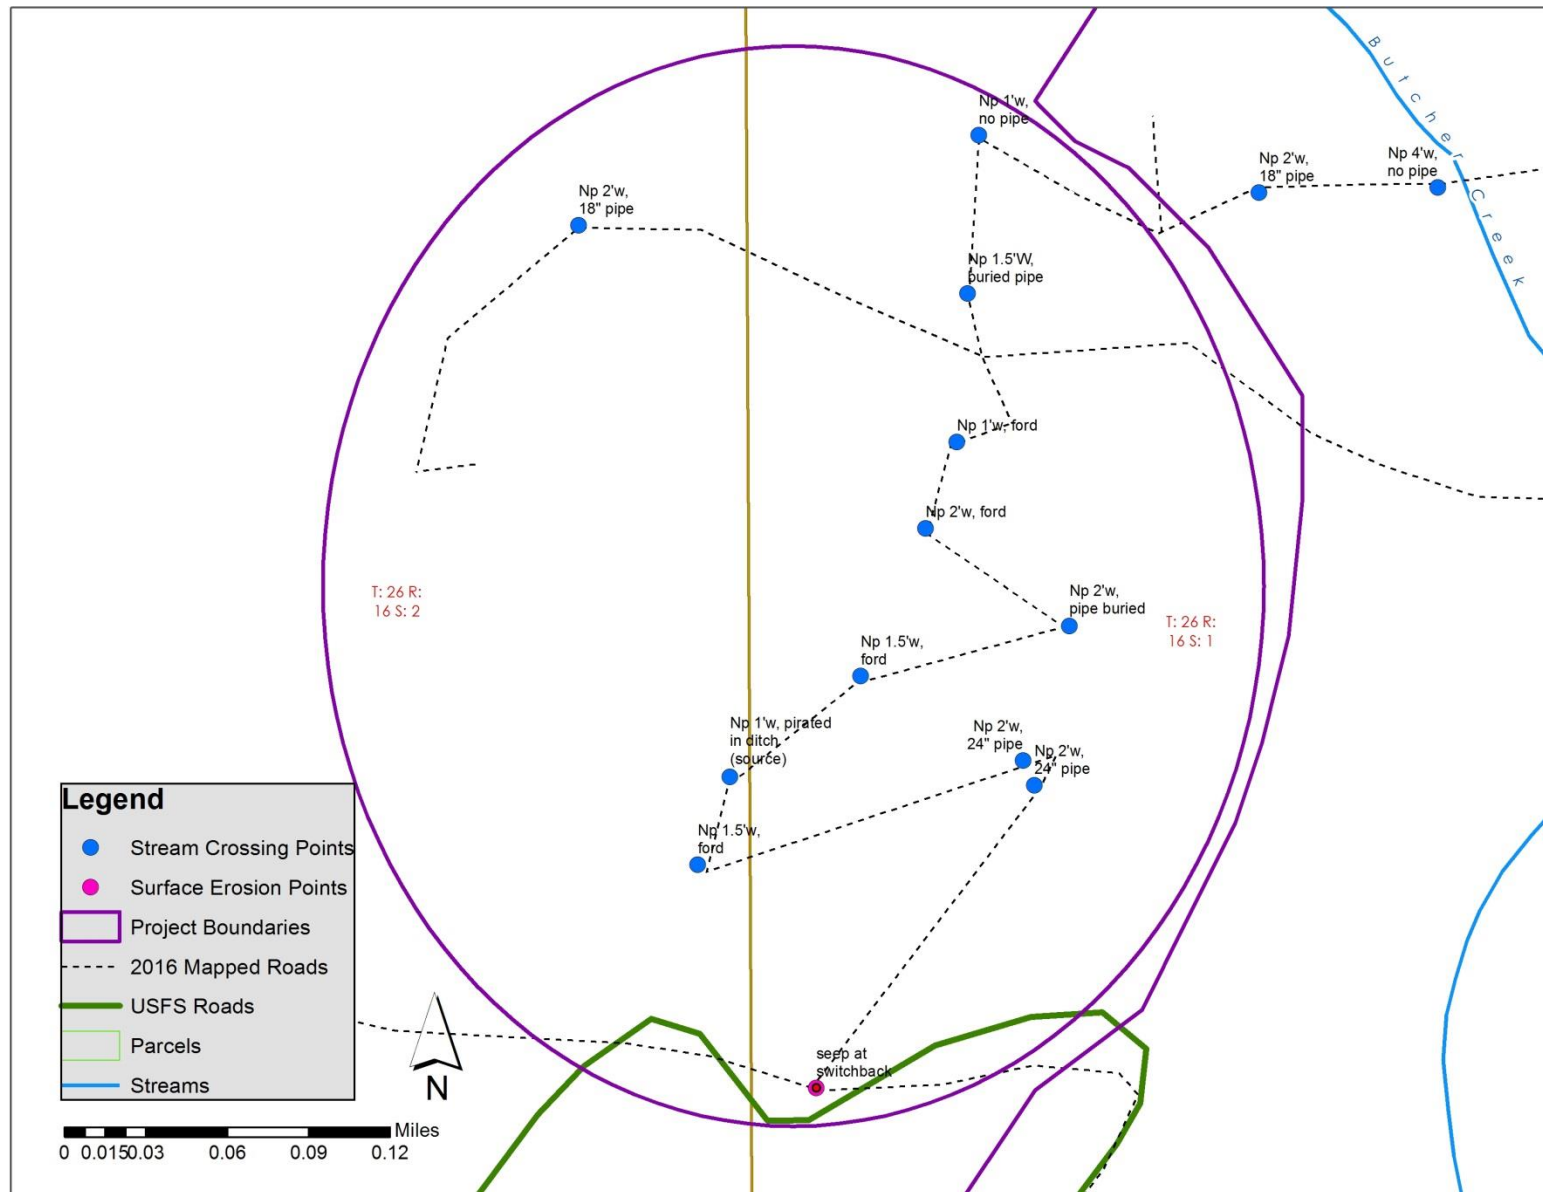
Project 12: Location of 2016 field inventory data overlaid on 2013 aerial photo

12	261601	938, 939, 941, 943, 944, 946-949, 952, 957, 960	Section 1 Butcher Creek non-system roads	The 1.77 miles of non-system roads in Section 1 contains 17 stream crossings. Of the mapped crossings four are described as fords plus one 1' wide stream crossing with no pipe. There are also two buried pipes at stream crossings and one notation that the stream is pirated in the ditch as the water source.	Non-system roads
13	261601	158, 162-164, 166, 168-178, 180, 183, 192-196, 931-934, 962-964, 1001-1003, 1005, 1006	Butcher Creek road USFS 6910 and spur roads	Part of this road system was built as temporary roads for timber salvage after the Round mountain fire in 1995-6. Some of these roads may have been partially de-commissioned. These roads contain large areas with moderate to high surface erosion potential. This road network (and similar conditions) extend slightly into adjacent sections 2, 35, and 36. Field inventory notes indicate 10 stream crossings deliver sediment directly to streams, one culvert is buried, 3 crossings have fillslope erosion or road failure, and 3 have water flowing in the ditch and/or the stream is the source of ditch water.

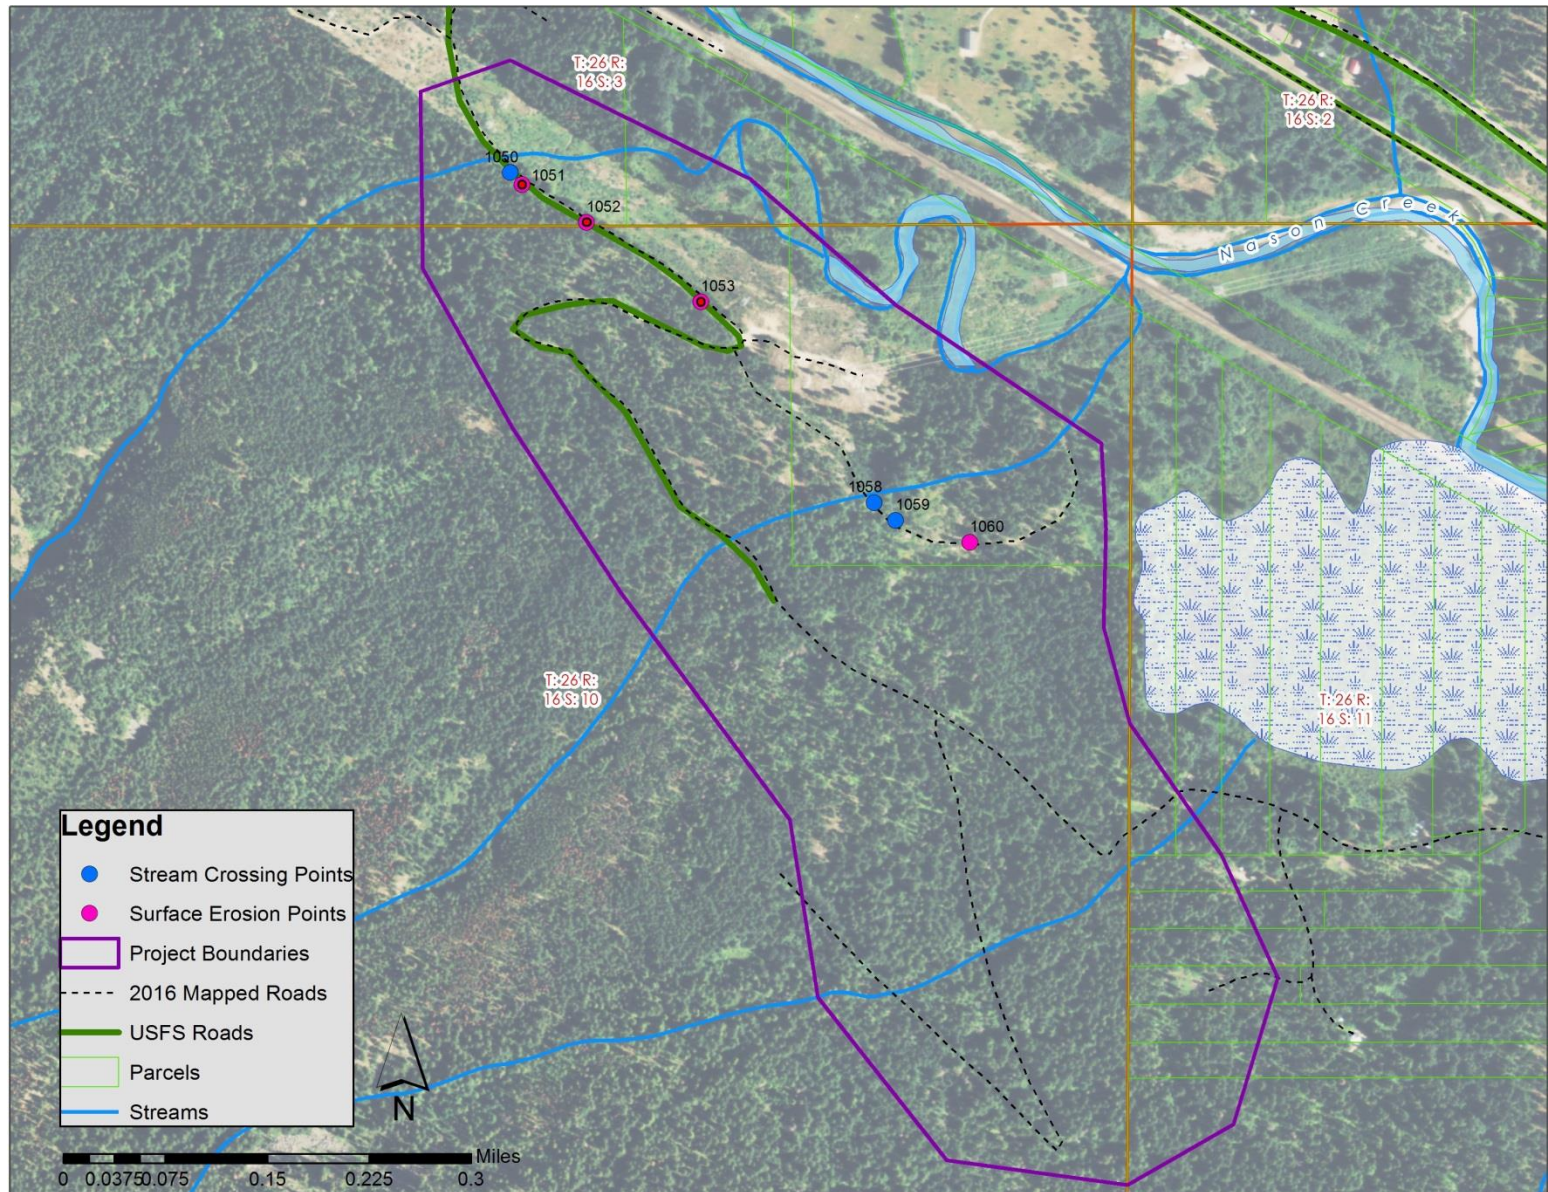
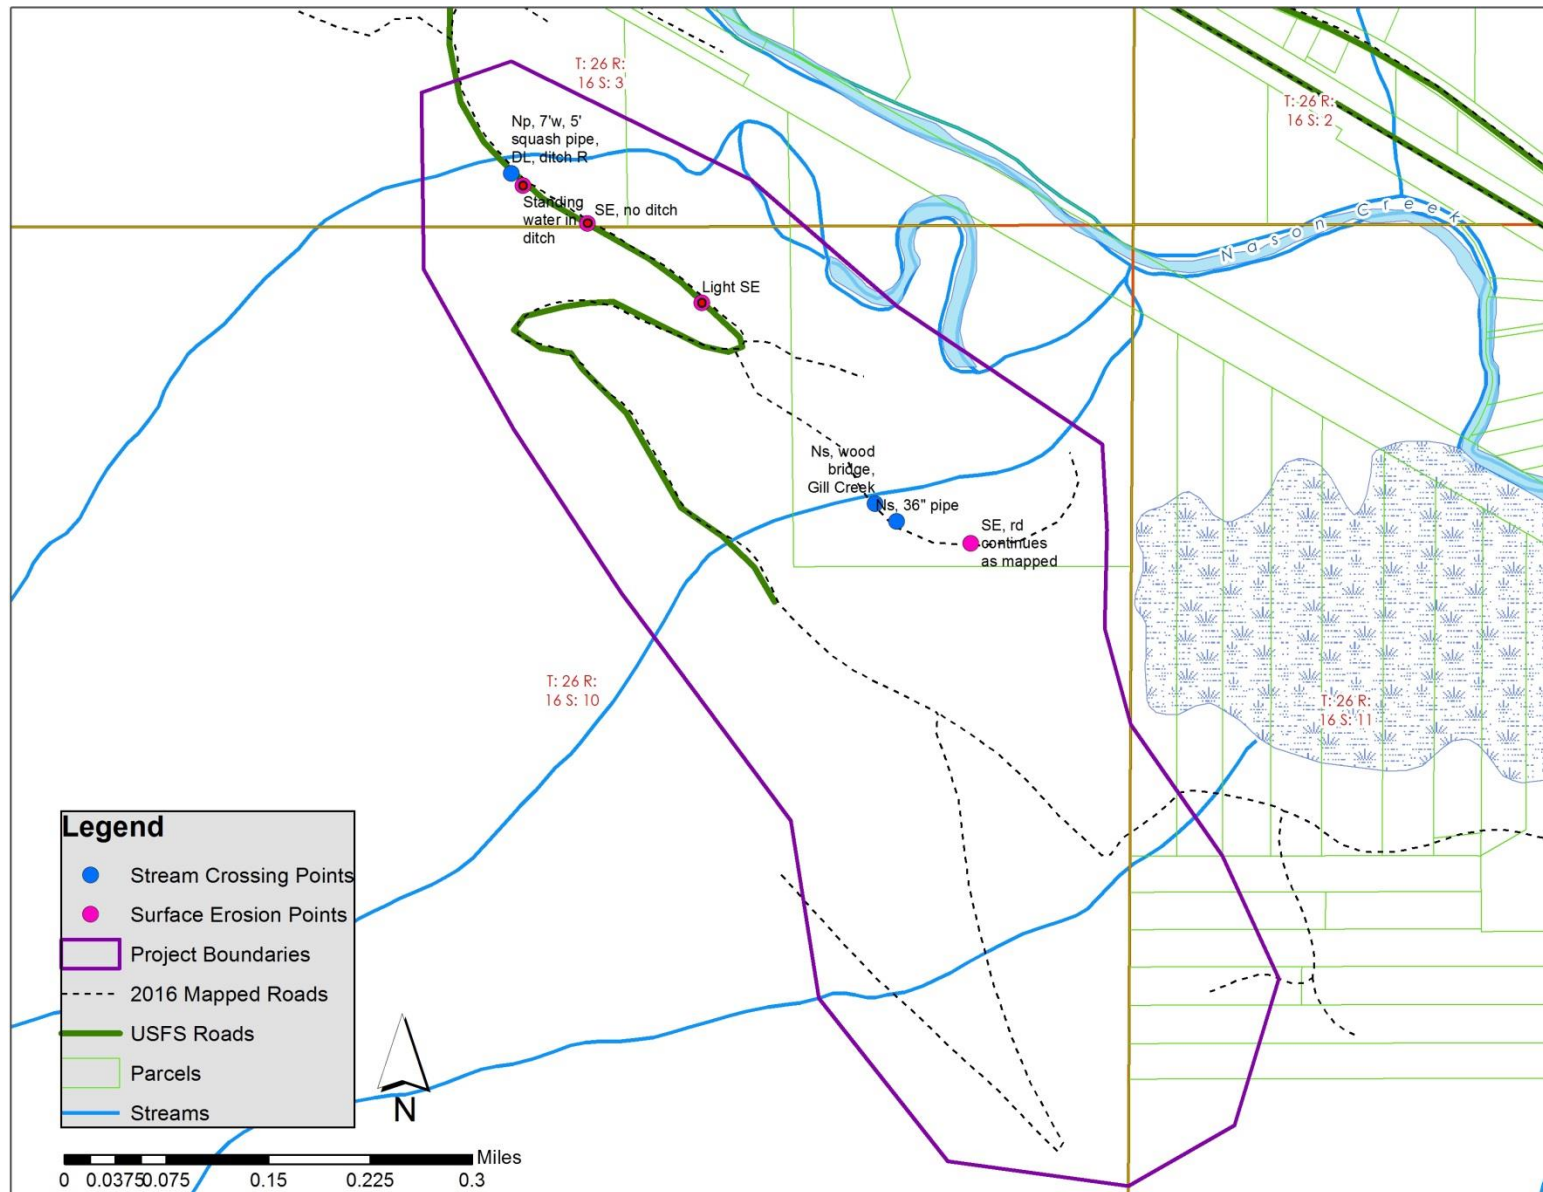
Project 14: Location of 2016 field inventory data overlaid on 2013 aerial photo

14	261610	1050-1053, 1058-1060	Gill Creek area	There are 4 surface erosion points and 2 stream crossings on this stretch of Gill Creek road. The field inventory maps surface erosion, standing water in ditches, and one stream crossing that delivers sediment to the stream. The section of road modeled to have moderate to high surface erosion potential was mapped based upon aerial photo interpretation so this needs field verification.	Once it heads up hill, most of this road is so wet, that it is not driveable during wet conditions. MRA recommends de-commissioning this road beyond the trail access point (~1.15 miles)
15		336, 339-345, 348-354, 357, 359, 361, 363, 365-370, 372, 373	Coulter Creek road, USFS 6930 and 6930270	Modeling indicates some areas with moderate to high surface erosion potential to deliver to the stream. The field inventory mapped 8 surface erosion points that include comments such as stream parallels the road and water flows across the road in 4 areas. Field inventory maps 20 stream crossings (4 where stream water runs in the roadside ditch, 2 crossings with sediment delivery to the stream, 5 where water runs across the road). One stream crossing notes that the road surface is half eroded by the stream.	MRA notes to de-com the last .75 miles (past the junction with 6930270). MRA suggests closure (reduce to ML-1) for 6930270.

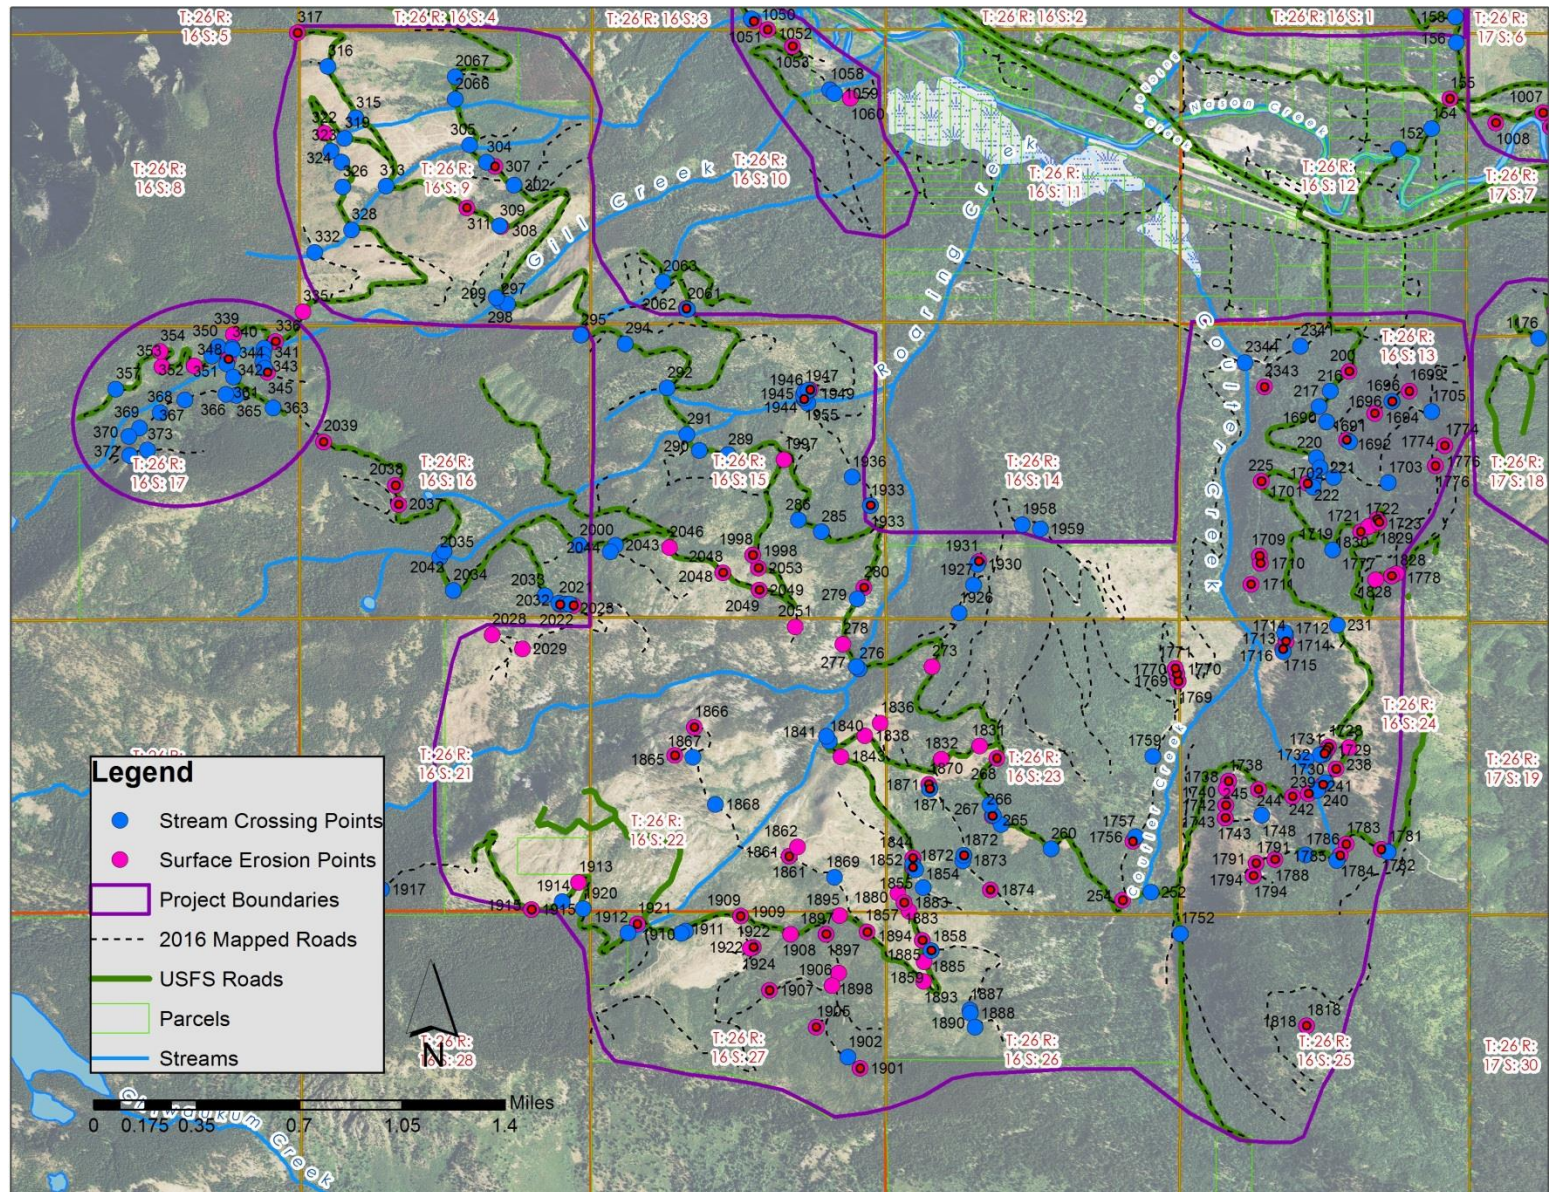
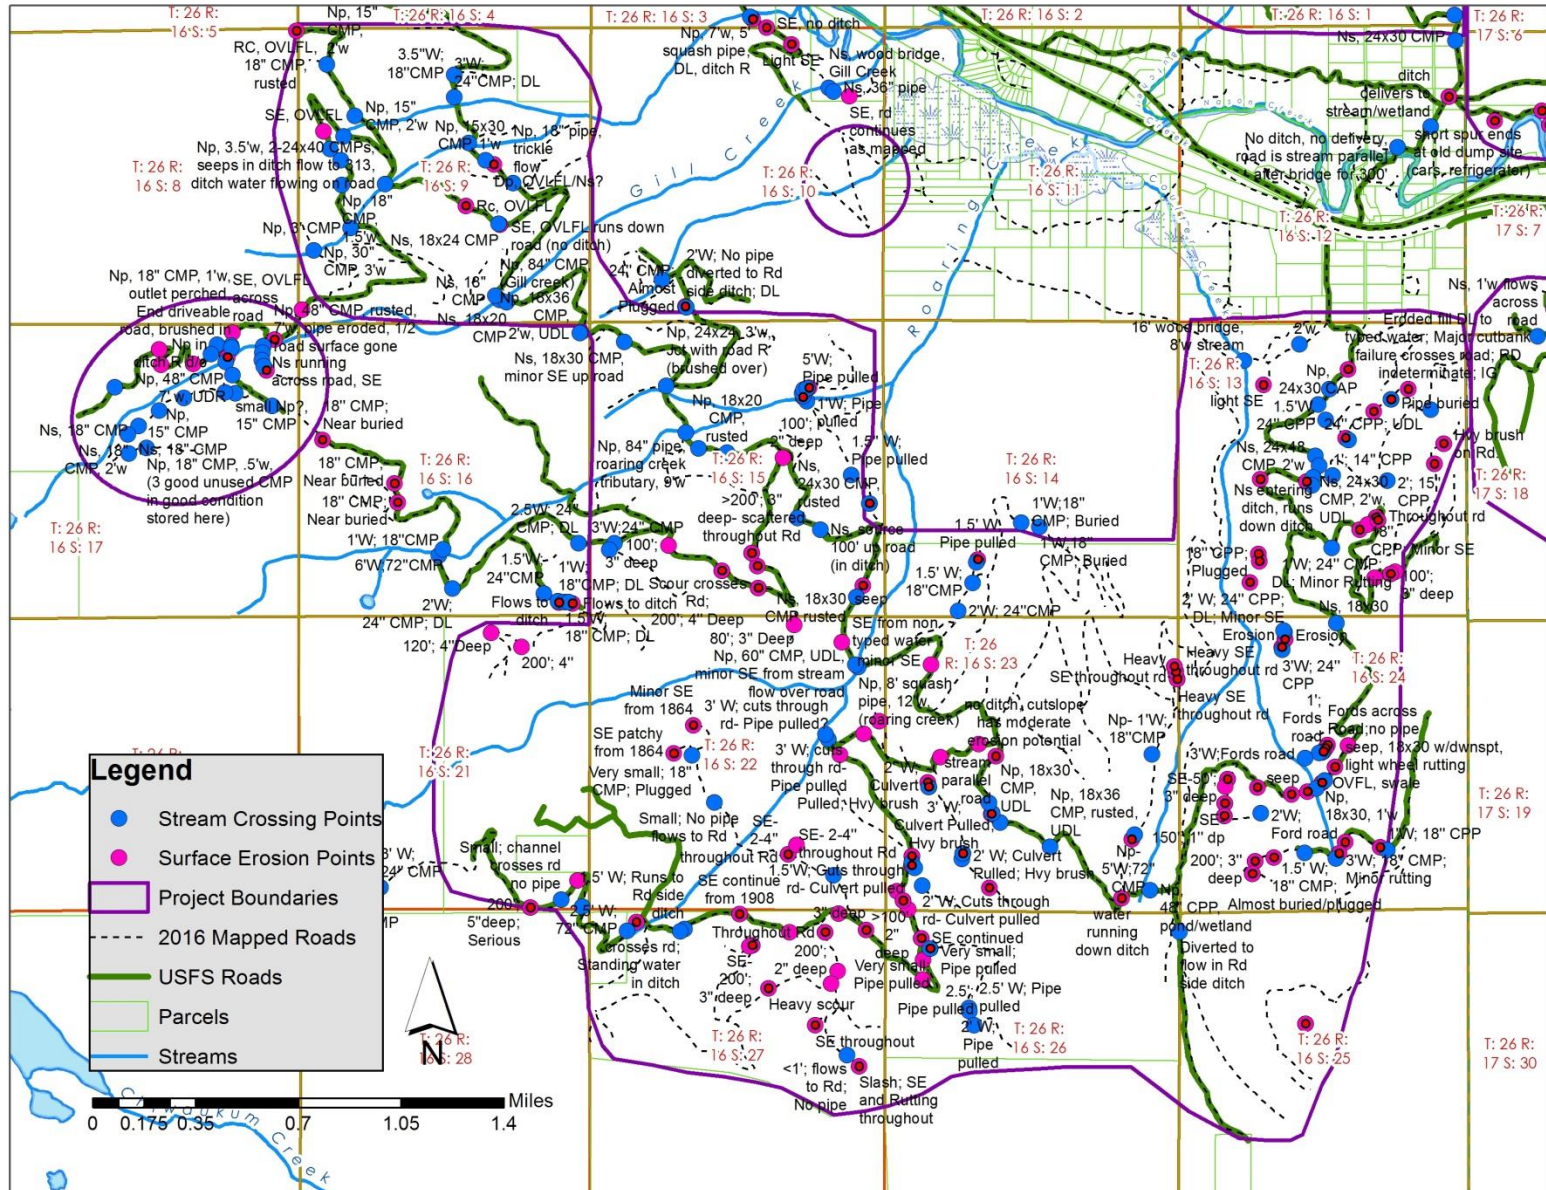
Projects 16 & 17: Location of DNR mapped streams and 2016 field inventory data overlaid on 2013 aerial photo

16	2616 Sections 13, 22-24, 25-27	198* sites within projects 16&17	Weyerhaeuser Butcher Creek block (S. of Hwy 2), Coulter Creek Road, USFS 6930, and 6935	Some portions of the road through these 9 sections are mapped as moderate to high potential for erosion and sediment delivery to streams.	Weyerhaeuser has completed road and stream crossing upgrades per RMAP requirements in this area. That said, they have agreed to review the surface erosion points mapped on their roads in summer 2017 to determine which, if any, have the potential to deliver sediment to streams. The MRA recommend to remove some cost share roads
17	2616 Sections 13, 22-24, 25-27	198* sites within projects 16&17	Cost share roads within Weyerhaeuser parcels, Coulter Creek Road, USFS 6930, and 6935	Even though most of these 9 sections are owned by Weyerhaeuser, much of the road network consists of cost share roads. DNR RMAP requirements do not apply to road conditions on cost share roads. Thus, the cost of road maintenance and upgrades are shared between the landowner and USFS.	The MRA recommends to remove some cost share roads

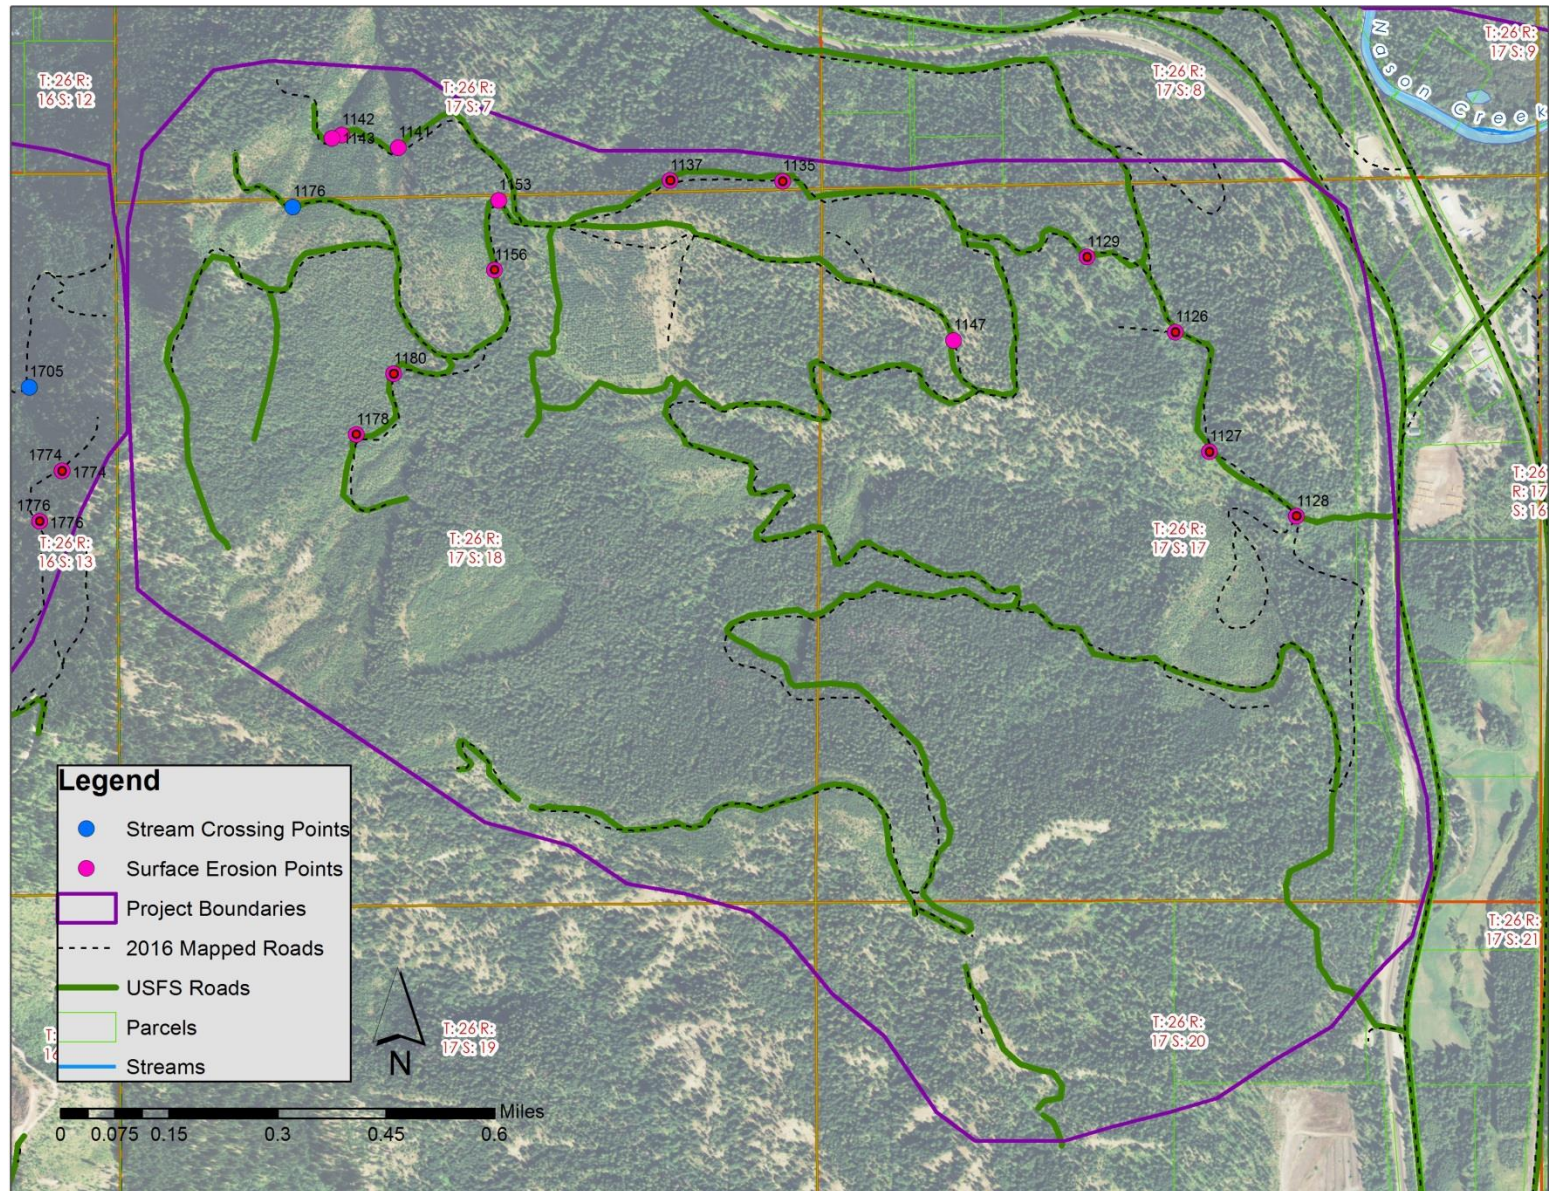
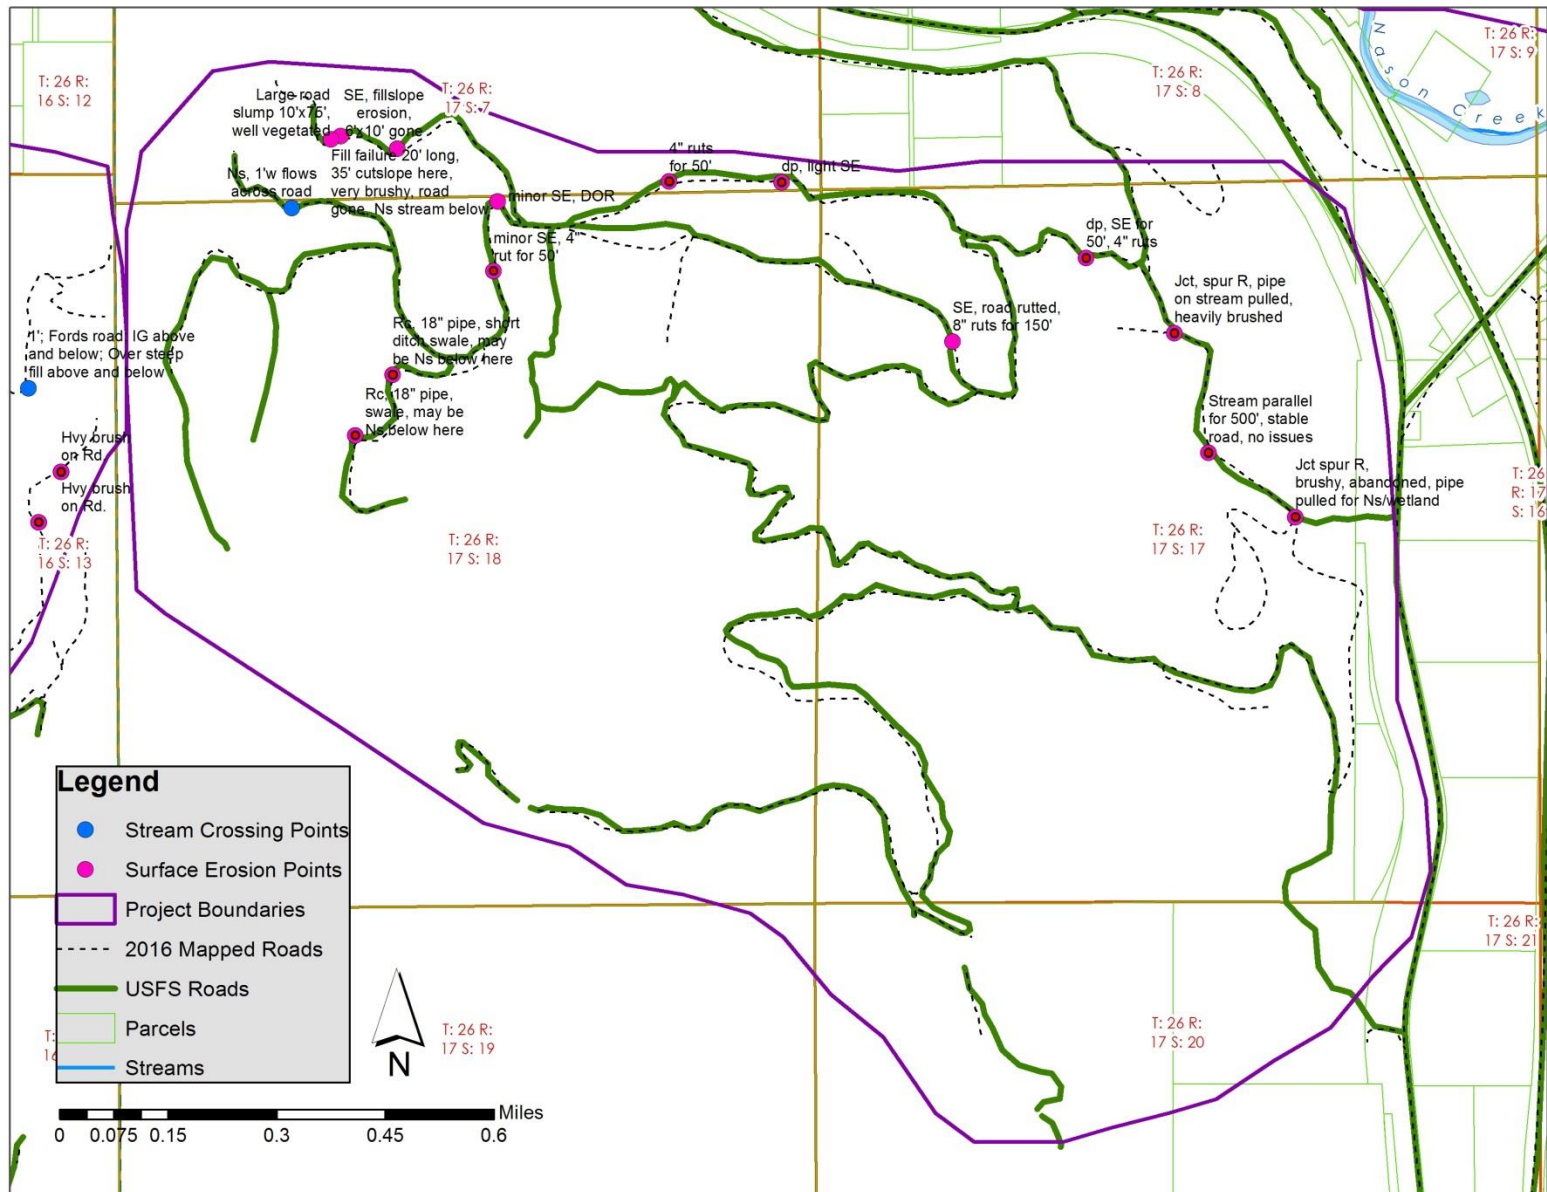
Project 18: Location of DNR mapped streams and 2016 field inventory data overlaid on 2013 aerial photo

18	261707, 261617, 261718	1126-1129, 1135, 1137, 1141-1143, 1147, 1153, 1156, 1176, 1178, 1180	USFS 7912, 7912100, 7912212, 7912201, 7912230, 7912225, 7912235	There are sections of the road mapped as moderate erosion potential with one spot mapped as high potential for sediment delivery to stream. The field inventory mapped 13 surface erosion points including three points near the end of 7912225 described as fill slope failures. Only 1 stream crossing was mapped in this area, but I'm not sure that is correct and probably should be field verified.	MRA recommends some of this road network be de-commissioned, some remain as is, and some has already been closed.
19	271731, 271732, 2617 Sections 4-6 and 7-9	128* sites within projects 19 & 20	Weyerhaeuser Kahler Creek block	Some portions of the road through these 8 sections are mapped as moderate to high potential for erosion and sediment delivery to streams.	Weyerhaeuser has completed stream crossing upgrades per RMAP requirements in this area and the upgrades to address surface erosion delivery to streams is in progress. They have agreed to review the surface erosion points mapped on their roads in summer 2017 to determine which, if any, have the potential to deliver sediment to streams. The MRA recommends to remove some cost share roads

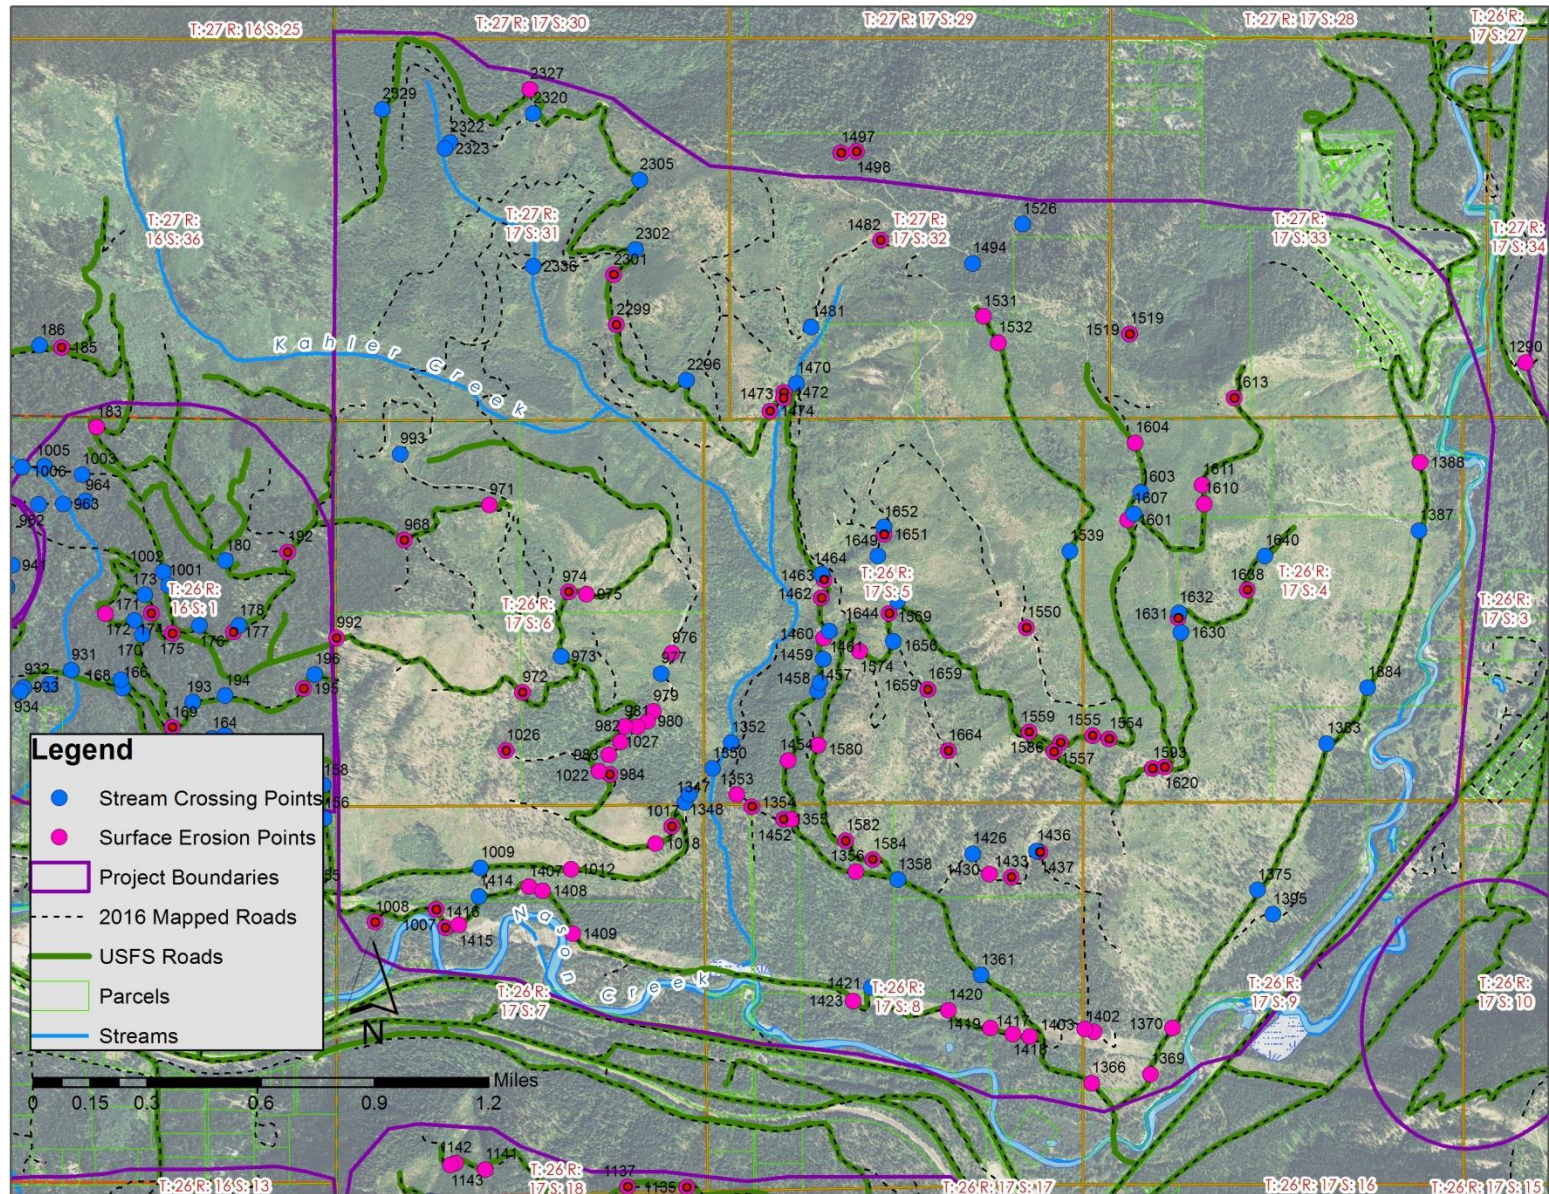
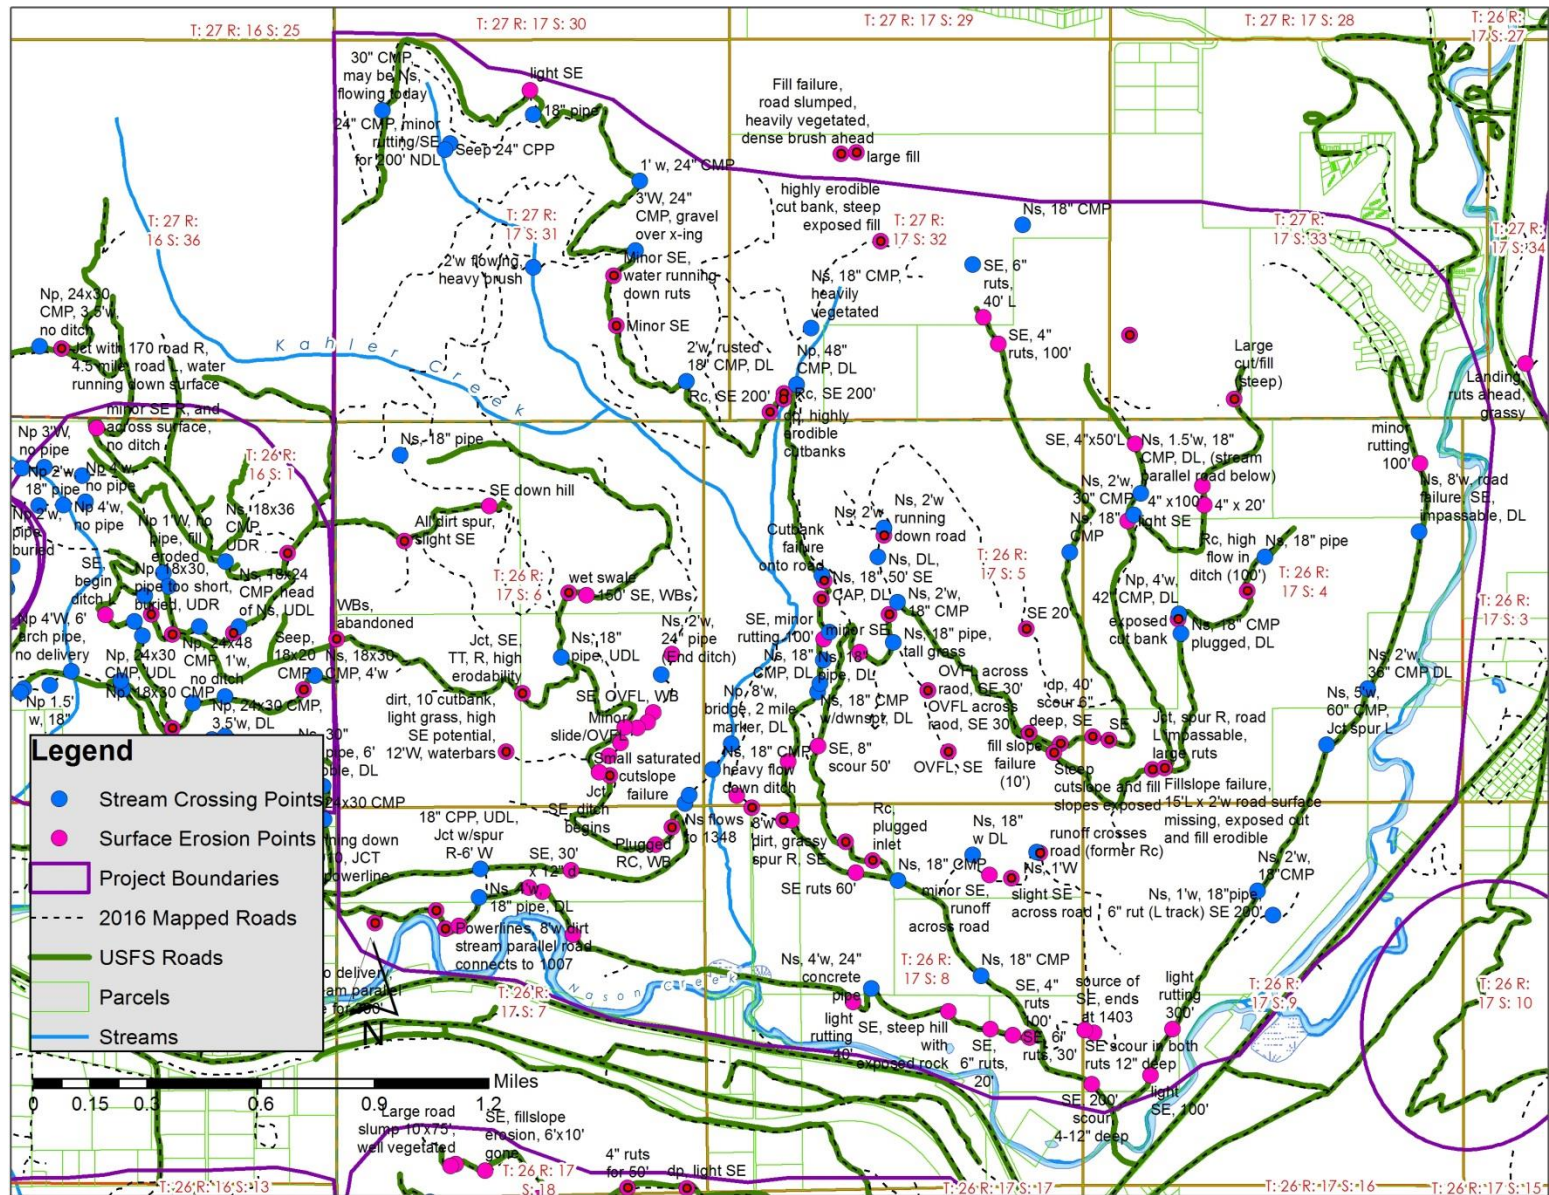
Projects 19 & 20: Location of 2016 field inventory data overlaid on 2013 aerial photo

20	271731, 271732, 2617 Sections 4-6 and 7-9	128* sites within projects 19 & 20	Cost Share roads within the Weyerhaeuser Kahler Creek block	Even though most of these 8 sections are owned by Weyerhaeuser, much of the road network consists of cost share roads. DNR RMAP requirements do not apply to road conditions on cost share roads. Thus, the cost of road maintenance and upgrades are shared between the landowner and USFS.	MRA recommendeds to remove cost share on some roads
21	261709, 261710		Old Hwy 207, 6603, 6601810	Modeling indicates areas with moderate to high potential for sediment delivery to streams, however, there were no surface erosion issues or stream crossings mapped here during the field inventory. There is one avalanche chute that crosses the road and that may be an ephemeral stream but it does not connect hydrologically to Nason creek.	Evaluate whether or not to implement actions here as part of design

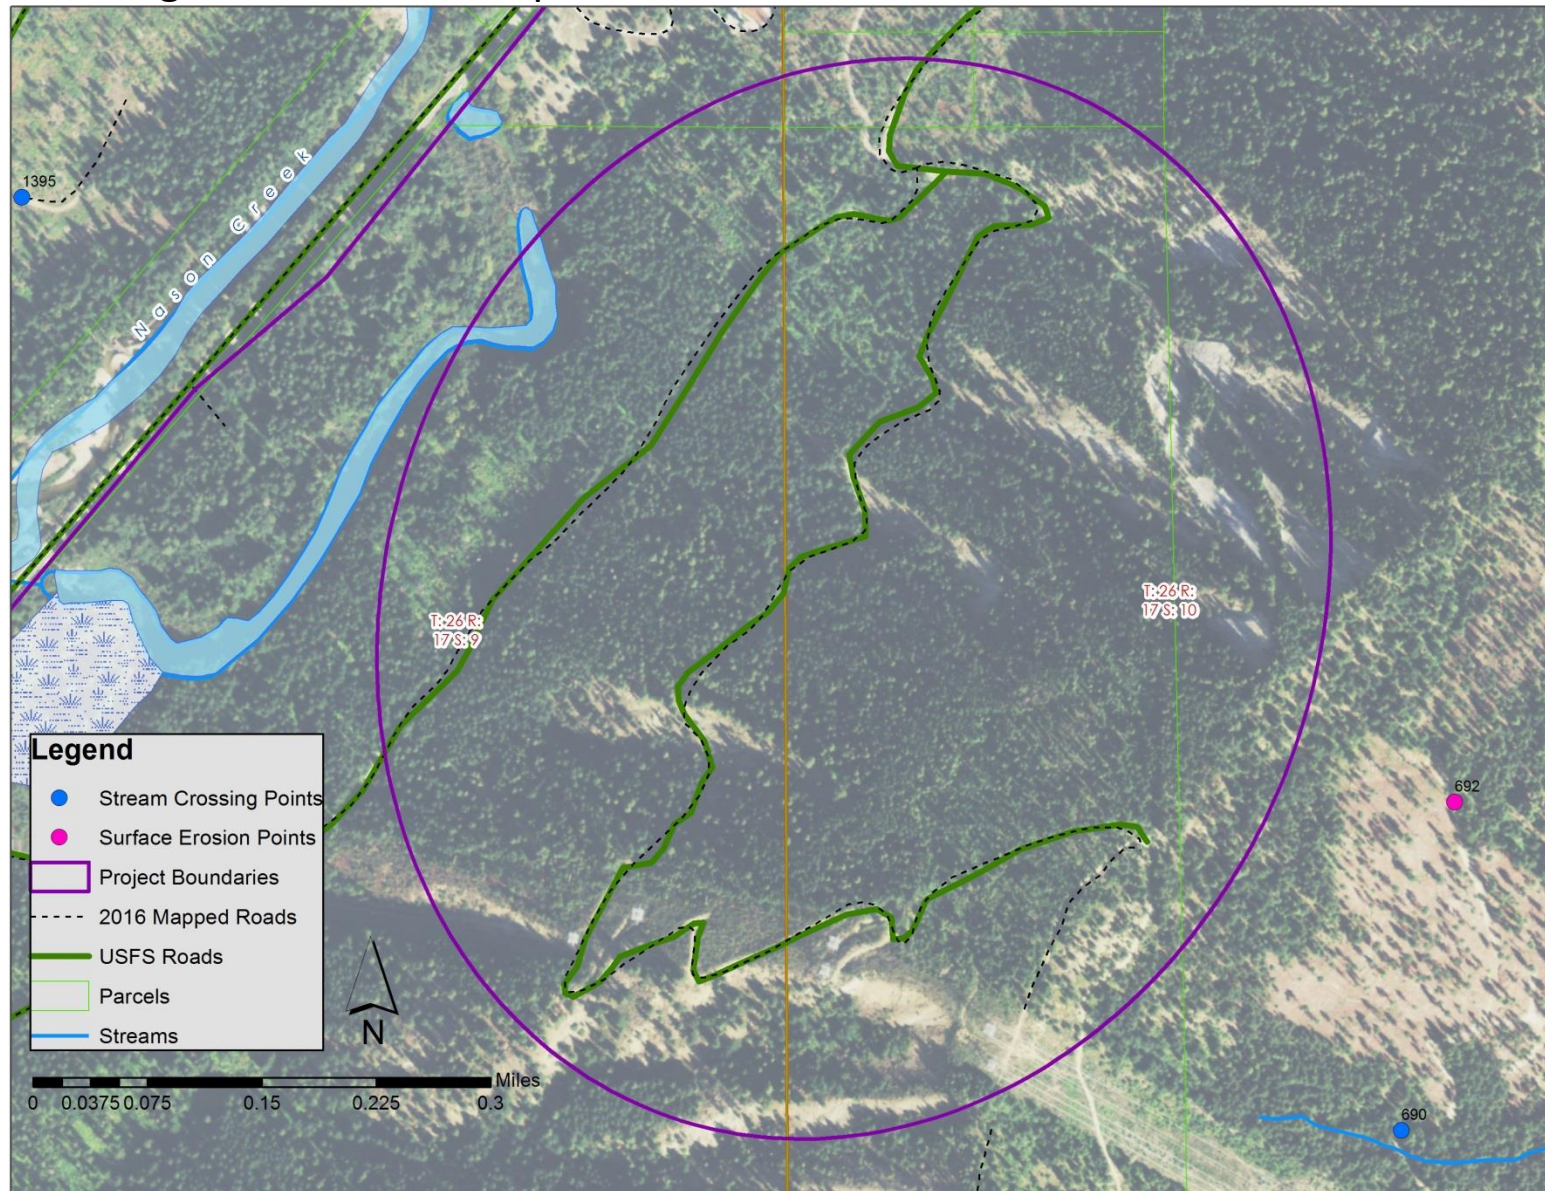
Project 21: Location of project area 21 on 2013 aerial photo; no surface erosion points or stream crossings were mapped here, however, it was included as a project area due to modeling results for future potential erosion issues
