Table 6: Potential Project Areas Identified by the Nason Roads Assessment

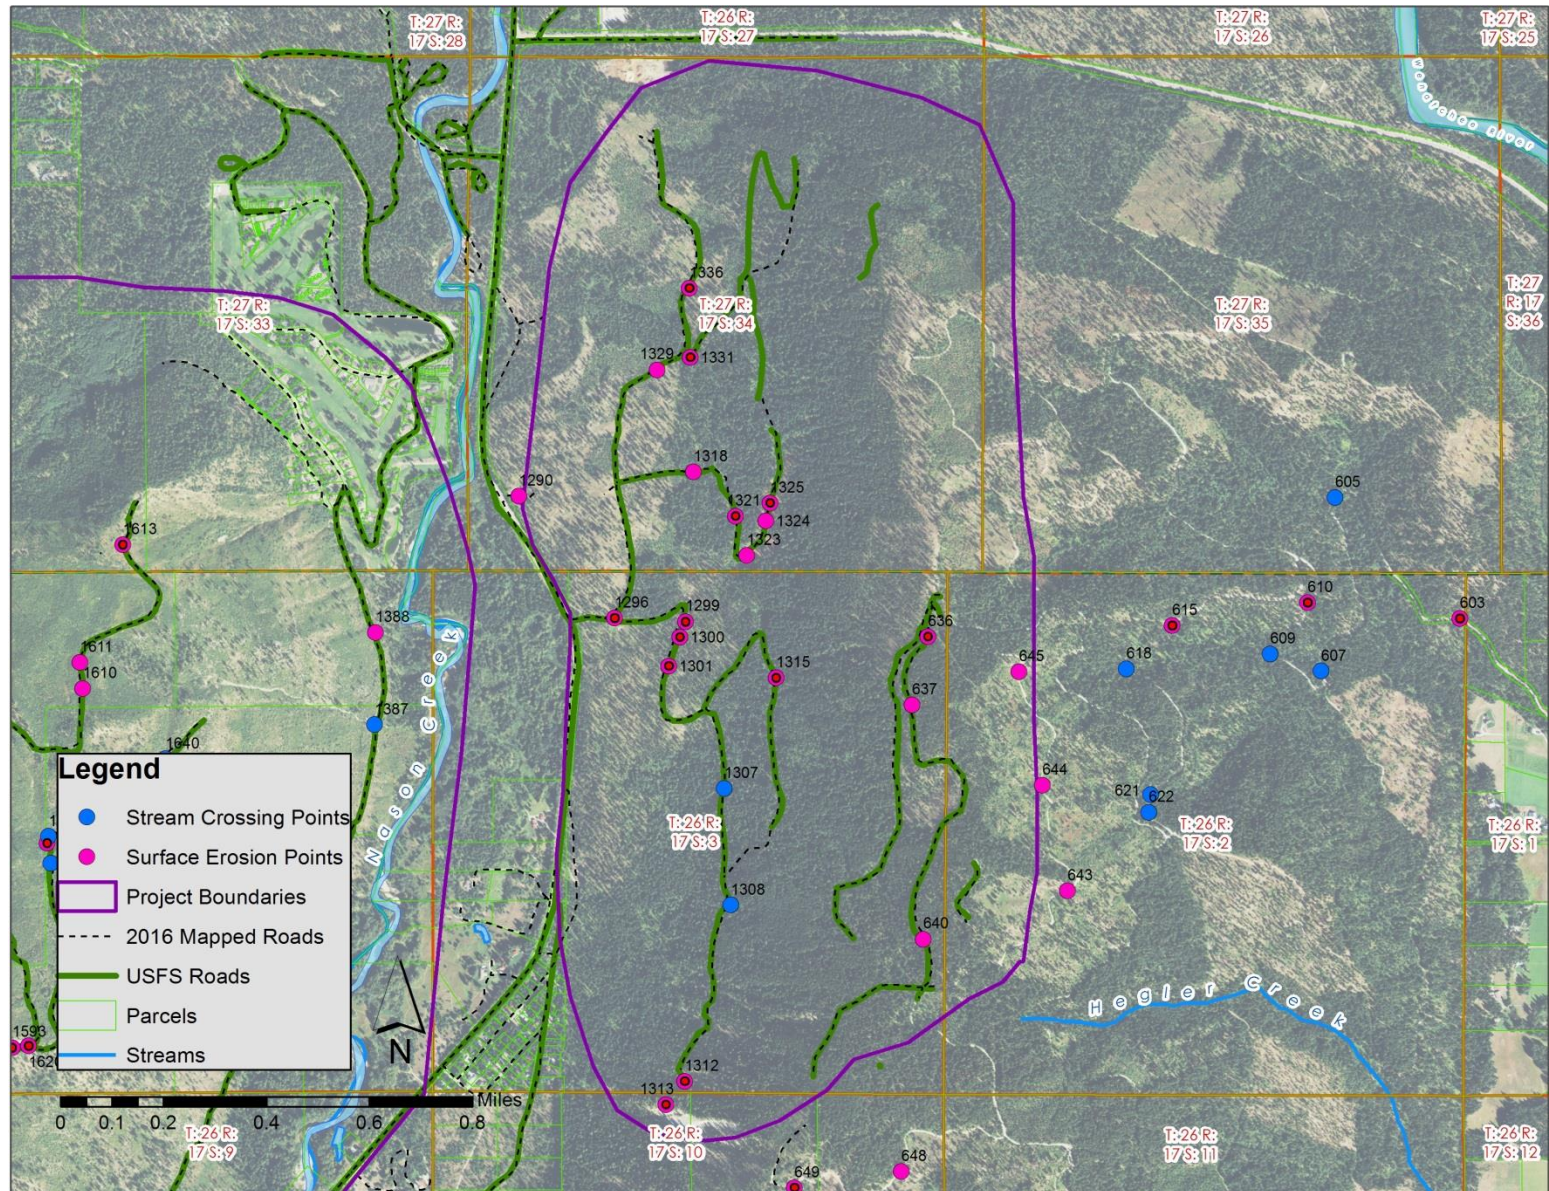
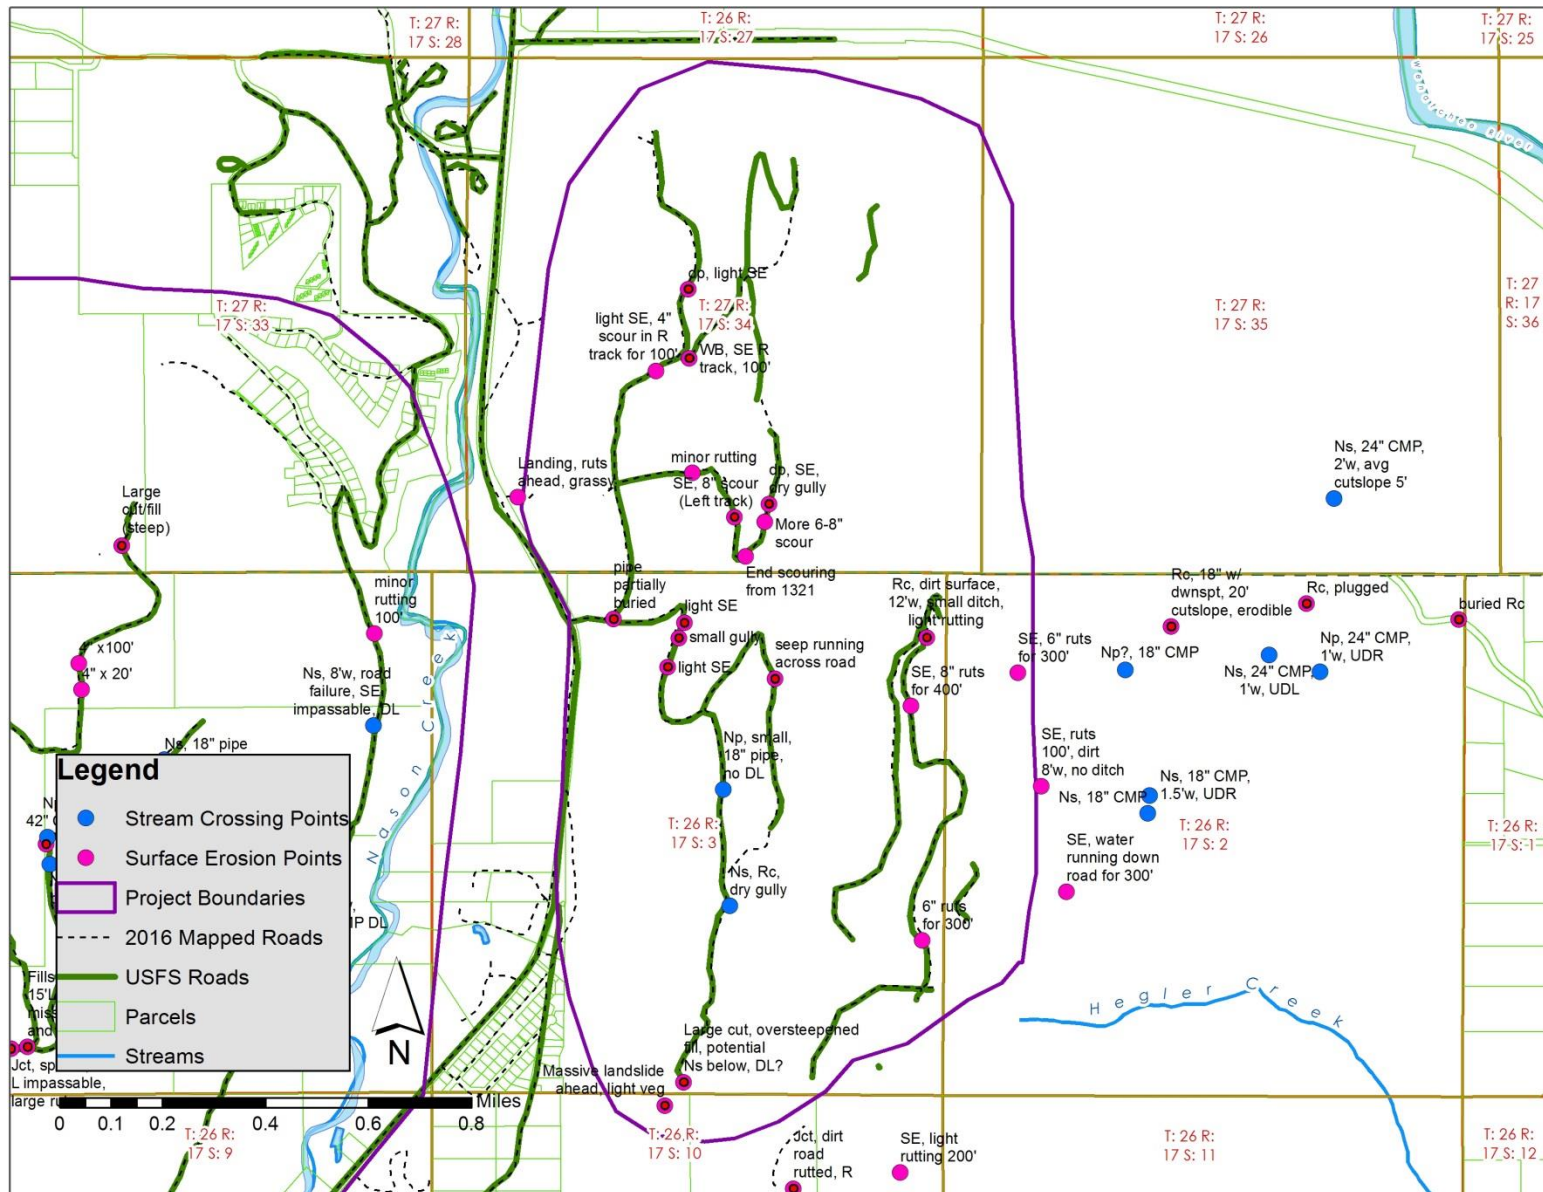
Project 22: Location of 2016 field inventory data overlaid on 2013 aerial photo

22	261703, 271734	636, 637, 640, 645, 1296, 1299-1301, 1307, 1308, 1312, 1313, 1315, 1318, 1321, 1323-1325, 1329, 1331, 1336	Happy Clown area, 6604, 6604111,	The field inventory mapped 8 surface erosion points on section 34 and 9 surface erosion points on section 3. Descriptions include over-steepened fill that delivers to the stream, ruts, massive landslide, and seep running across the road. There are two stream crossings mapped in Section 3.	These are gatead roads that are seasonally open. Road segments 112, 113, 114, and 115 (> 2 miles) were proposed for de-commissioning as part of the Natapoc EIS. Need to field check what was completed and what work remains.
23	26152	2512	1612010416, 9186010602	Modeling indicates areas with moderate to high potential for sediment delivery to streams	Evaluate whether or not to implement actions here as part of design.
