GNN Project No.: 217-854

Subject: MEMO: Review of Revised Expansion Plans
Proposed Mission Ridge Ski Resort Expansion Project
Chelan County, Washington

RECONNAISSANCE-LEVEL EVALUATION OF GEOLOGIC HAZARDS REPORT

**PROPOSED MISSION RIDGE SKI RESORT EXPANSION PROJECT
THE VILLAGE AT MISSION RIDGE
CHELAN COUNTY, WASHINGTON**

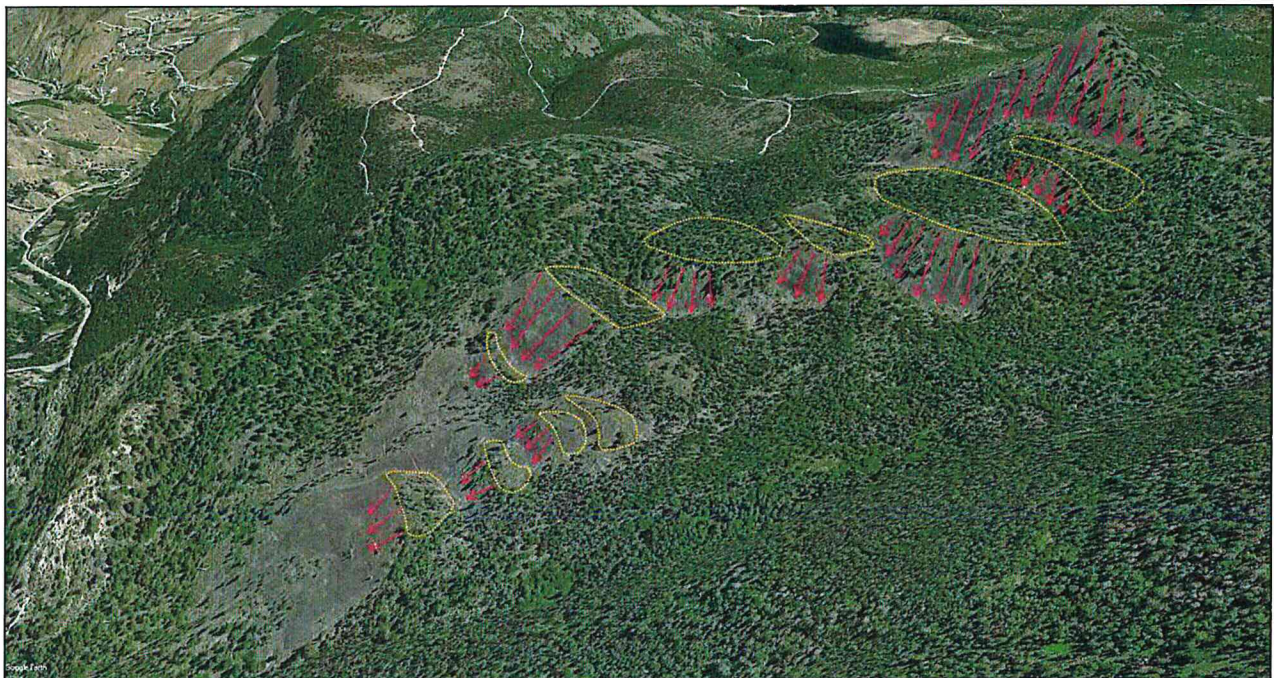
Current site topography is best characterized as variable and erratic landslide terrain. The top of the highest local peak ($\pm 5142'$) in the southeastern portion of the site grades down to the northwest ($\pm 4500'$) and includes a series of steps in the terrain. Large rubble fields consisting of broken cobble- to boulder-size basalt (talus) can be seen on the northwestern faces of the slopes between the steps (Figure 2). Various displaced yet intact blocks of Grande Ronde basalt were observed at the crest of these steps. The following oblique aerial image depicts the noted slump-block failures across the site. The dotted yellow perimeters represent the rotated upper surfaces of the slump blocks, while the red arrows denote the face/relative displacement of the secondary scarps.

Oblique view of site obtained from Google Earth, looking northeast (3x vertical exaggeration)

The noted landslide events are believed to have occurred under notably different geologic and climactic conditions during the end of the Pleistocene Epoch. The classic characteristics of landslides can be readily seen in the vicinity of the basalt talus slopes at the site, including clearly identifiable head scarps, rotated slump blocks, and hummocky topography of the slide mass. The noted slump-block failures at the project site may be secondary to the overall regional deformation of the surrounding area, possibly triggered later during a seismic event in the Holocene. The noted slump-block failures and surrounding mass wasting deposits from older landslide events appear to be relatively stable under the modern day geologic and climate conditions.

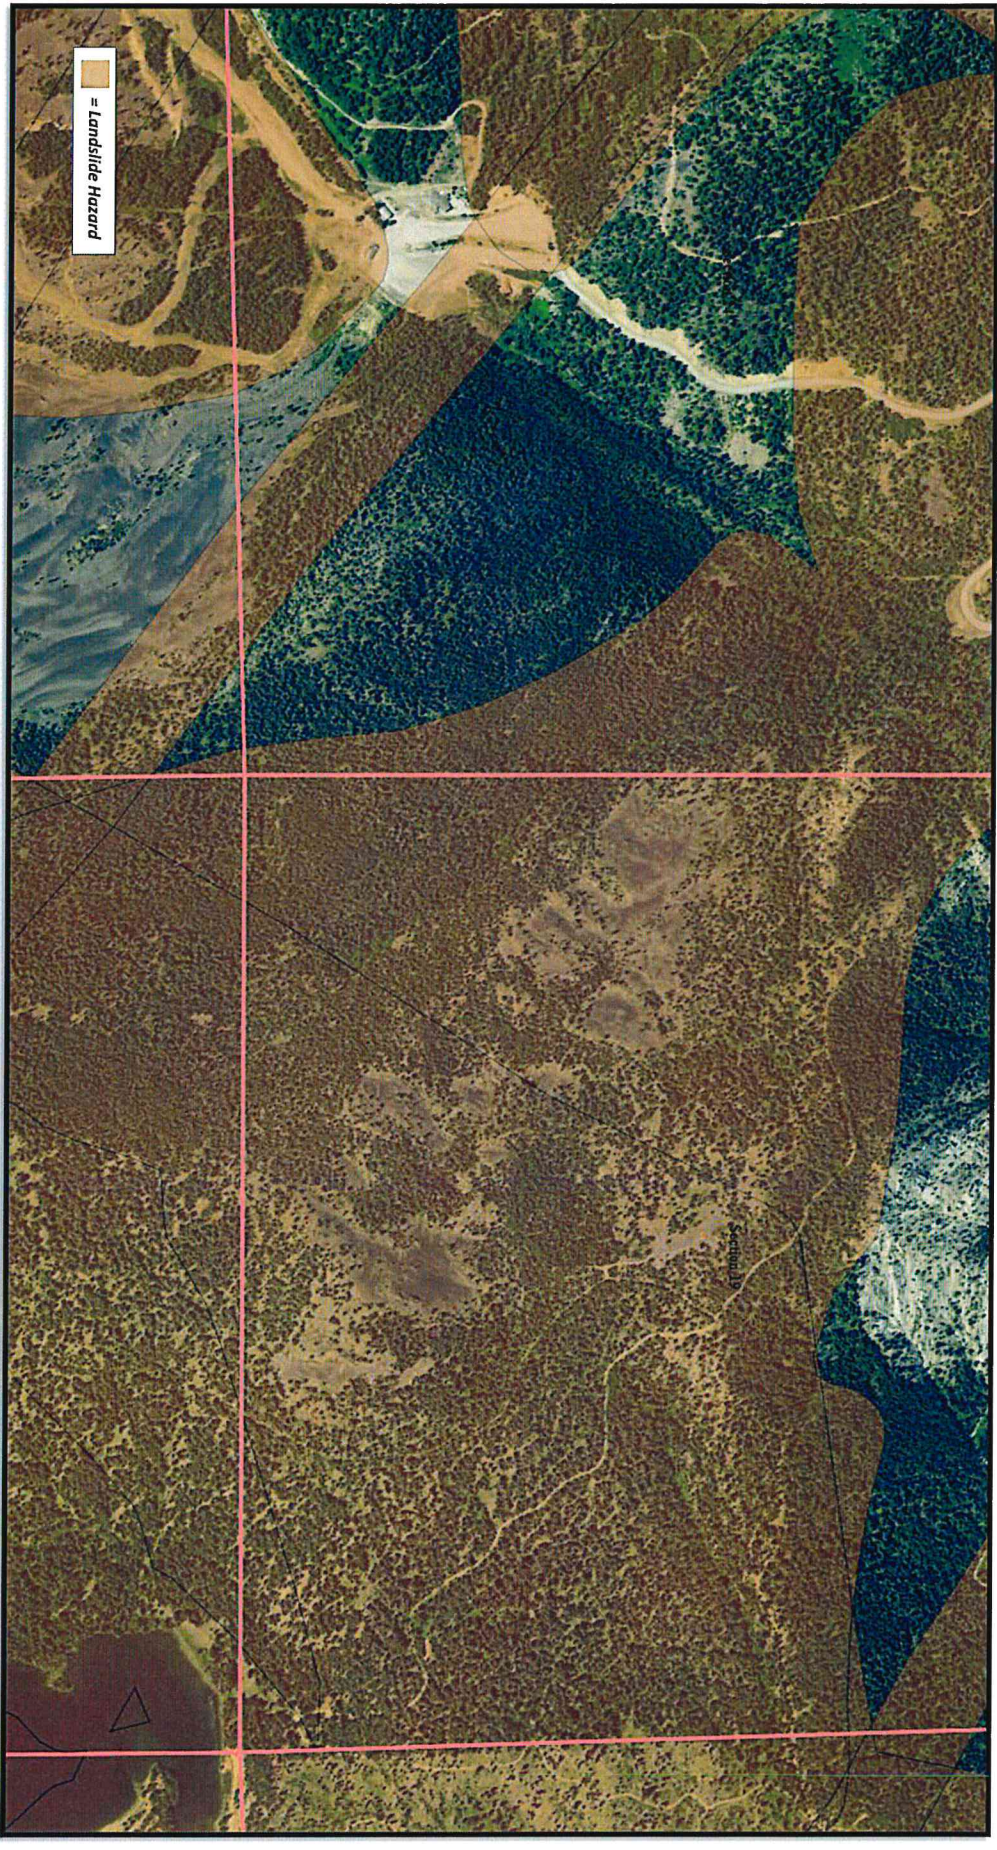
CHELAN COUNTY GIS - LANDSLIDE HAZARD OVERLAY MAP (FIGURE 4)
Village at Mission Ridge
Chelan County, Washington

The ±140-acre site of the proposed Village at Mission Ridge expansion project is located southwest of the City of Wenatchee in Chelan County, Washington. The entire subject site is mapped within areas defined by Chelan County as Geologically Hazardous Areas due to the risk from landslides and erosion hazards (see Figures 4 & 5).

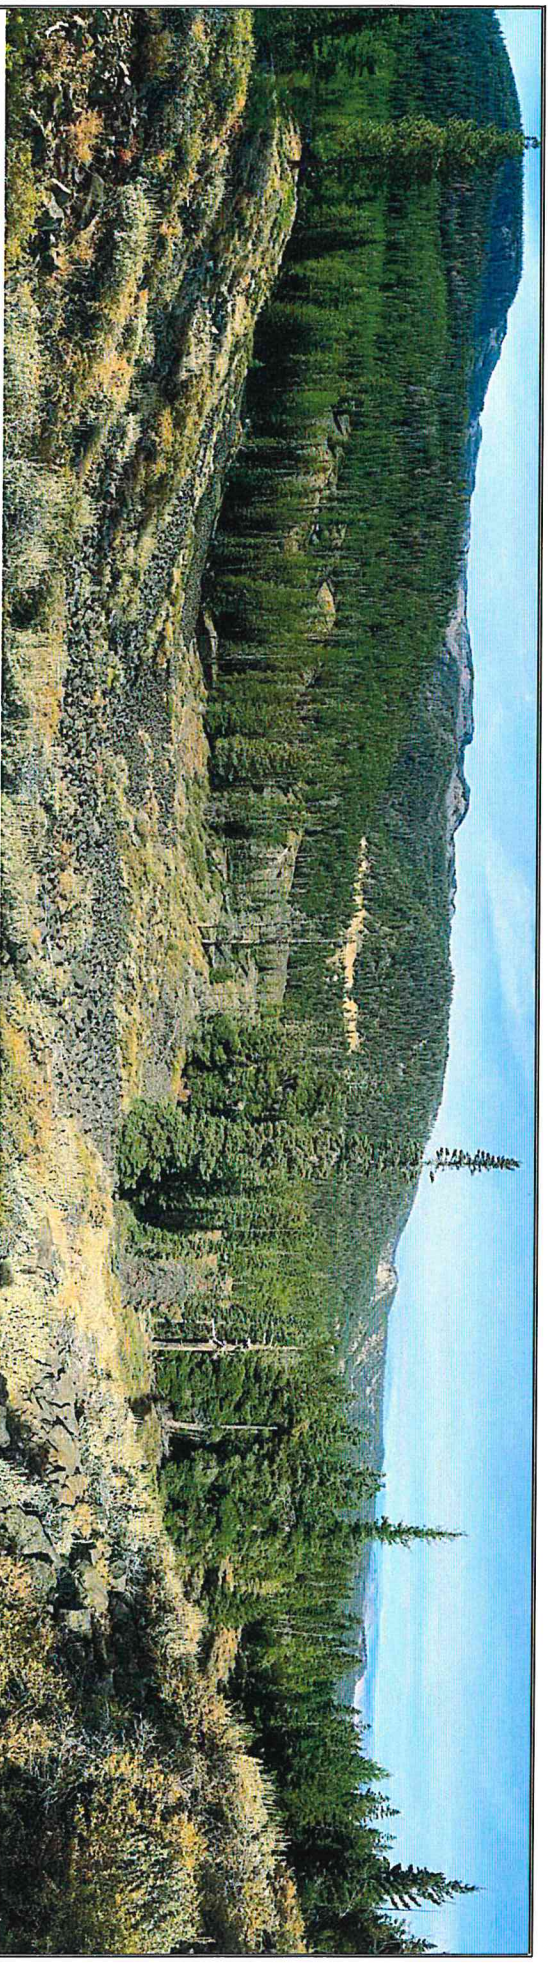
Overall panoramic view of the basalt cobble/boulder rubble talus from the southeast, looking northwest

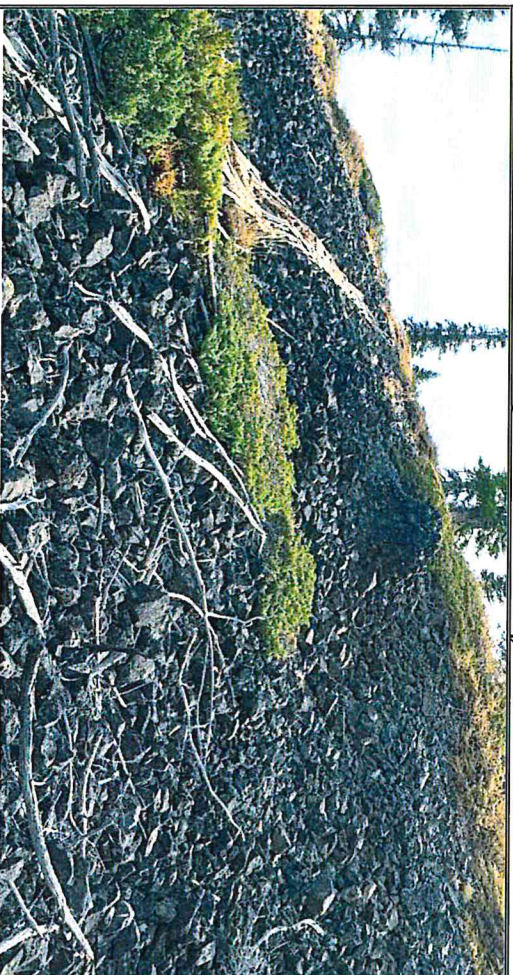
Talus slope with basalt outcrop near crest of slope

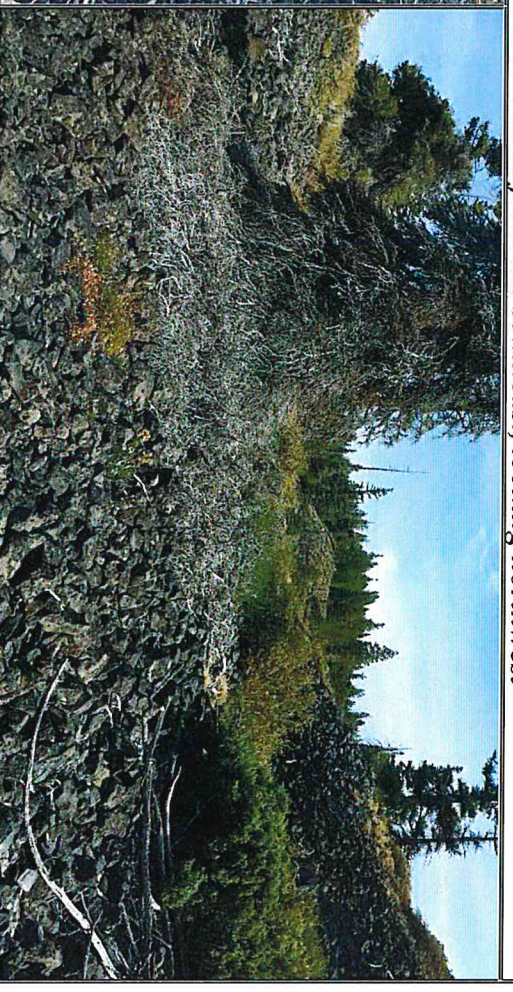
View of basalt rubble (talus) at the site

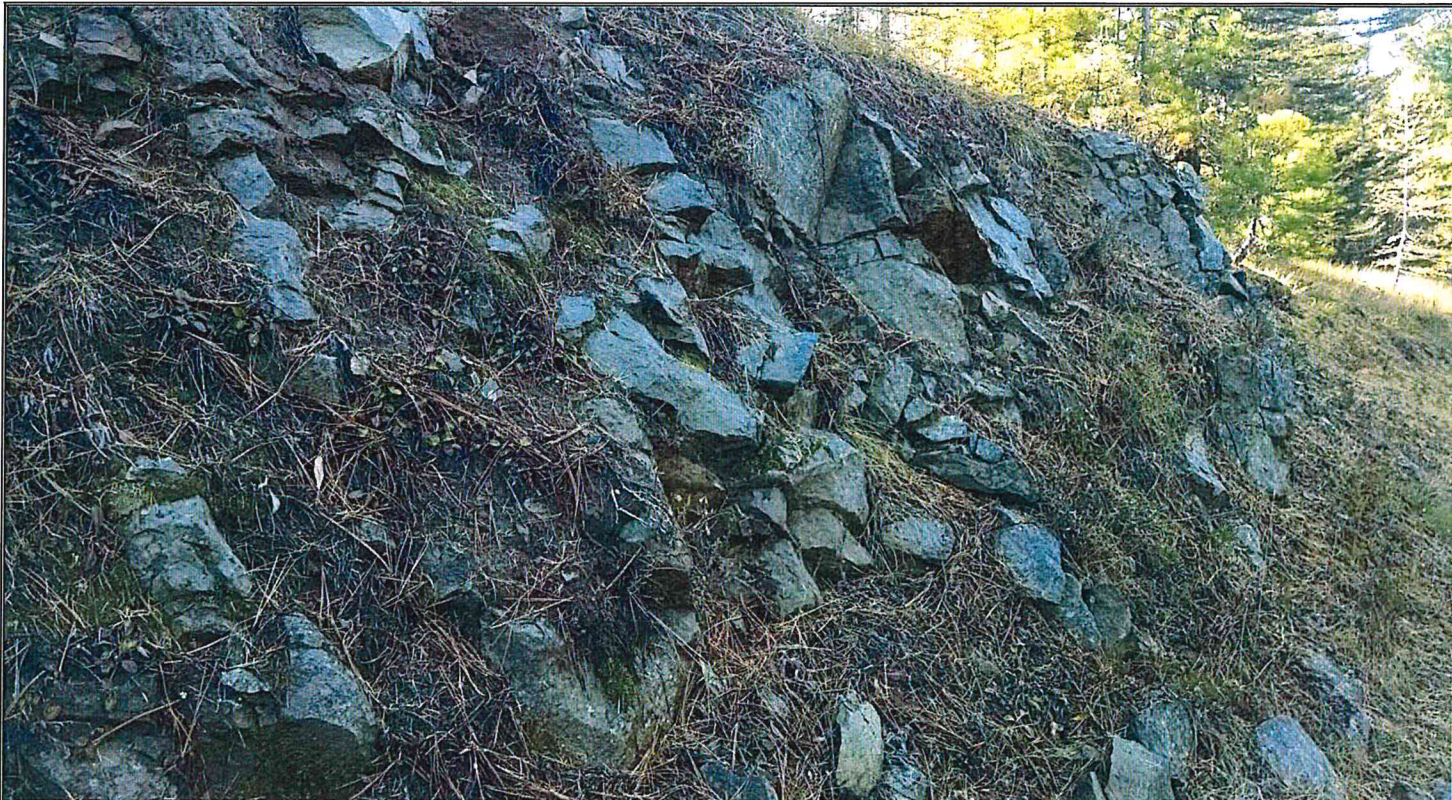
Sedimentary Chumstick Formation exposed along existing road cut at project site

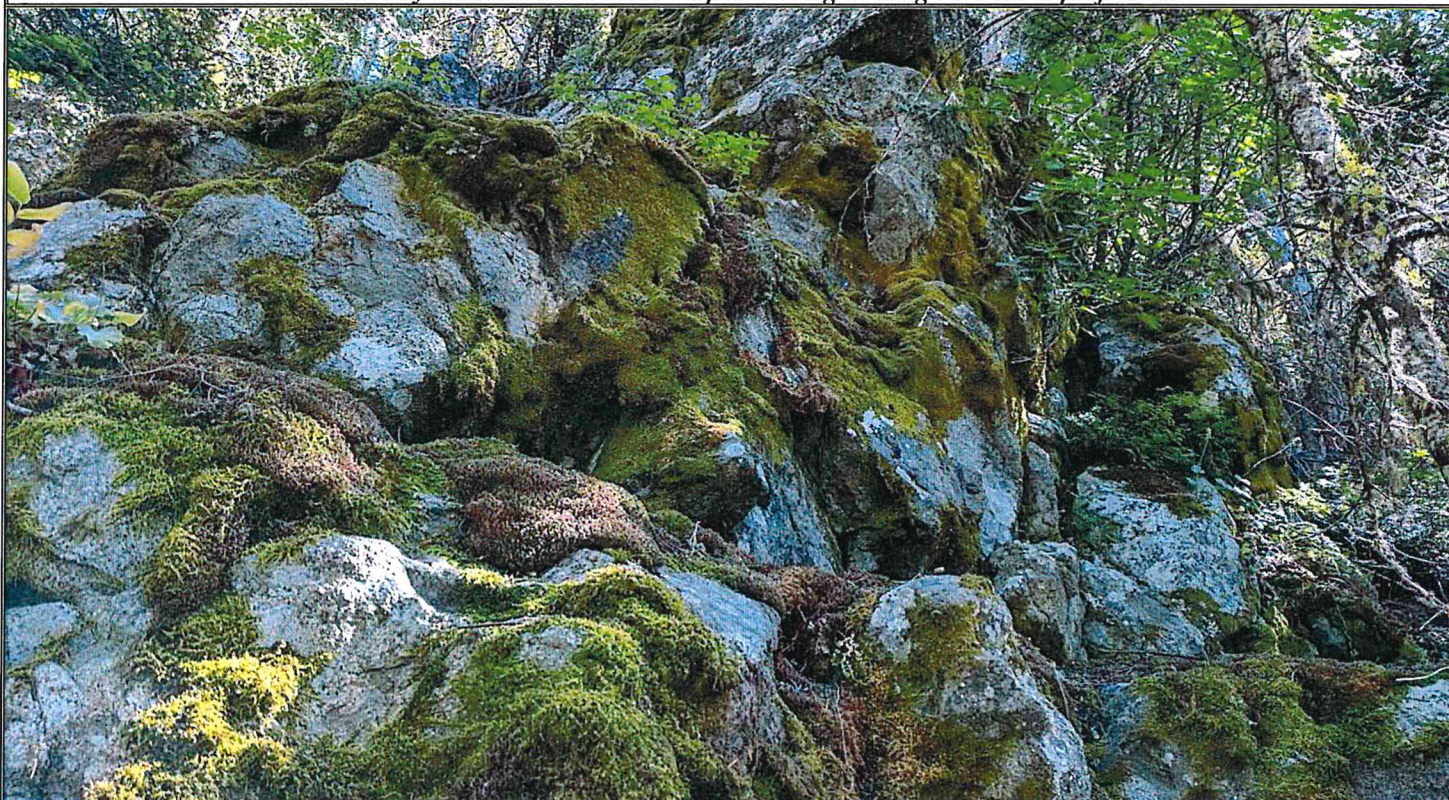
Intrusive igneous (granitic) dike noted at the site

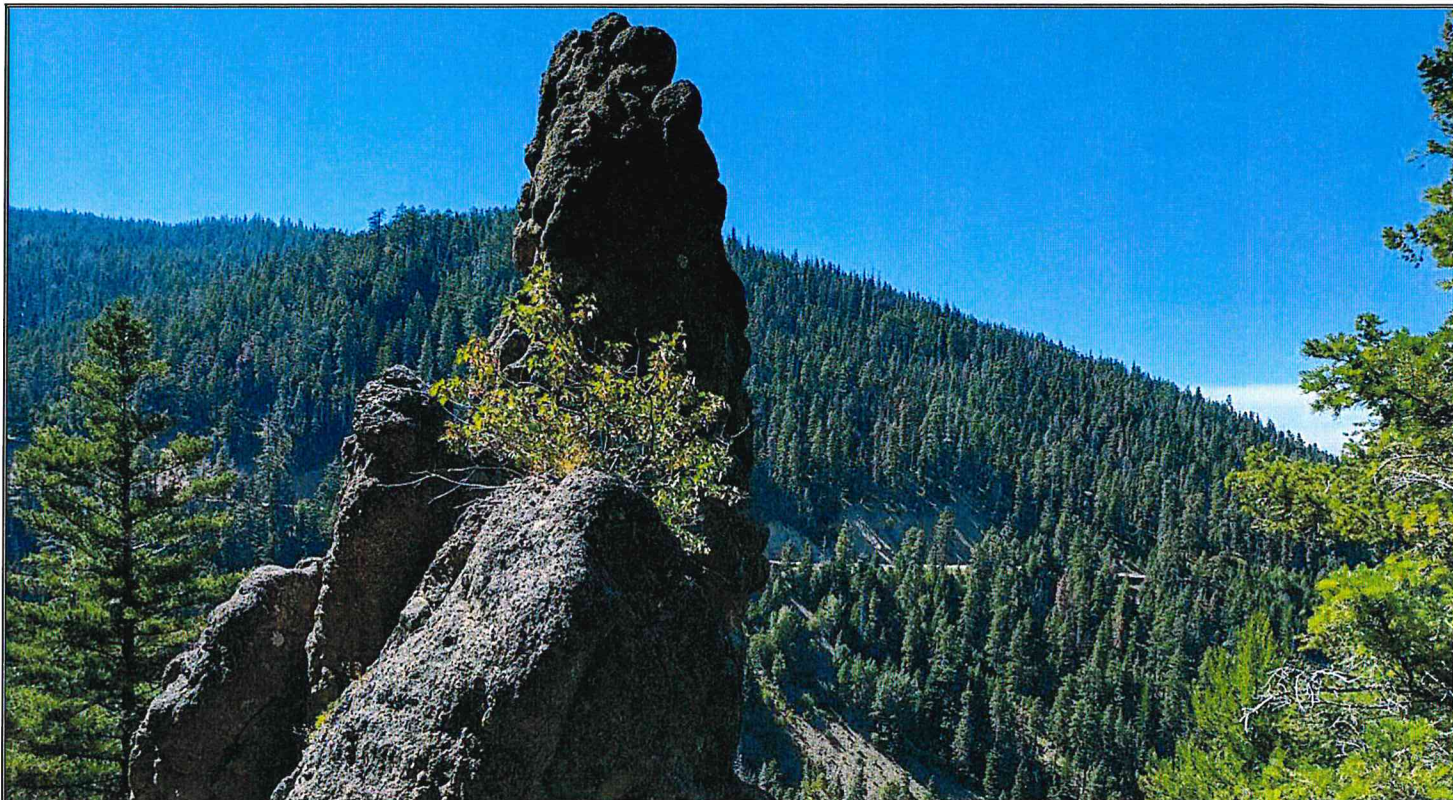
Intrusive igneous (granitic) dike noted at the site

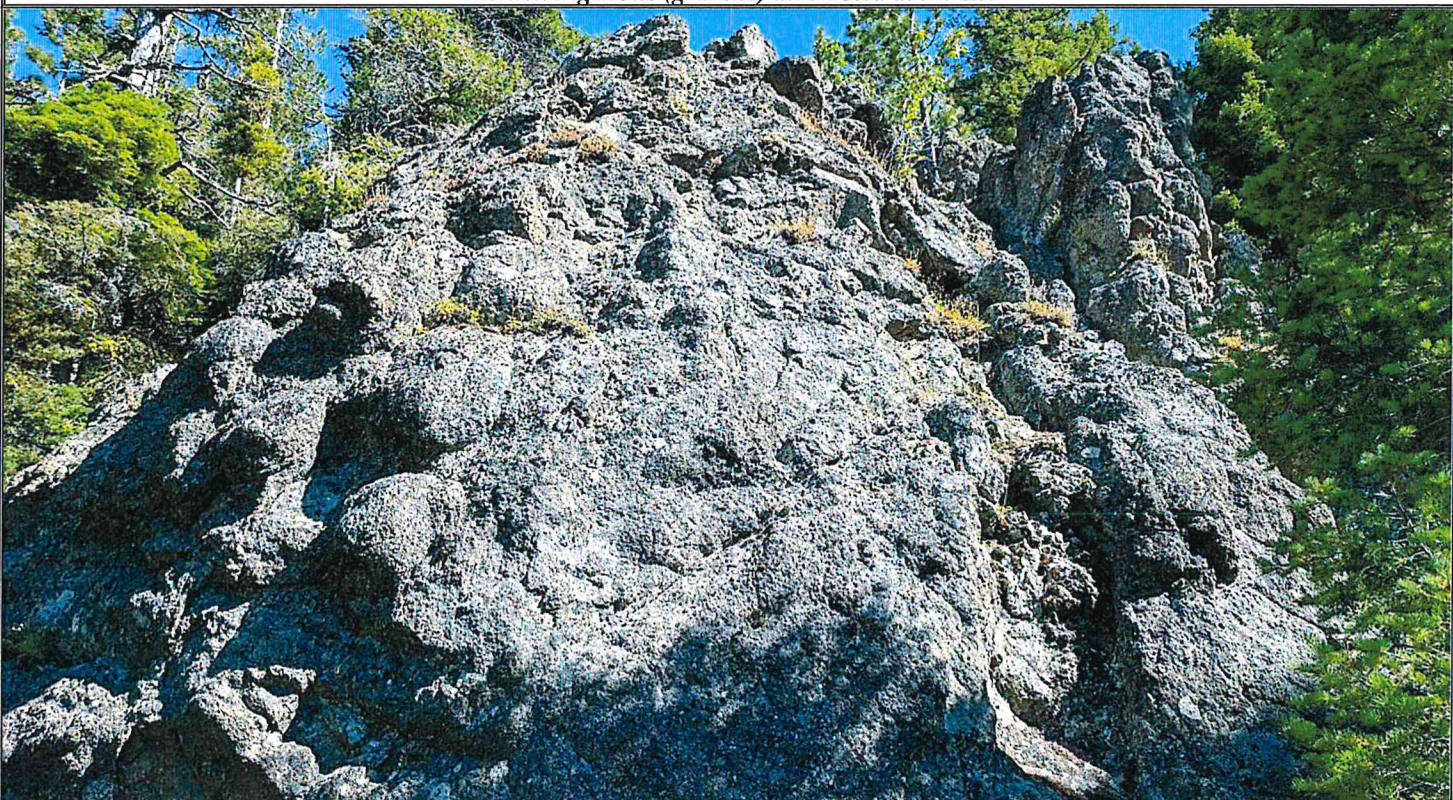
Intrusive igneous (granitic) dike noted at the site

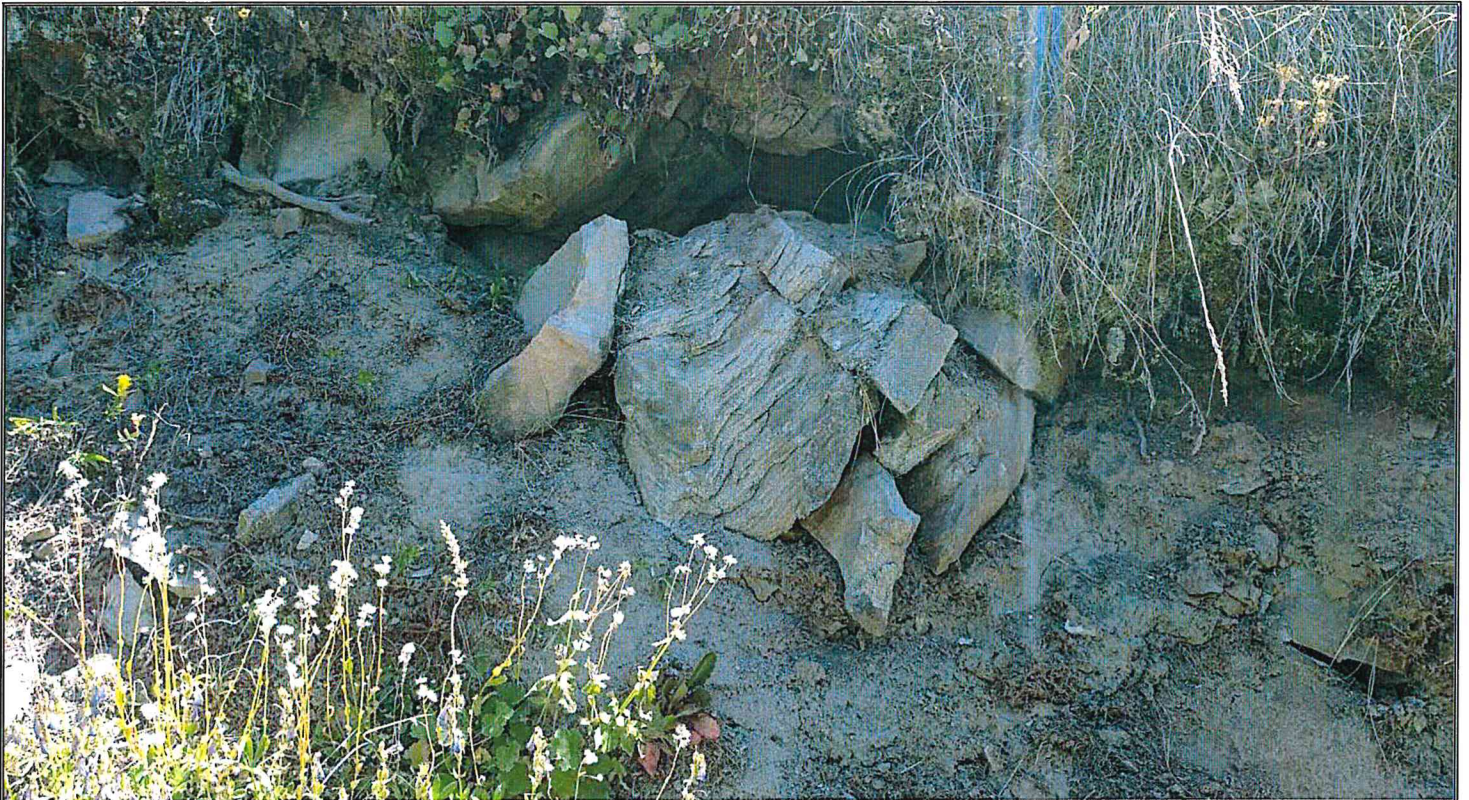
Sedimentary Chumstick Formation exposed along existing road cut at project site

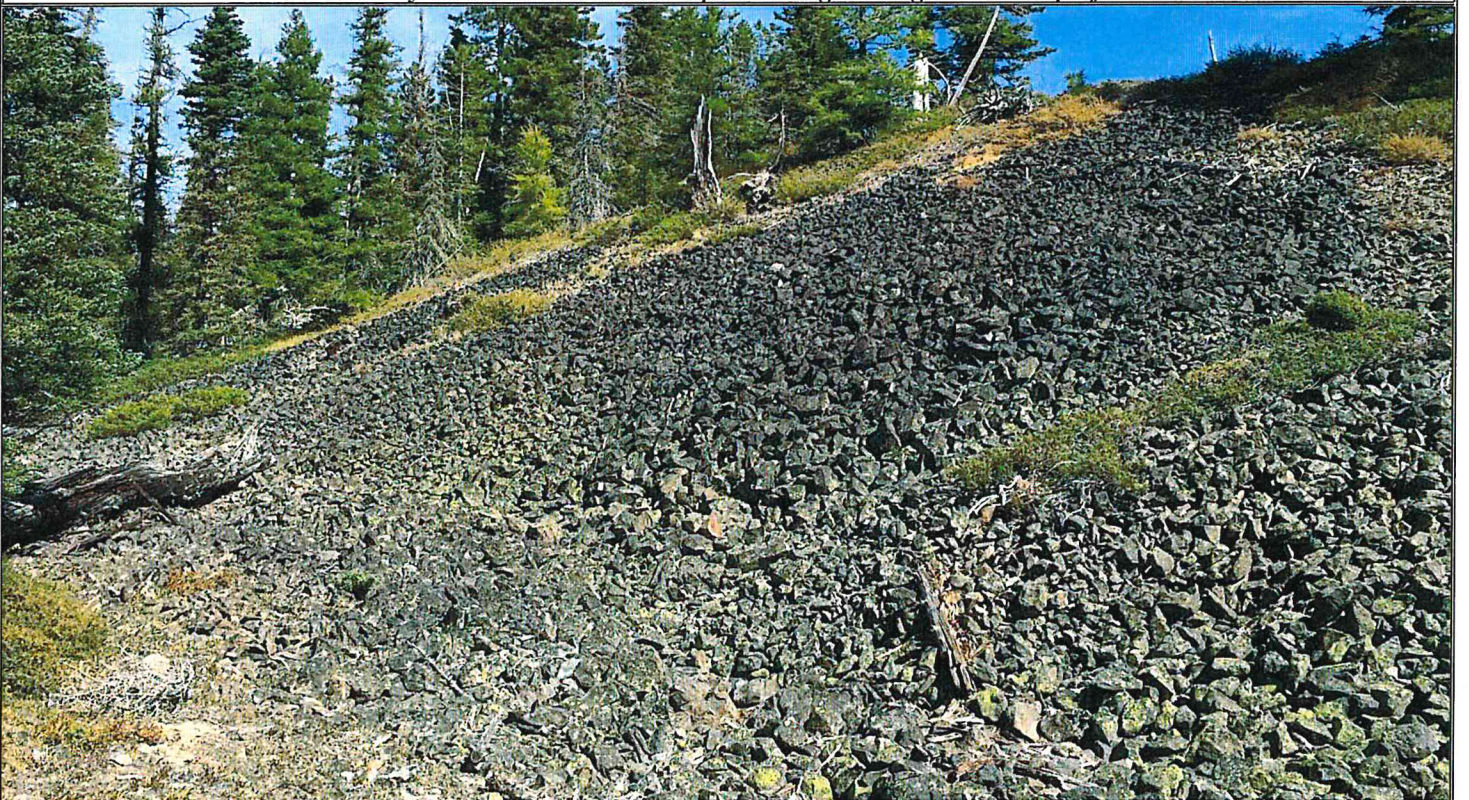
View of basalt rubble (talus) at the site

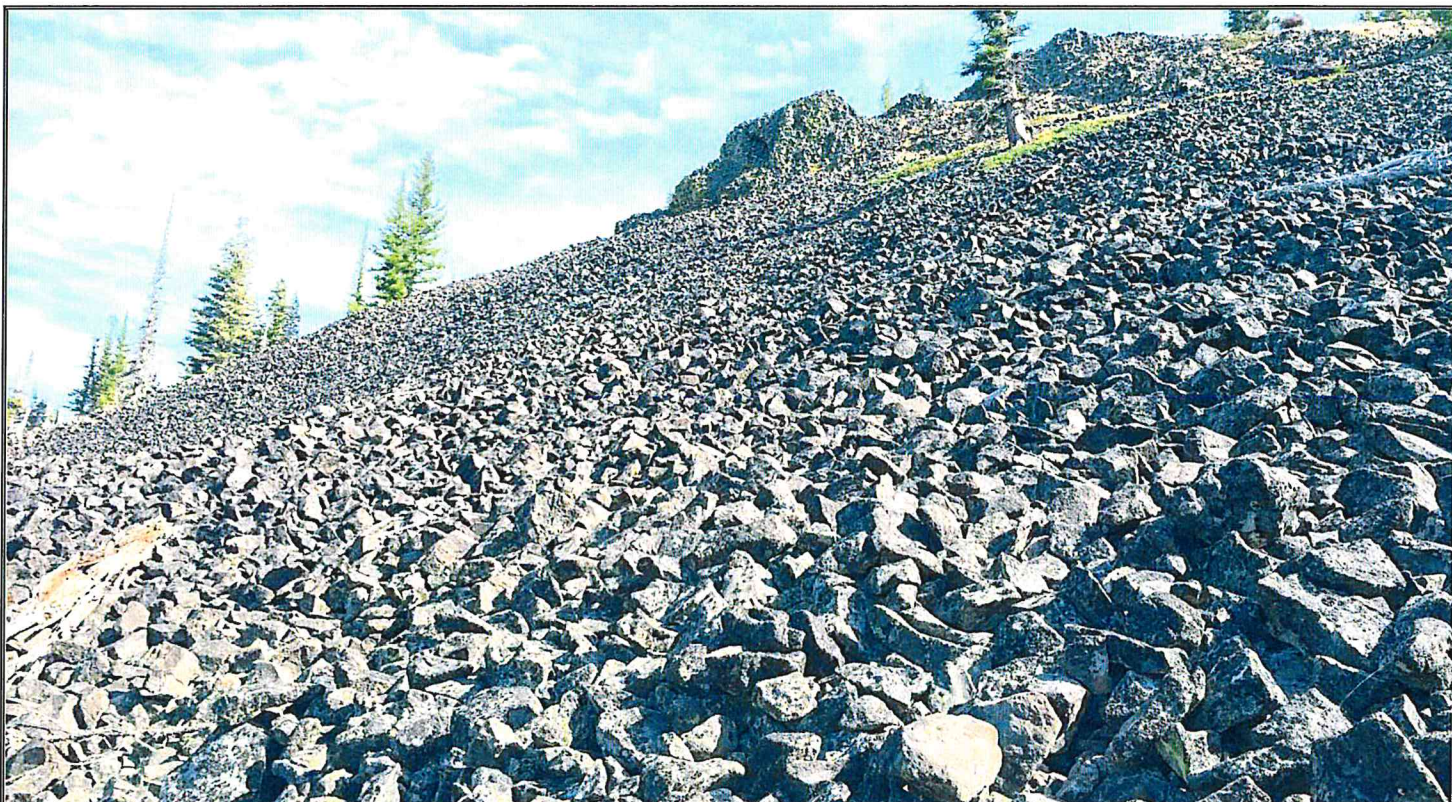
Talus slope with basalt outcrop near crest of slope

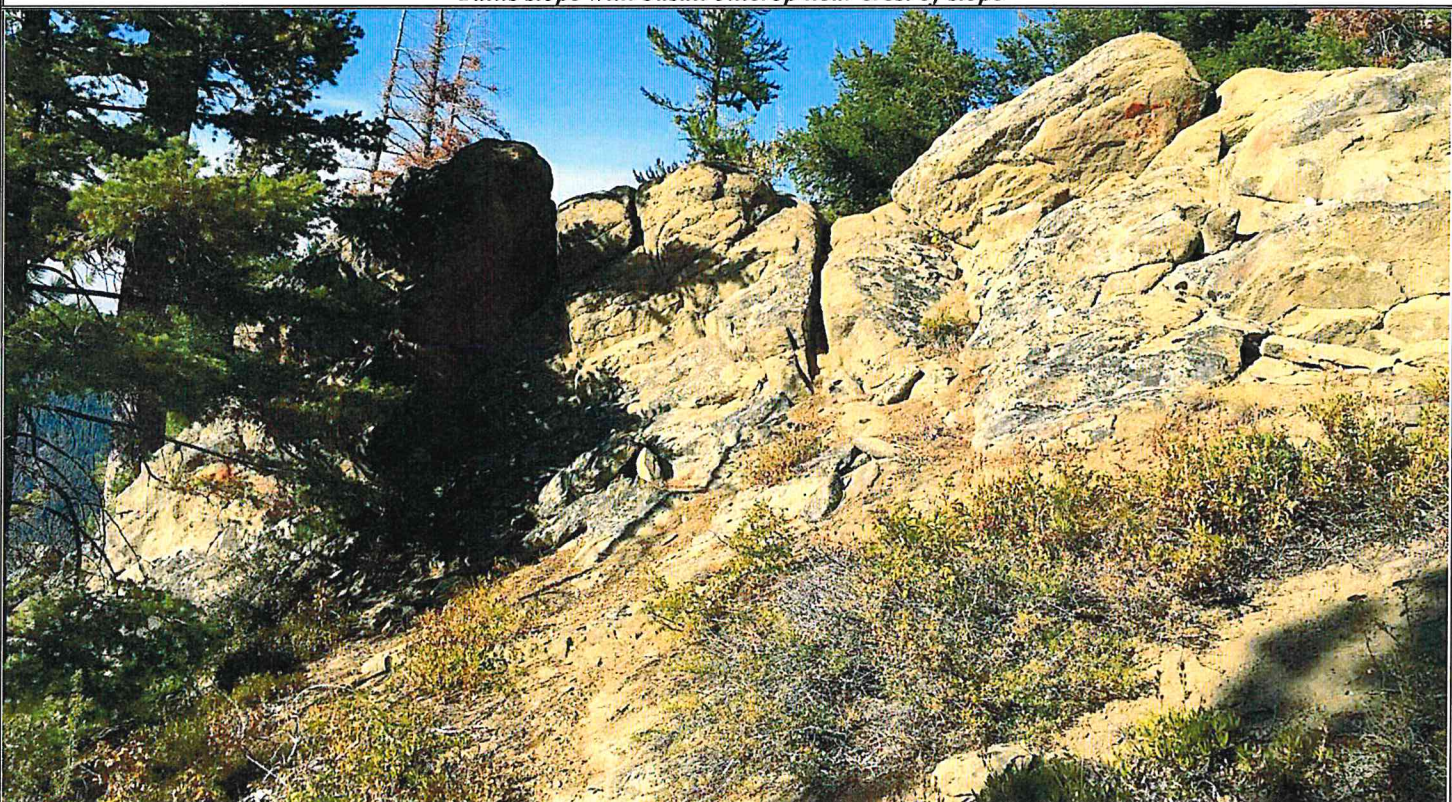
Outcrop of the local sedimentary Chumstick Formation noted near the northwestern portion of the site

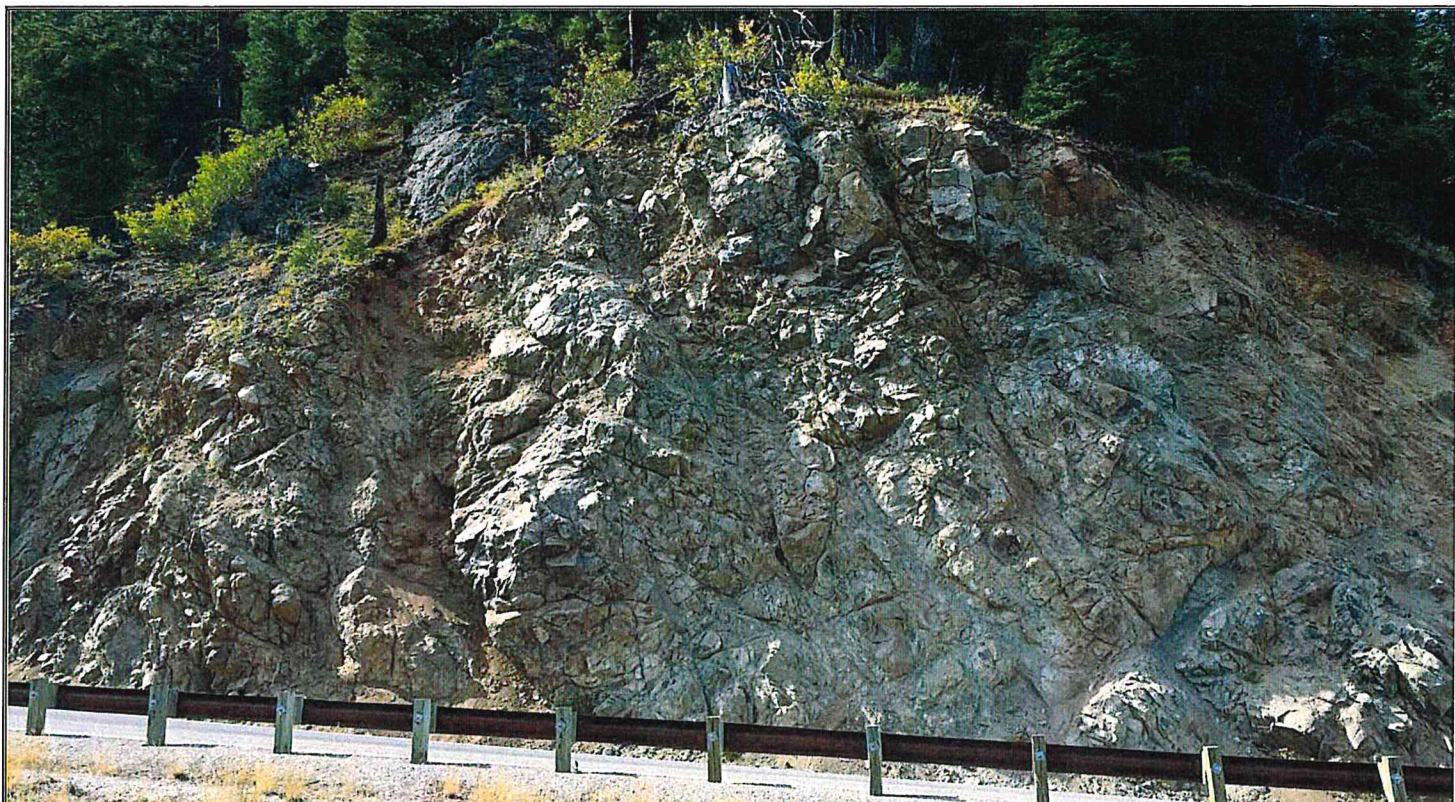
Correlating intrusive igneous dikes noted along Mission Ridge Road

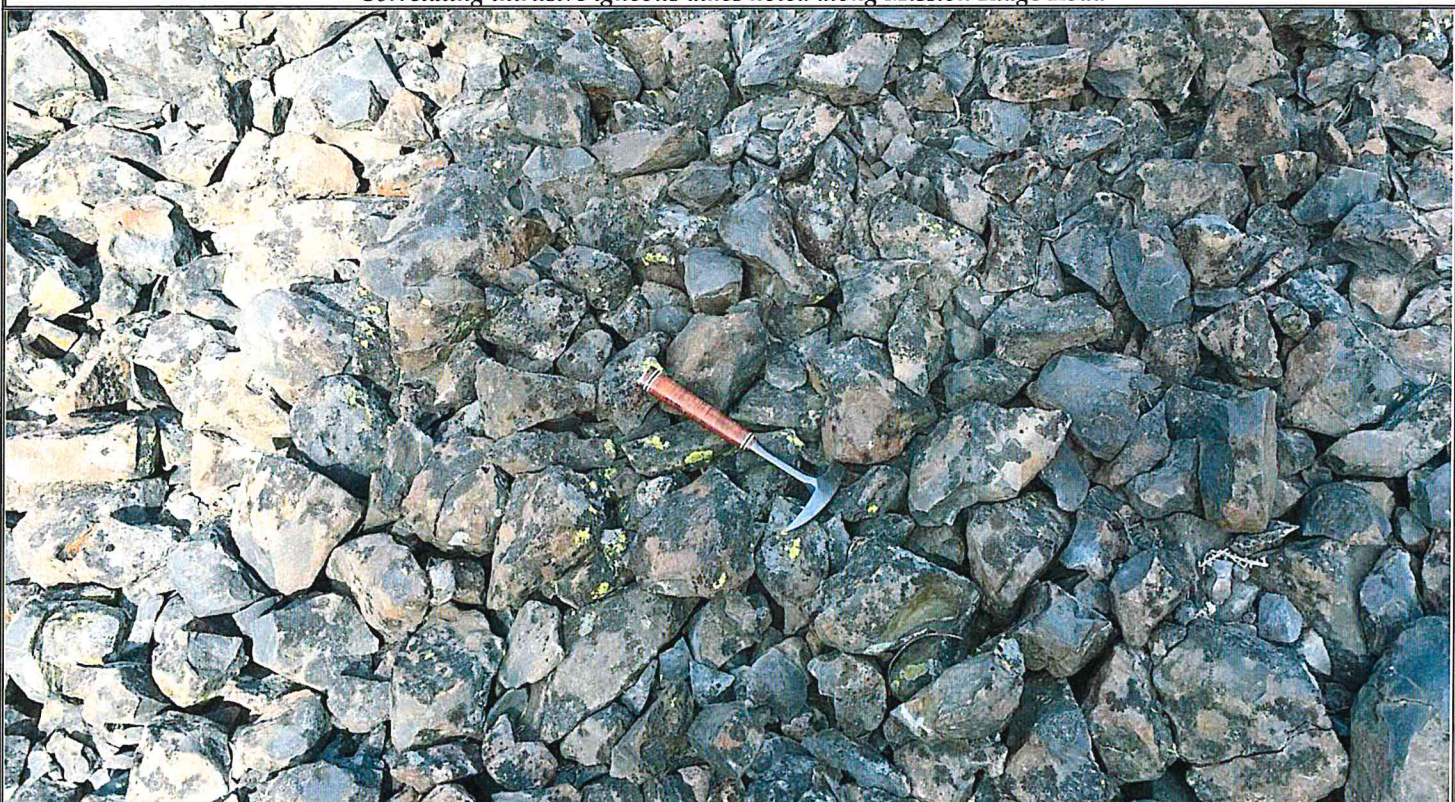
Close-up view of the basalt cobble/boulder rubble (talus)

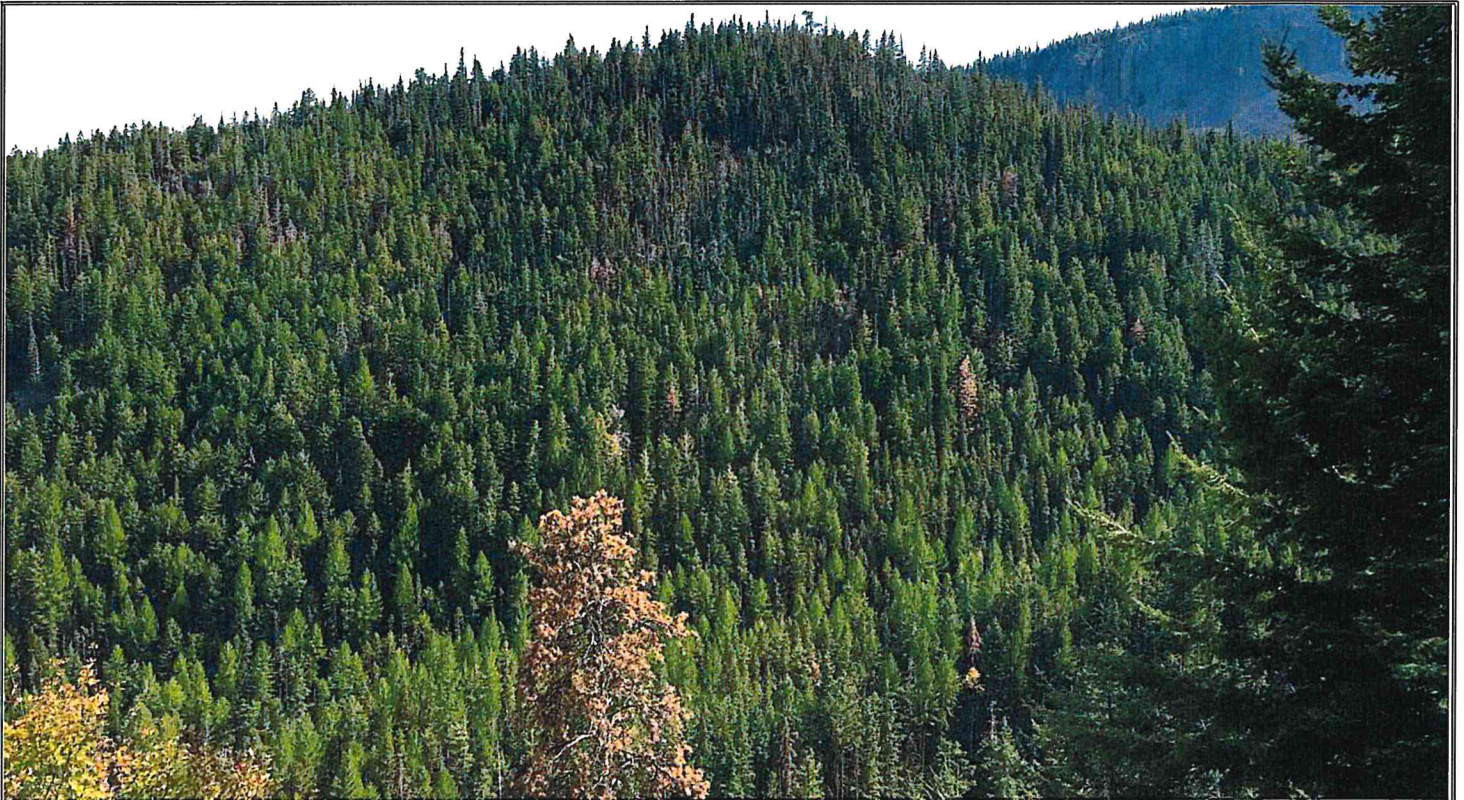
View of project site from Mission Ridge Road, looking southeast

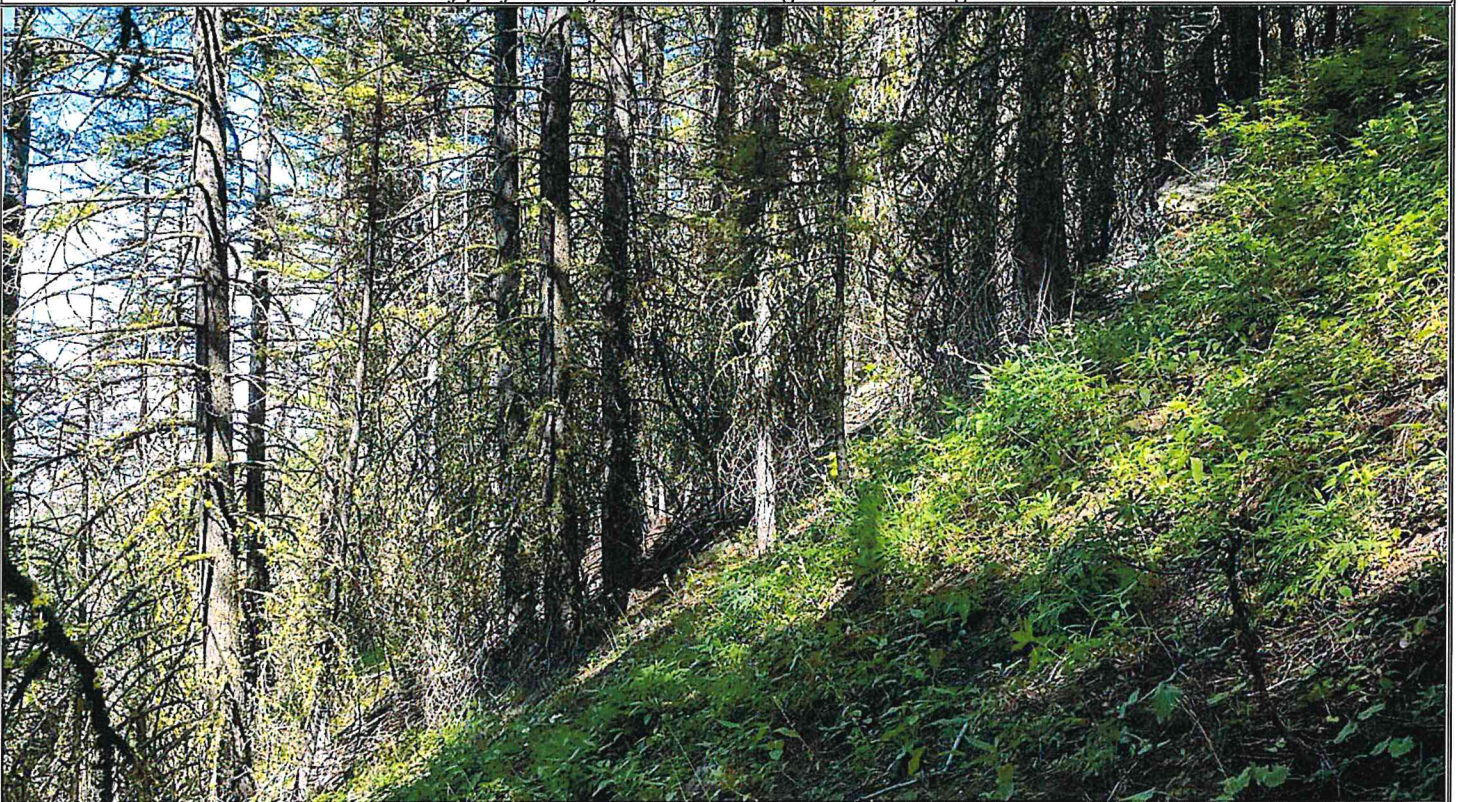
View of typical sloping terrain with dense tree cover at the project site
