Wenatchee River Whitewater Park Feasibility Study Chelan County, Washington

PREPARED FOR: Chelan County Natural Resource Department 411 Washington St. Suite 201, Wenatchee, WA 98801

Mason Lacy, PE and Mike Harvey Recreation Engineering & Planning Inc. 485 Arapahoe Ave, Boulder, CO 80302

DATE: August 3, 2021

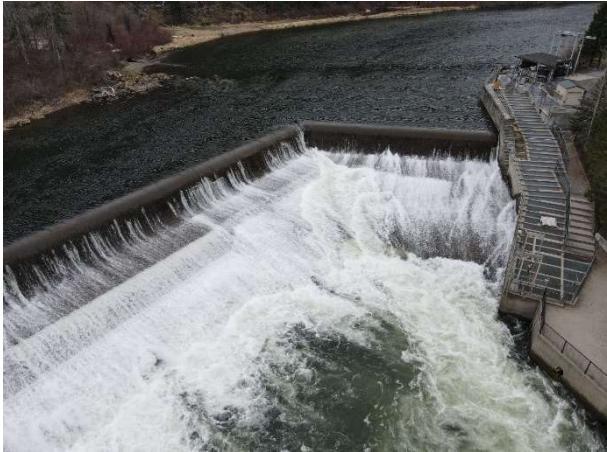
Figure 11. Tumwater Dam, looking upstream. The fish passage facilities are on the right of the photo.

Aquatic habitat conditions are naturally limited around the Tumwater Dam site. Tumwater Canyon is a narrowly confined canyon with steep hillslopes directly adjacent to the channel on both sides. Highway 2 further constricts the channel on river left. The gradient is consistently steep, velocity is high, and the bed material is large. This is primarily a migratory corridor for salmonids with little spawning or rearing habitat. There is some limited floodplain development and high flow refugia on river right downstream of the dam. Upstream of the dam, the impoundment creates a slowmoving section of river for several hundred feet.

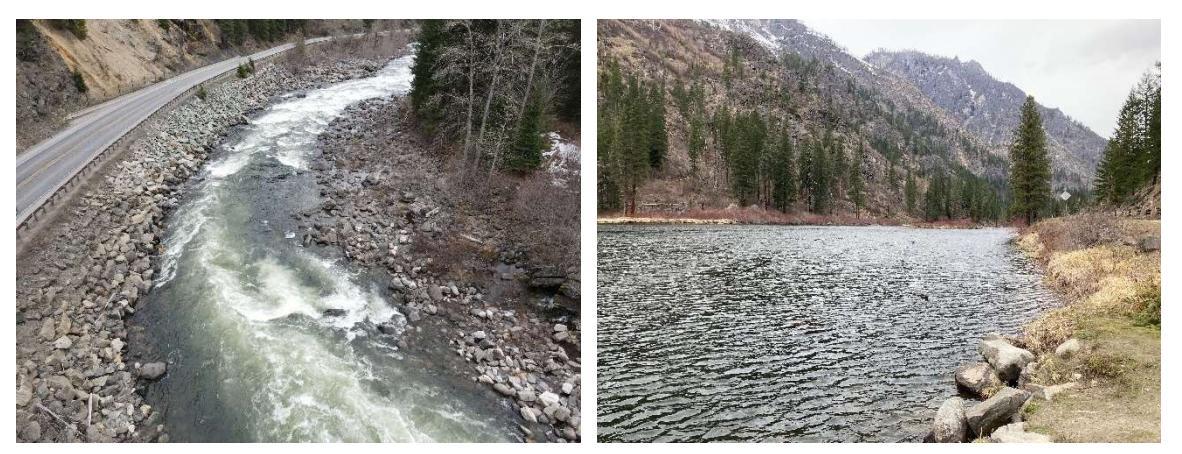
Habitat improvement potential is naturally limited due to the character of the river at this location. The main opportunities would involve habitat feature incorporation into channel re-configuration during installation of recreational features. There would be the potential to include step-pool features that would ease fish passage and provide increased pool and holding habitat important to migratory reaches. Channel hydraulics including high velocity precludes the placement of other habitat features such as large wood. Upstream of the existing dam, there would be additional opportunity to place cover habitat in the form of large wood structures along the channel margin, or as midchannel log jams. Hydraulic forces are reduced in this low velocity area and could support habitat enhancement.

Figure 12. High velocity channel downstream of the dam (left). The impoundment upstream of the dam creates a low velocity area (right).

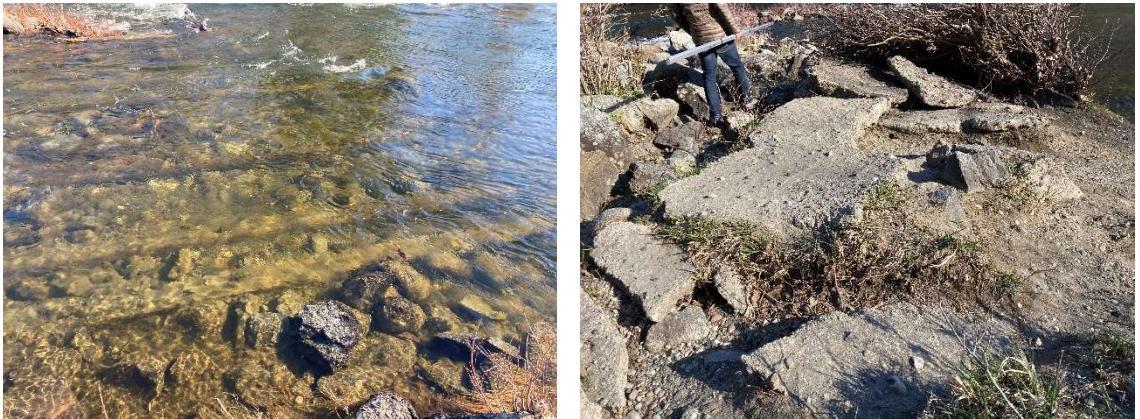
The bed and banks of the river primarily consists of larger rock, with sand deposition in the eddies creating beaches. There are no signs of lateral channel migration, and the channel appears stable, partially due to the remnants of the historic dam.

Figure 14. Timber cribbing (left) and chunks of concrete (right) remain today at the dam site

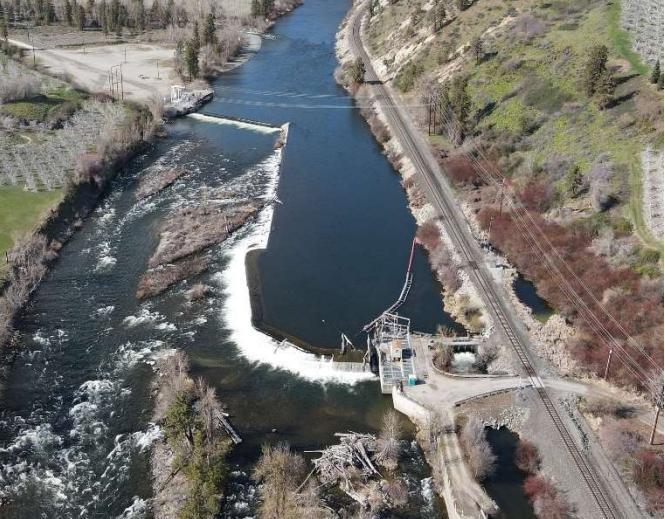
The hydraulic roller formed by the upstream-most section of dam presents an extreme public safety hazard. Hydraulic rollers located at low head dams such as this one are effective at trapping objects (including humans) in a dangerous recirculating pattern, whether the victims are wearing a personal floatation device (PFD) or not. With their low height and

Figure 17. Dryden Dam looking upstream

calm water upstream, low head dams can look innocuous to an inexperienced river user, when in fact they are extremely dangerous due to their man-made uniformity that is not found in nature.

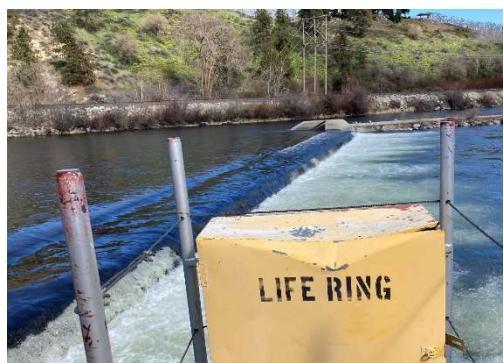
The hydraulic formed at the Dryden Dam is a classic low-head dam hydraulic scenario. The American Whitewater description of the run calls the hydraulic "a guaranteed drowning machine". There has been at least one documented drowning at the site, and unfortunately it is rarely documented whether a drowning was associated with a dam. The documented case occurred in 2016, and the American Whitewater accident description is attached to this report. The victim was on a commercial raft trip and wearing a PFD.

Figure 19. A life ring located at the dangerous hydraulic.

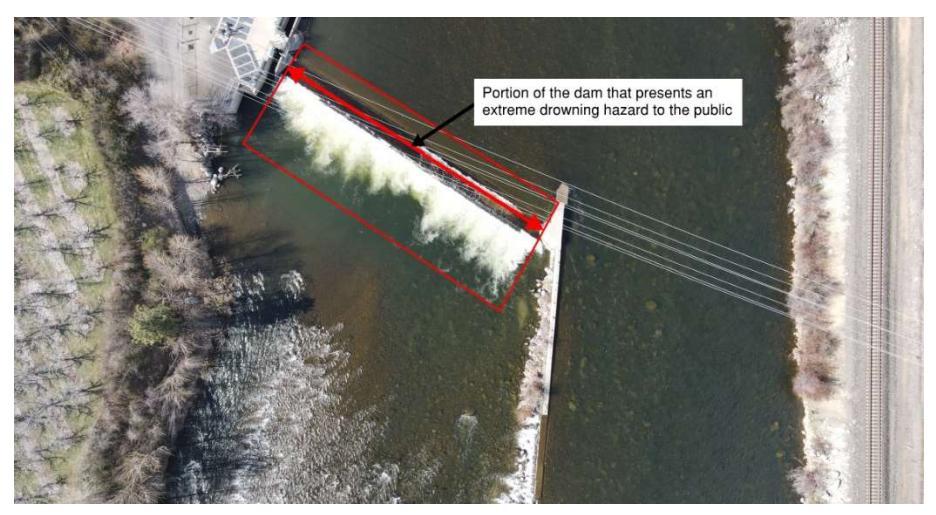
During the dam reconstruction in 1986, the concrete weir was designed to create a hydraulic to attract upstream migrating fish to the fishway entrance located at the right bank. The design appears to have been effective in attracting fish, but also created the extreme public safety hazard. REP has designed many fish passage facilities, and optimizing attraction flow for upstream passage is an important component of the design, but can be designed to avoid creating an extreme public safety hazard. We are confident the weir could be reconfigured to still provide effective attraction flow for the fish passage facility while mitigating the safety hazard.

Figure 20. The location of the most dangerous portion of the weir.

The REP team has been involved in multiple expert testimony cases related to low head dam drownings and river safety incidents. We regularly provide support, guidance, and safety consulting related to river projects across the country. Based on our experience, more drownings at the site in its current configuration are inevitable, and safety modifications at the dam should be collaboratively pursued to avoid potential for future accidents at the site.

Without a change in the right bank broodstock collection facility, recreational improvements can still be made to the weir. At a minimum, safety improvements should be considered to address the public safety hazard. REP has designed many similar dam safety retrofits, and are confident that the weir could be modified to allow safe downstream passage by rafts and other river users, while still maintaining at the existing uses of the dam including attraction flow for the fishway, diversion of water for irrigation,

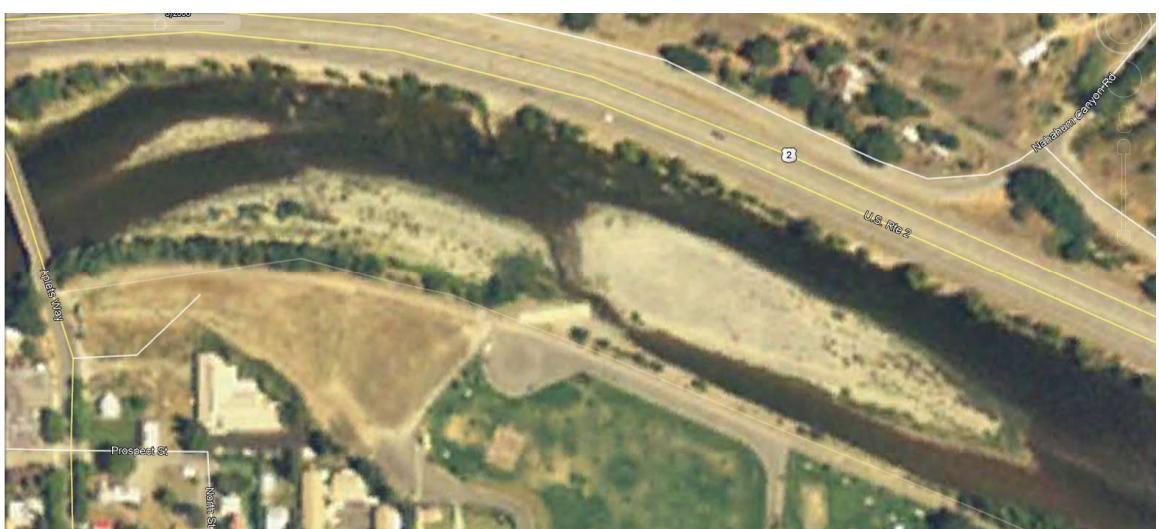
However, the location of the site on a large bend in the river makes a whitewater park located along the right bank of the river nearly impossible. The thalweg is located along the left bank as the current flows around the outside of the bend, and significant deposition occurs at a large point bar adjacent to the park. This has caused issues with use of the boat ramp at low flows, as access to the ramp dries up with the water concentrated along the left bank. The area has been dredged previously to help mitigate the issue, but sediment deposits again along the right bank during high flows.

Figure 26. In this image from the end of July, there is barely any water reaching the boat ramp on river right. *Image source: Google Earth, image date 7/31/2005*

If the sediment was dredged and a whitewater park constructed along the right bank, the features would likely function for a season before being filled in with sediment during runoff.

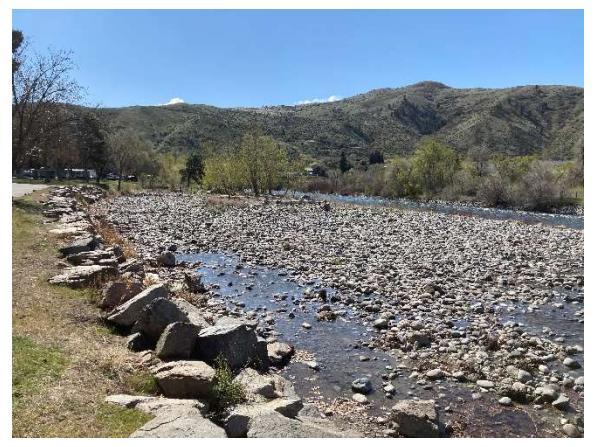
The site is located within Reach 4 of the LWRA. Habitat in this reach is described as limited in the LWRA due to extensive bank armoring and development of the floodplain. These conditions are consistent with habitat observed near the site. The channel is

Figure 28. Bank armoring and entrance to high flow channel on river left.

The LWRA identified potential projects up and downstream of the site. At some locations, suggestions include using large wood to enhance artificially hardened banks, and at other locations project opportunities are identified as adding boulder clusters to the channel to increase complexity. Either of these approaches could be employed in the vicinity of the site as well. There is also opportunity to explore options on river left to enhance the high-flow channel.

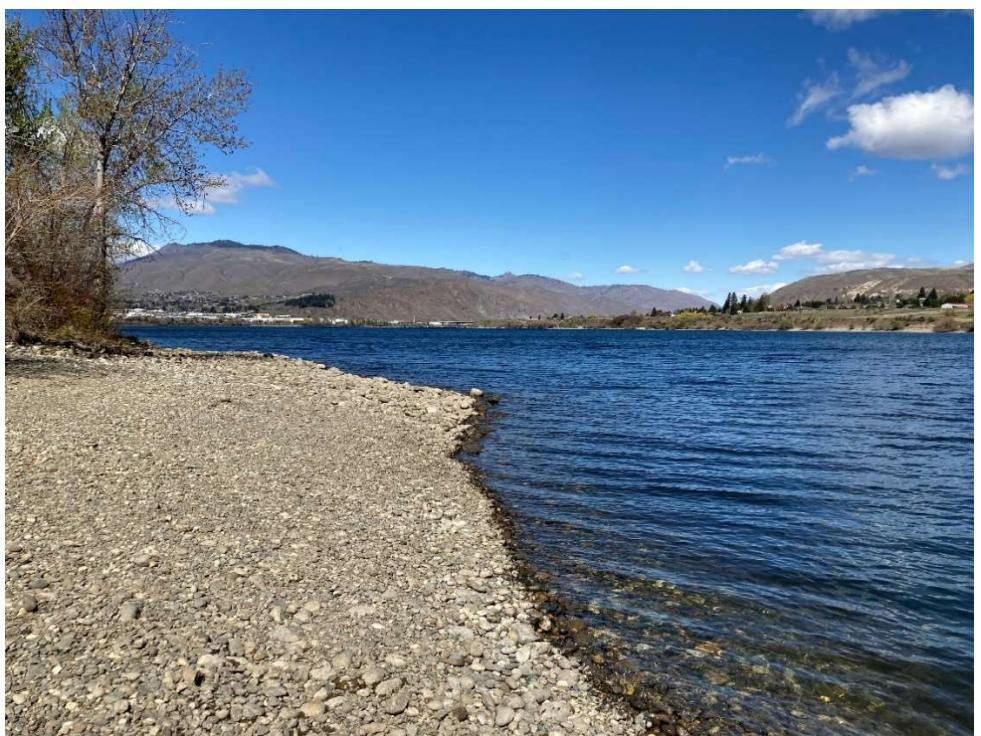
Figure 30. Lake-like conditions during the site visit. Unlikely that a whitewater feature is possible here with the current operation of the Columbia River dams.
