SURVEY OF SUBMERGED NOXIOUS WEED SPECIES IN LAKE CHELAN WASHINGTON

1/26/2015

Produced by AquaTechnex

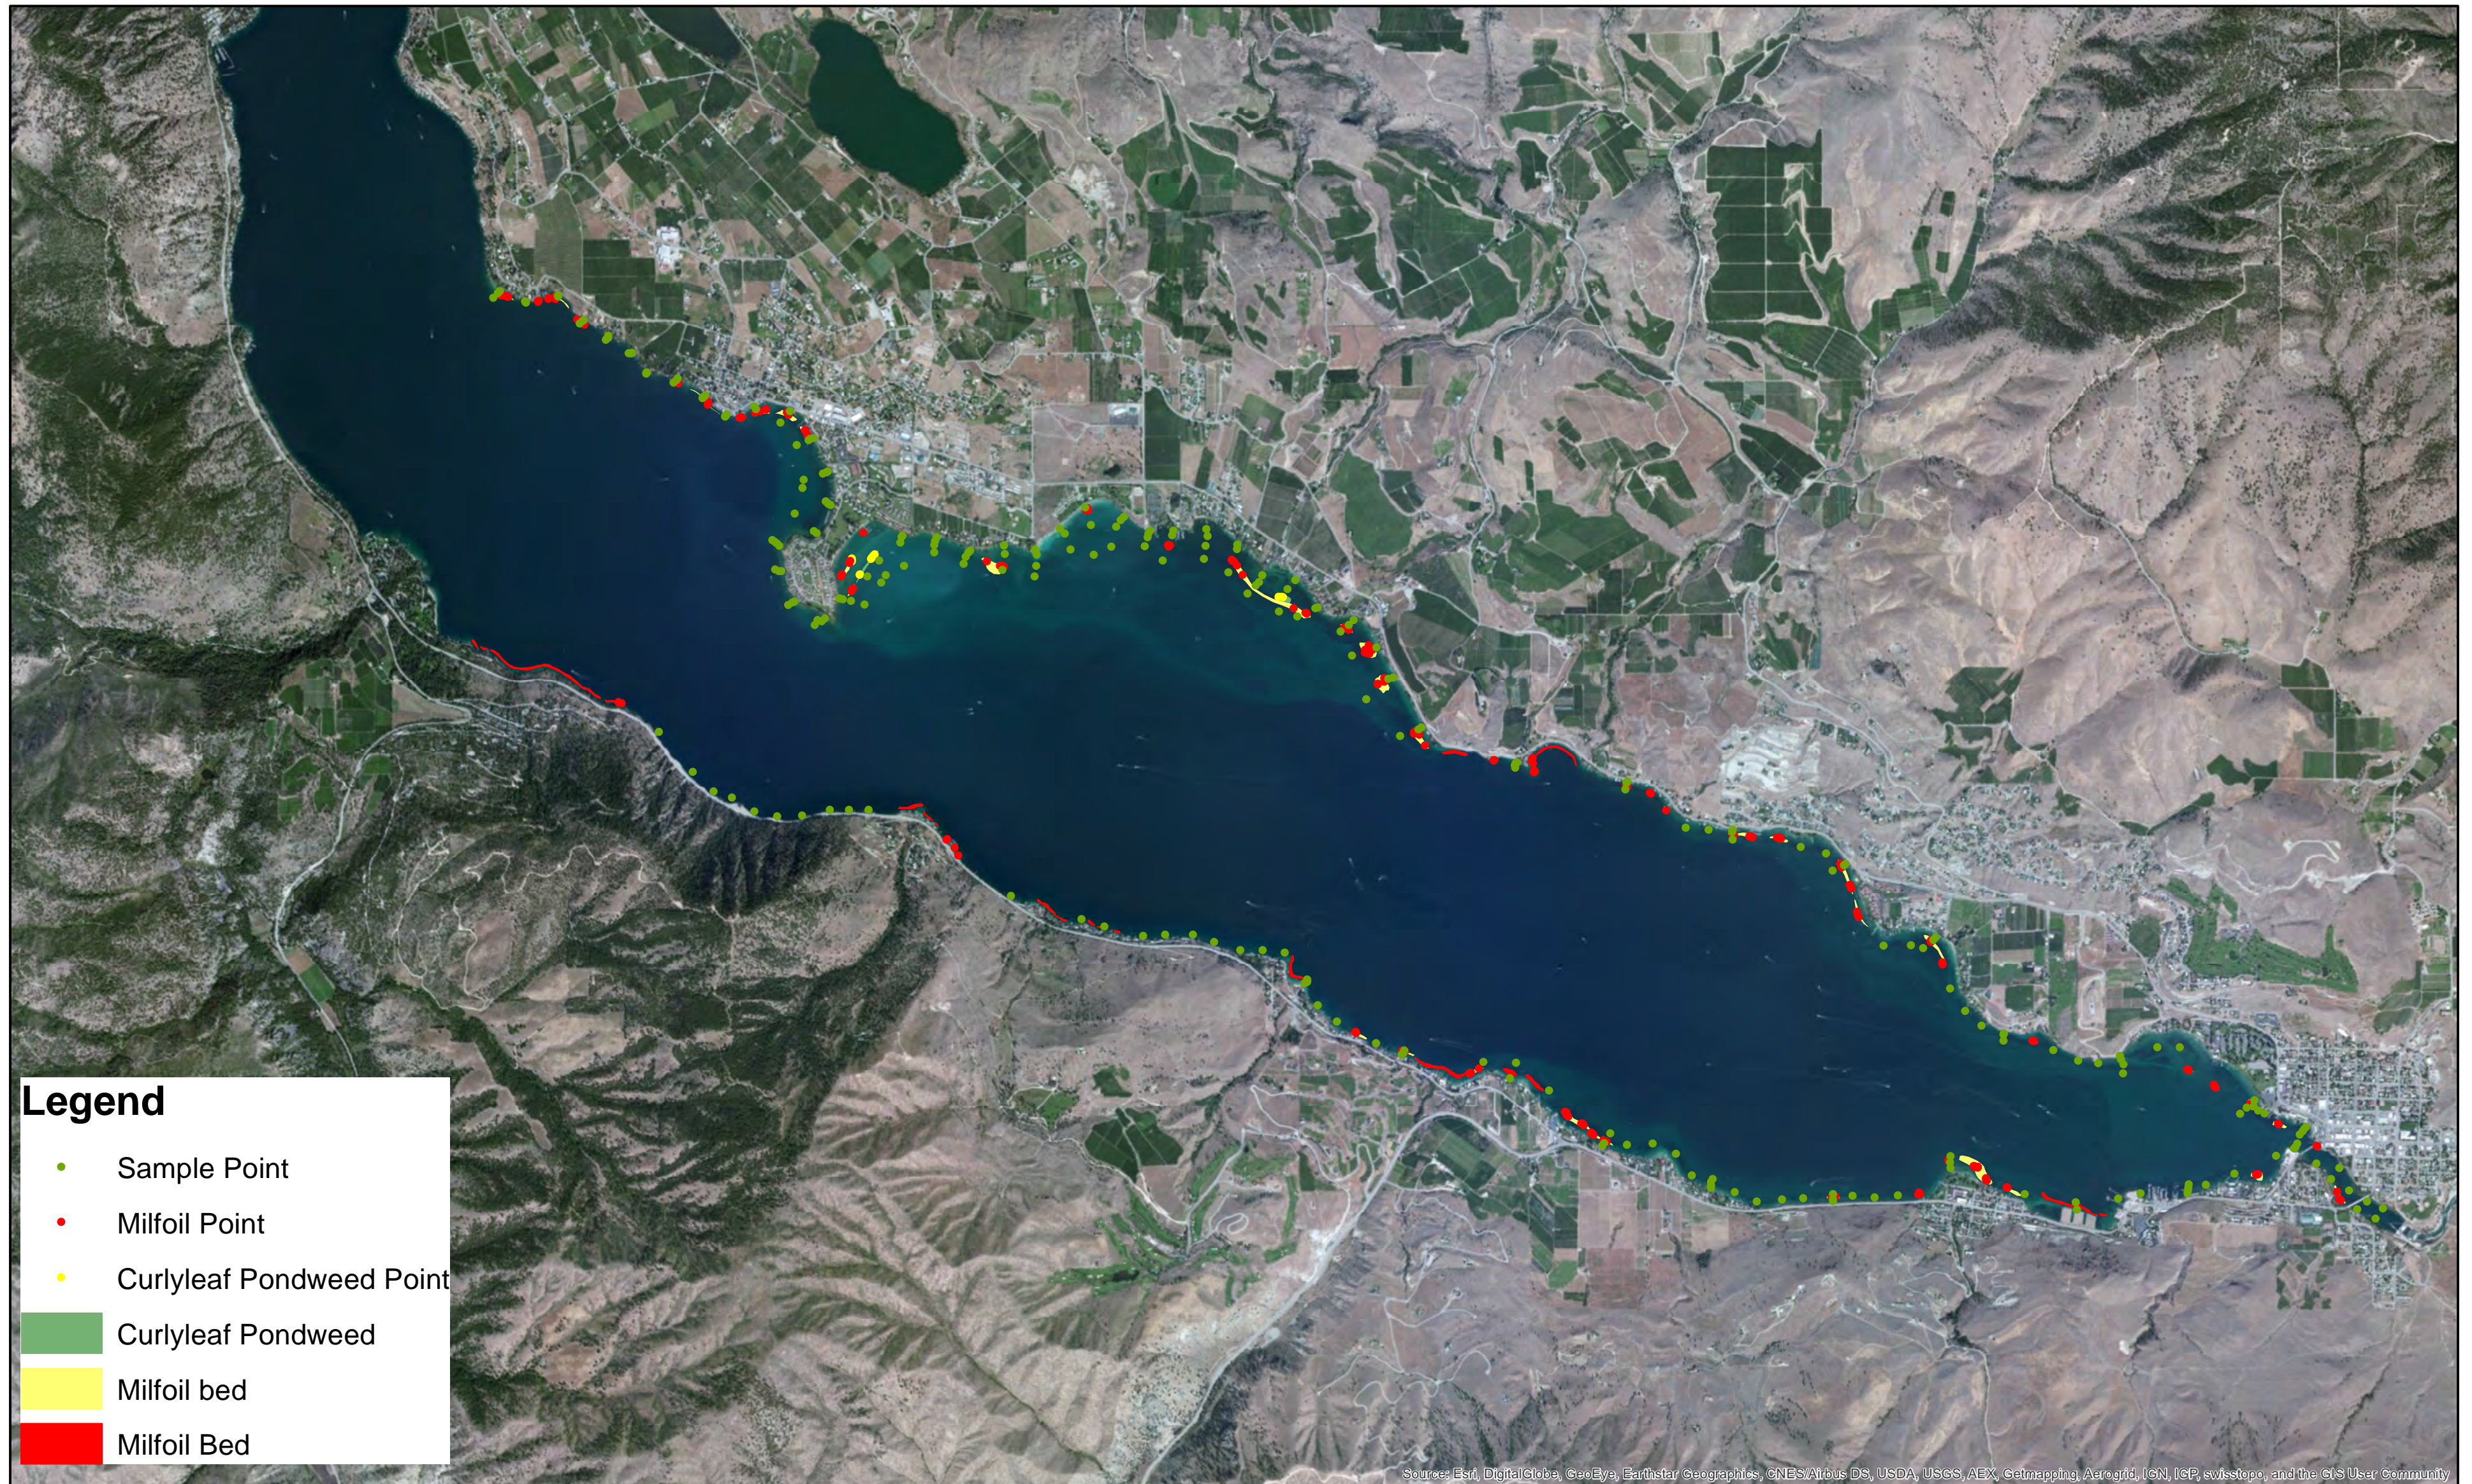
Lake Chelan Submerged Noxious Weeds

Several maps are included in the following pages. The first map in the series is one showing the entire survey area. There are red boxes on this map indicating the area which is projected in more detail on maps pages which follow.
