# Icicle Creek Boulder Field Fish Passage Assessment

## Icicle Creek, Chelan County, WA

## FINAL May 2013

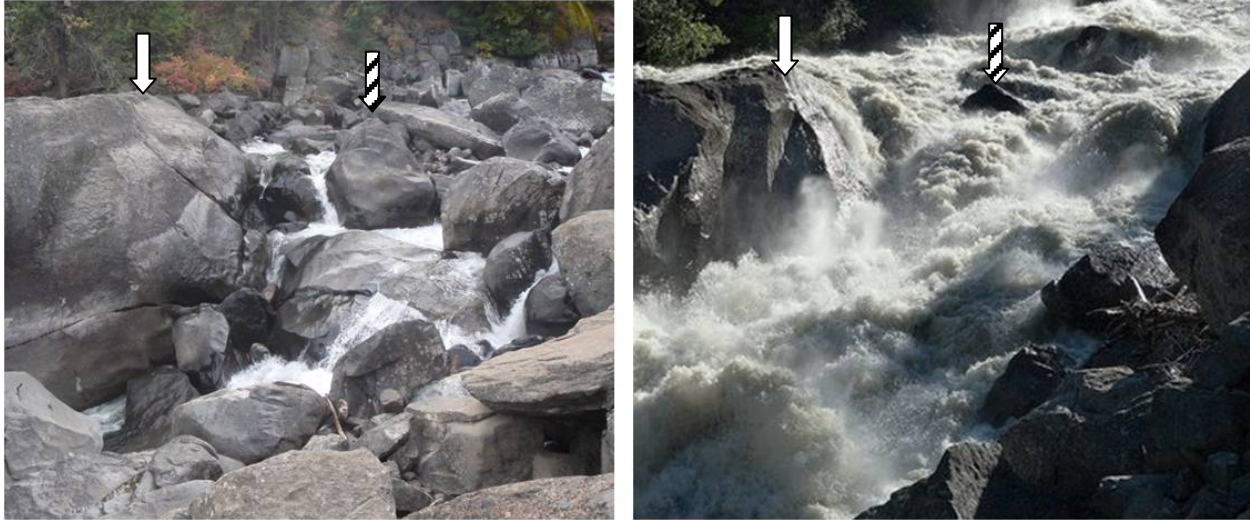
**Photo 1 - Side by side comparison of Anchor Boulder flow chute at 200 cfs (l) and 12,000 cfs (r). The 20,000 cfs 50-yr flood and site constraints of high velocity, large-sized sediment and debris transport limit the in-channel fish passage alternatives. (Arrows provide location reference).**

Icicle Creek experiences a large range of flows on a regular basis. Site visits during low and high water extremes assisted the study team in identifying challenges to the assessment and alternative development (**Photo 1**).

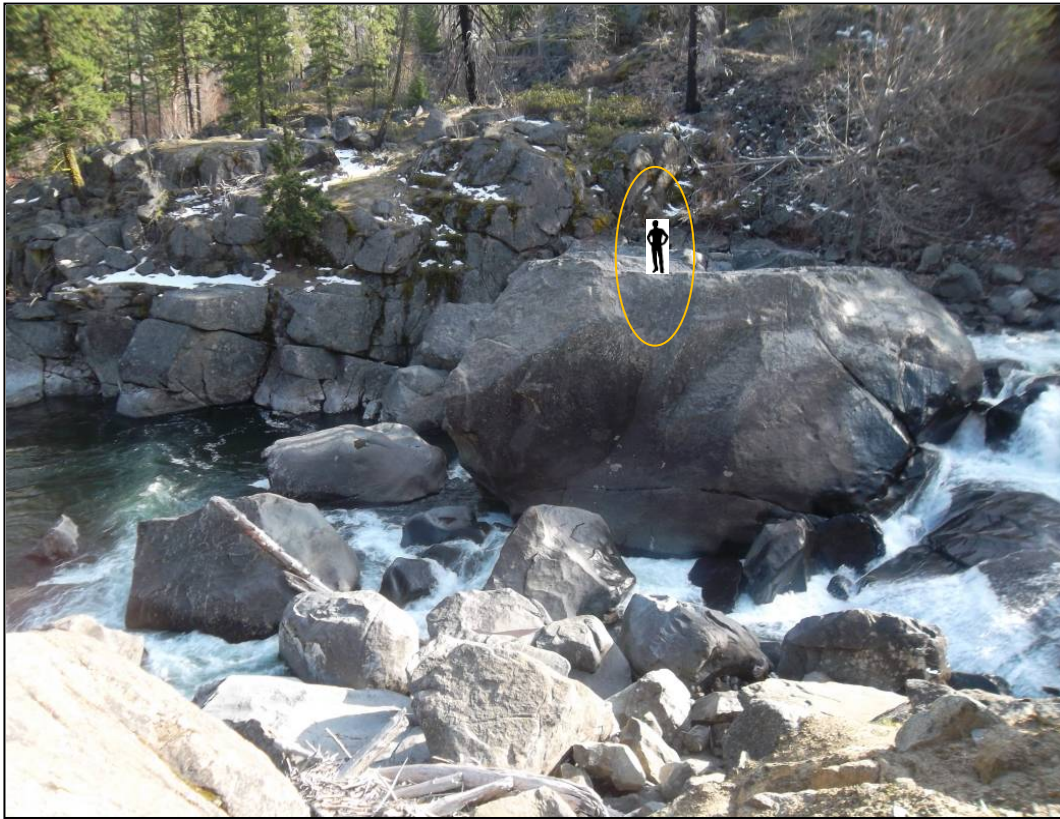
**Photo 2 - Anchor Boulder and surrounding area at crux of the Middle Reach analysis. Calibrated man-sized image inserted for approximate scale.**

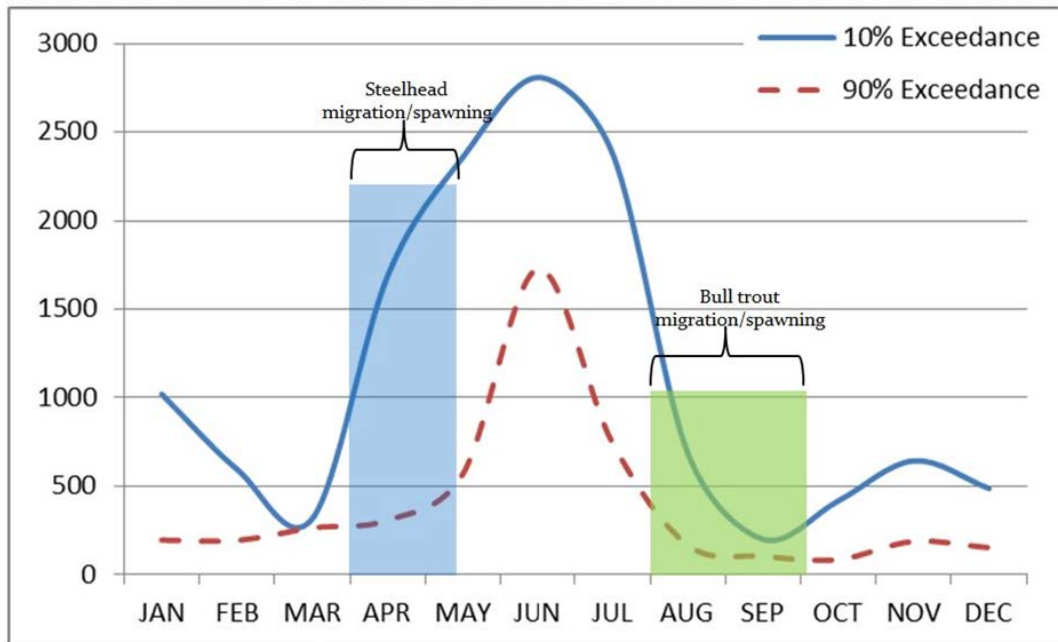
**Figure 3 - Steelhead and bull trout migration timing windows (upright bands) overlaid on the estimated 10% and 90% exceedance flows.**

The above chart identifies the primary target flow ranges for bull trout and steelhead to move upstream. Initial field observations in October 2012 suggested that the flows most likely to pass fish in the channel's current condition would be approximately 200 cfs. A wide range of flows occur through the migration period (Table 1 and Figure 3). Timing of life history stages for Lower Icicle creek based on Wenatchee subbasin information and regional expert opinion are presented in Table 2. The main determinant for developing passage alternatives through the Boulder Field however would be flows, rather than explicit timing windows. For example, designs would assist steelhead in the spring that typically encounter higher flows and bull trout in the fall where low flows are encountered on the receding end of the hydrograph.

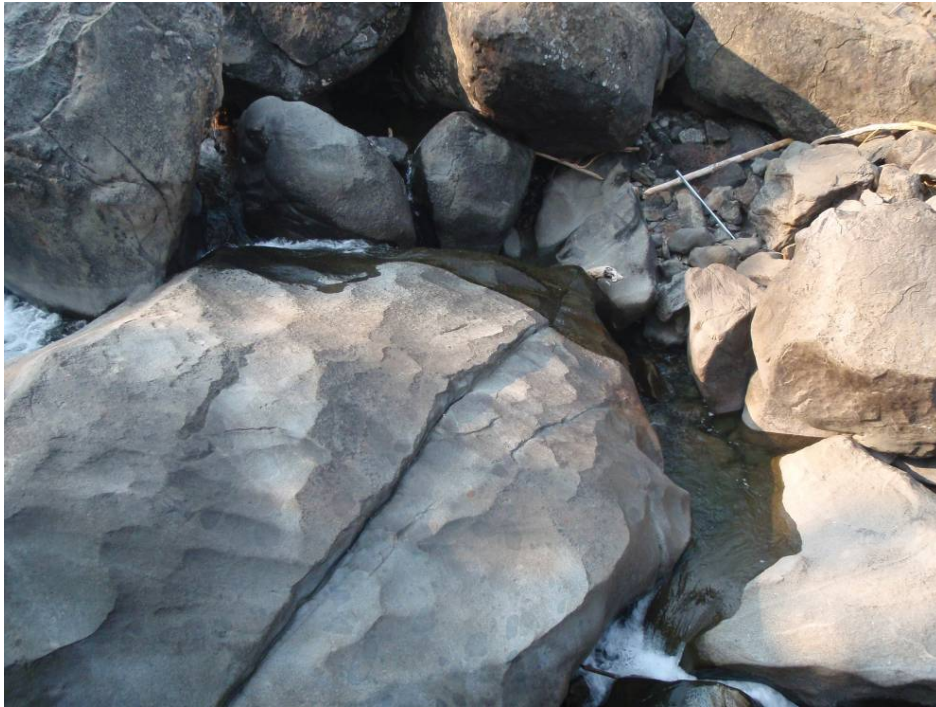
**Photo 3 – Icicle Creek Boulder Field Middle Reach. View is of left bank from top of Anchor Boulder depicting flows going under boulders.**

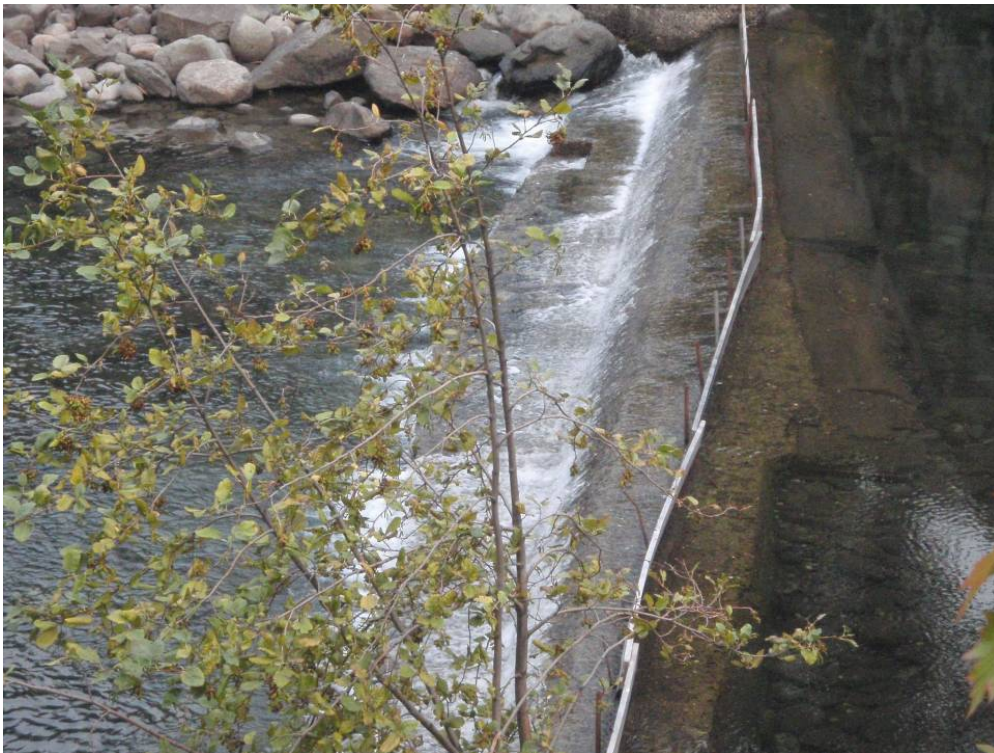
**Photo 4 – Concrete Diversion Dam with flashboards at 20 cfs.**

Field observations to identify flow characteristics that would provide fish passage opportunities occurred at flows of 20, 200, 1000 and 2800 cfs. A site topographic survey was also performed at approximately 20 cfs in September 2012. The diversion canal at the Diversion Dam was conveying about 90 cfs, so the actual flow at the USGS gage was about 120 cfs (accounting for some surface flow loss through boulders). The main observation at 20 cfs was in the Middle Reach, a flow which was insufficient to bring the water to the surface (**Photo 3**). By observation some of the Middle Reach was determined passable, but a passage route could not be identified in the section through the Anchor Boulder. In the Upper Reach at the Diversion Dam, shallow sheet flow passed over the dam with a 4 to 5 foot drop (**Photo 4**).

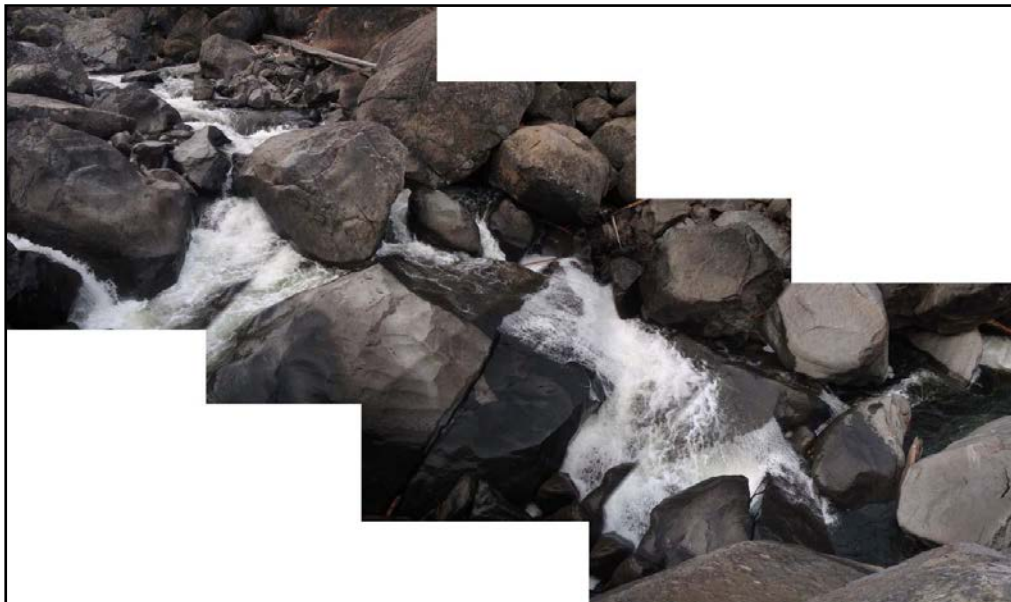
**Photo 5 – Icicle Creek Boulder Field Middle Reach along LB. View is from top of Anchor Boulder at 200 cfs. Note sheet flow over rocks at several locations.**

In another observation, at 200 cfs in the Middle Reach, there appears to be passage opportunities, through the Anchor Boulder segment where there was enough surface flow and pool depth for a potential fish passage route (see **Figure 7** and **Photo 5**). This is a viable route to develop an alternative for two reasons: 1) a velocity or drop could not be measured indicative of a barrier, and 2) while flows under boulders could be concentrated into a fish passage route. This situation was also observed along the right bank next to the Anchor Boulder where there is more direct leaping route within a 21 foot drop, but the crest is blocked by boulders wedged into the clear openings where fish would jump (**Figure 8, Photo 6**).

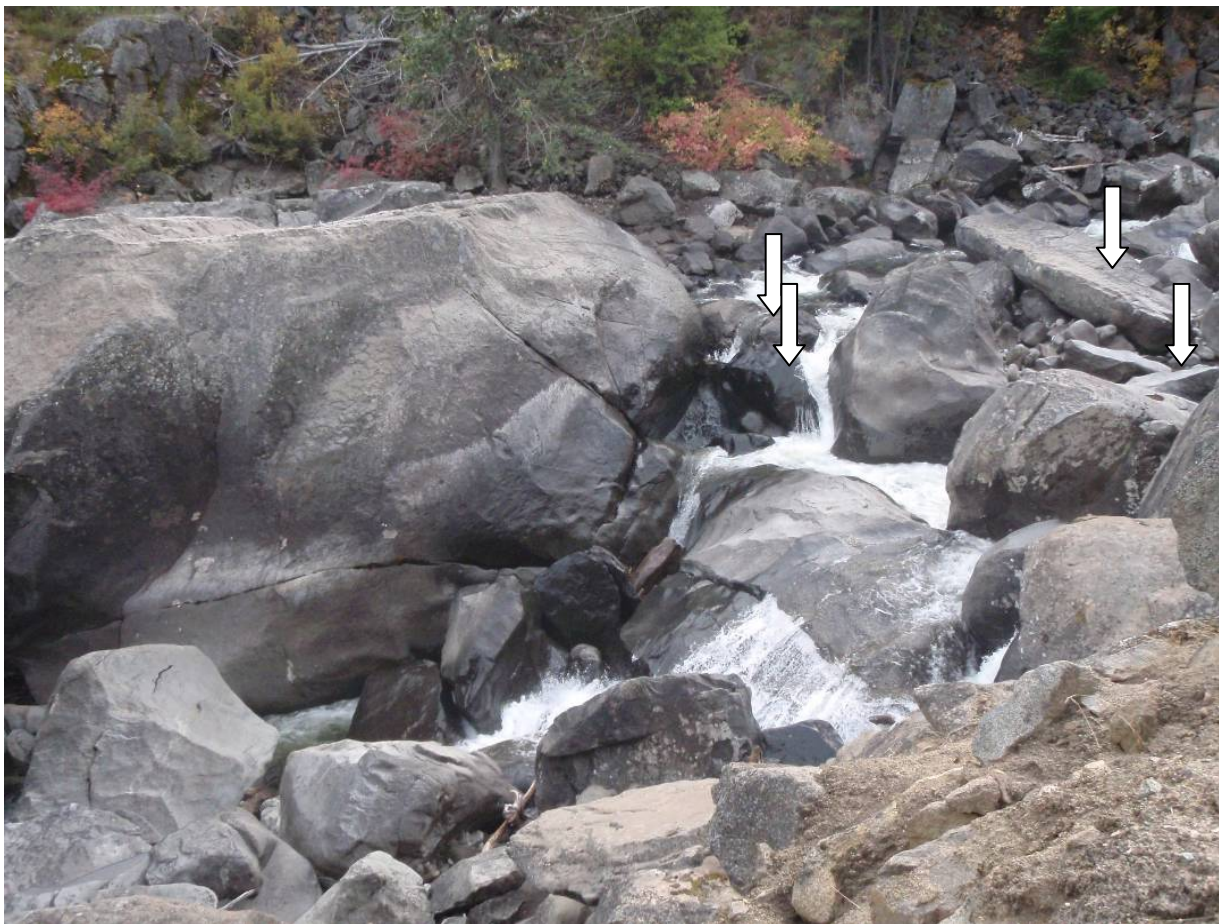
**Photo 6 – Icicle Creek Boulder Field Middle Reach (Anchor Rock) showing 21 foot drop from right to left and the crest blocked by boulders (arrows) that have filled in the openings.**

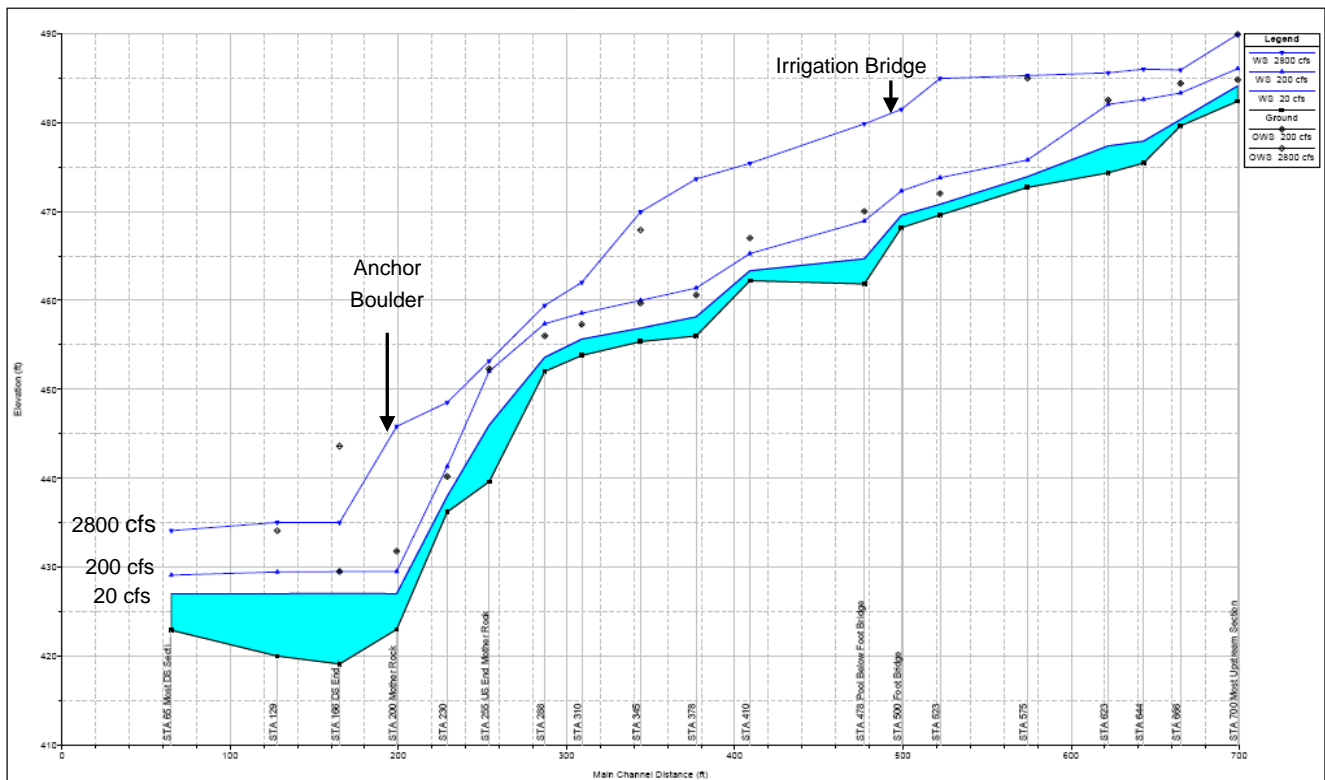
**Figure 9 – HEC-RAS water surface profiles for the Middle Reach at 20, 200 and 2800 cfs. The dots along the lines are measured elevations.**

To assess the Middle Reach for passage a HEC-RAS model (see Definitions) was developed to calculate the depths and velocities. HEC-RAS is a backwater computation model and cannot normally model gradients found on this site (**Figure 9**). Accounting for this caveat, water surface elevations were measured at a range of flows so the model could be calibrated and hydraulic gradients constructed (**Figure 10**). The Manning's  $n$  roughness factor was then adjusted until the modeled condition was close in value to the measured flow conditions (**Figure 9**). With the velocity and depth calculations from HEC-RAS, the fish energetics spreadsheet was used to calculate the energy expenditure balance of bull trout and steelhead attempting to swim through the Middle Reach. The velocities generated from the HEC RAS model are average velocities and therefore may not accurately represent what fish may encounter.

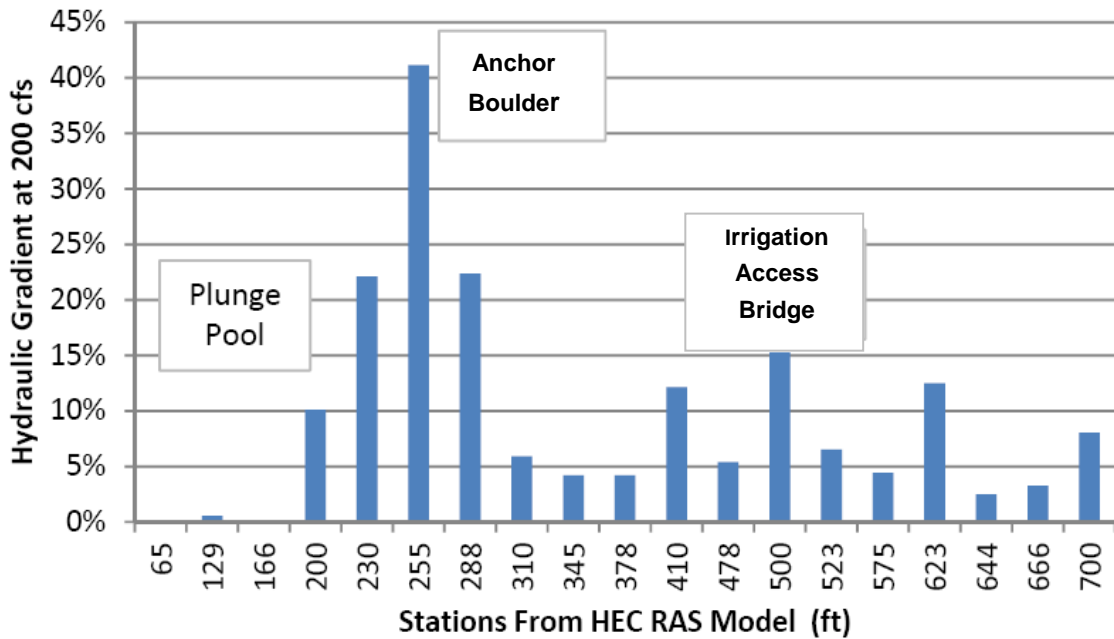
**Figure 10 – Hydraulic gradient of the Middle Reach as calculated by the HEC-RAS model at 200 cfs**

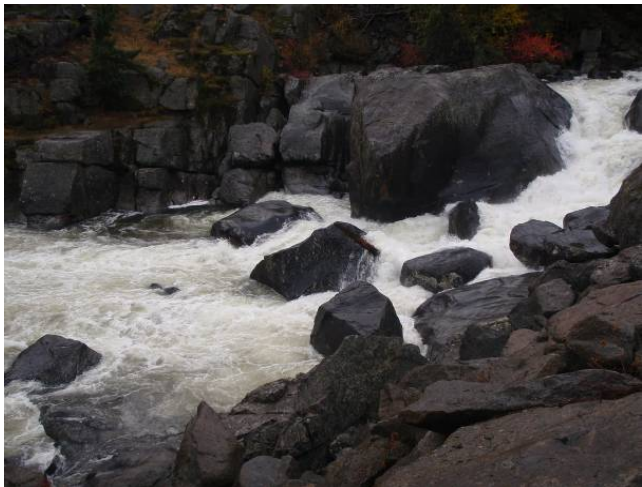
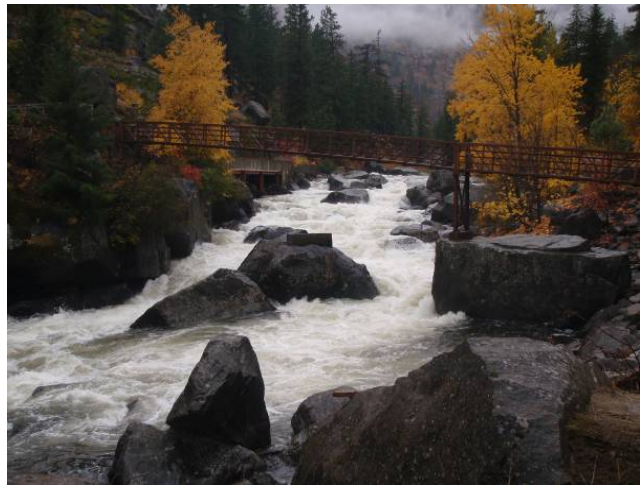
**Photo 7 – Middle Reach at Anchor Boulder (left) and upstream of Anchor Boulder (right) at 1000 cfs.**

The complexity of the Boulder Field could provide for multiple fish passage routes with some areas exhibiting higher velocities and constricted flow with other areas with lower velocities but shallow or sheet flow over boulders. **Photo 7** shows the Middle Reach at 1000 cfs, a flow providing multiple pathways for a fish to negotiate are joining and increasing in turbulence to the point where pathways are potentially no longer detectable by fish.

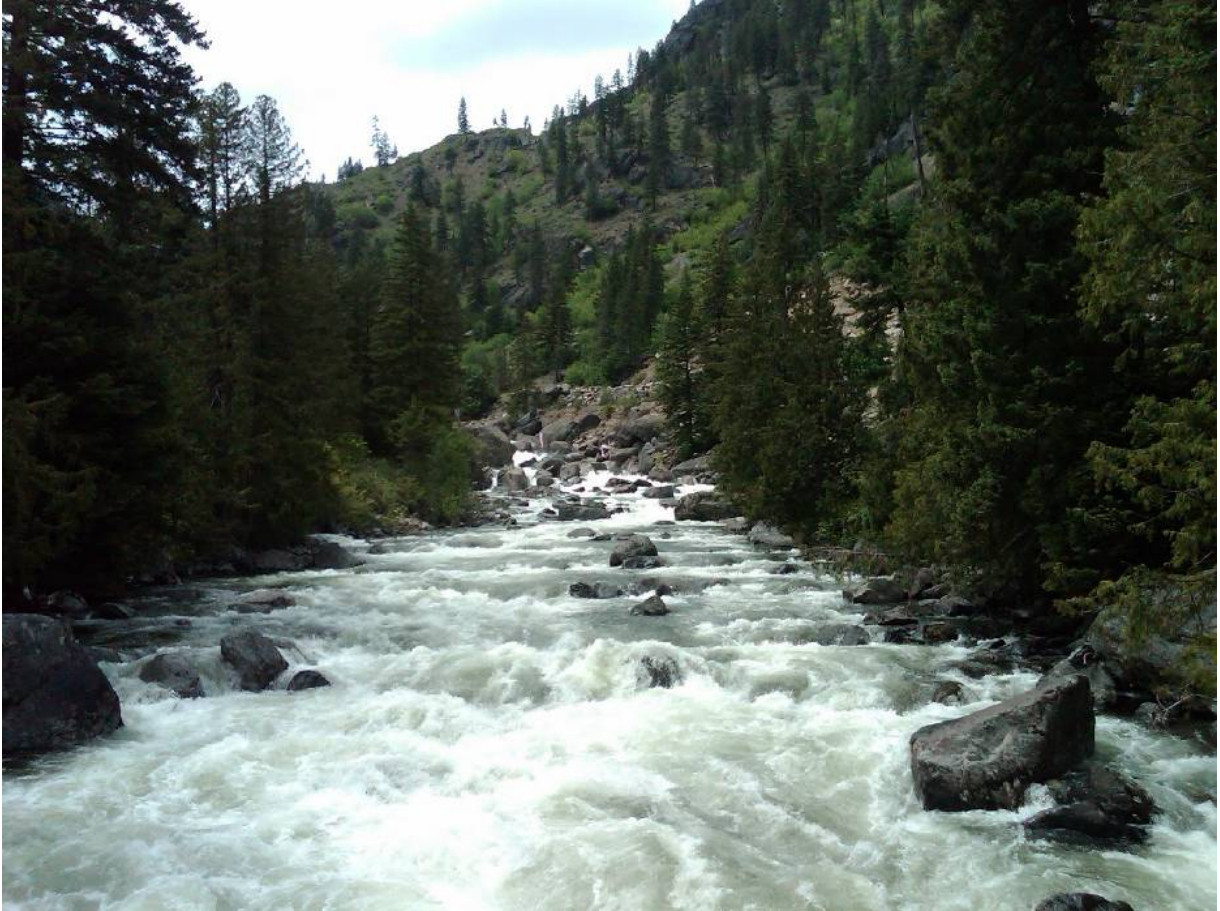
**Photo 8 - View upstream through Lower Reach from Snow Creek Trail bridge, about 1250 cfs. Channel margins and relatively lower gradient compared to Middle Reach in the distance allows fish passage through here.**

The lower reach of the study area, upstream of the Snow Creek trailhead bridge does not have fish passage impediments. Natural flow impediments exist at low flows where surface connectivity is lacking and at high flows above 3,000 cfs although the relatively lower gradient does have channel margin migration corridors most prominently on the left bank (**Photos 8, 9**).

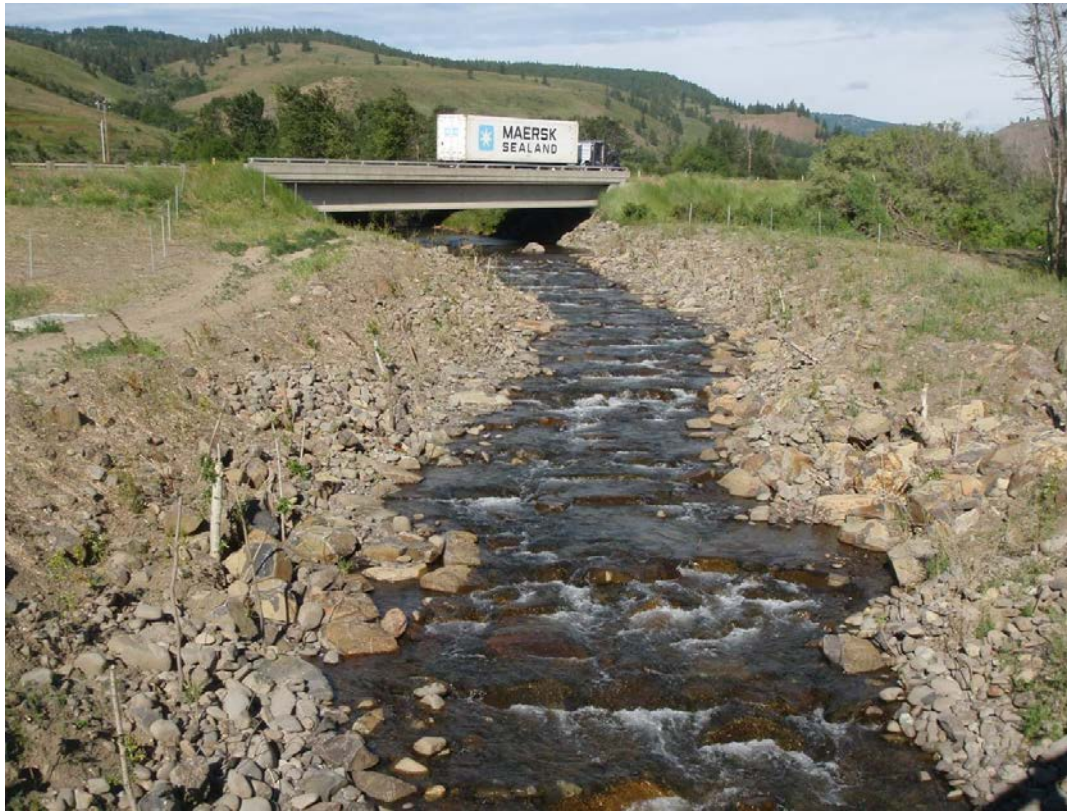
**Photo 10 – Example of roughened channel fishway**

The design options for the Middle Reach around the Anchor Boulder have to address 25 feet of vertical elevation. This design option creates a passage way for fish by pulling back the left bank and constructing a channel along the toe of the slope. The design requires a large excavation along the left bank of the Boulder Field and construction of a 14 foot wide roughened channel. The Irrigation District access road would be utilized for construction access and the channel would need to be incorporated partly into the road prism making a section of the road at least 100 feet downstream of the irrigation footbridge unusable. The irrigation foot bridge could be accessed from the western portion of the IPID parcel with a new entrance developed for the access road. An example of a similar roughened channel is shown in **Photo 10**. Approximately 5000 cubic yards of rock material would be removed either by blasting or large excavator. The rock material would be pushed down into the low areas of the Anchor Boulder and plunge pool and allowed to sort through the Icicle Creek system over time. The slope of the new channel would be 11 percent over a length of approximately 240 feet. The channel would have some protection from frequent flood flows by creating a rock berm and protected entrance. Despite the protection, larger, infrequent would inundate the channel. These would be flows above when fish passage occurs. The channel would be comprised of a graded mix of boulders and cobble in the range of 6 inches to 4 feet, with isolated boulders up to 6 feet. A section of the access road would need to be removed, approximately 100 feet above and 150 feet below the Anchor Boulder, to make room for the channel. The slope excavation would be 1:1.

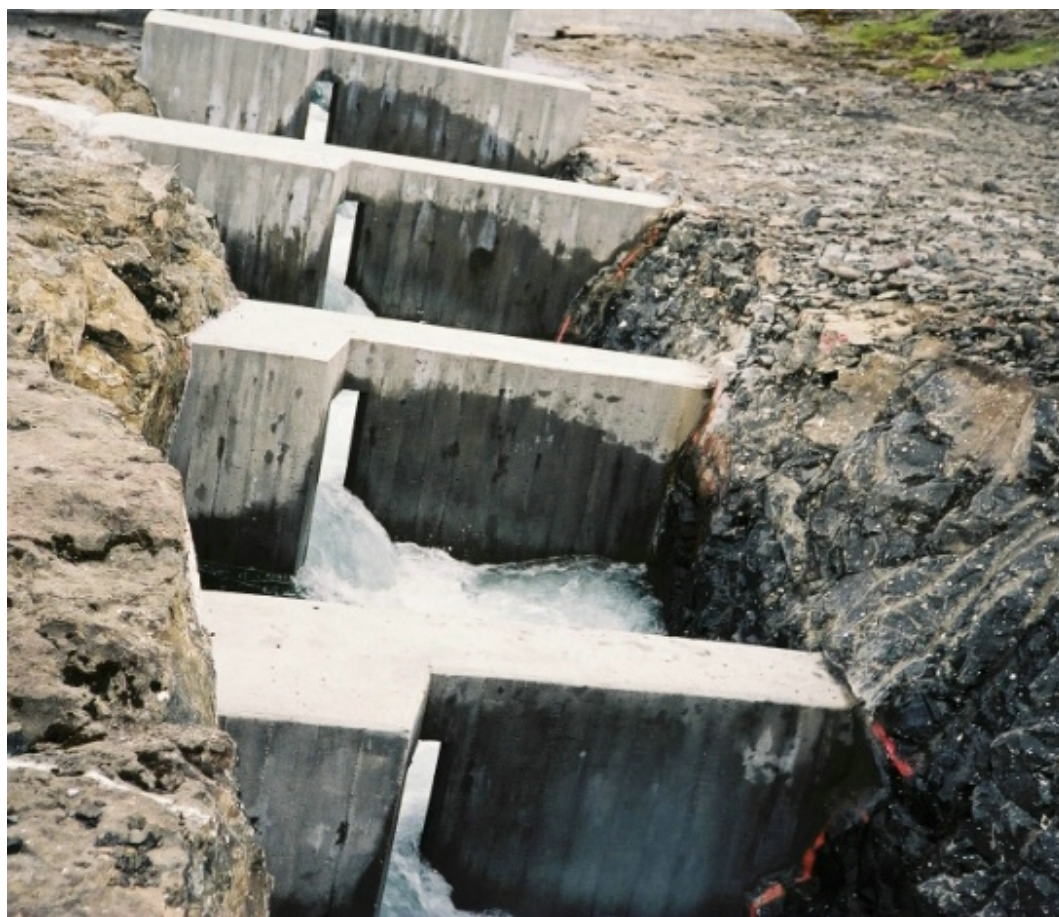
**Photo 11 – Example of vertical slot fishway constructed within a rock trench excavated by blasting.**

This design option (**Photo 11**) would construct a 25 pool vertical slot fishway along the right bank between the Anchor Boulder and bank below the irrigation canal. There is bed rock in this area, so some of the fishway would be blasted into the rock and have rock walls, while other sections would have concrete walls. A detailed survey and geologic assessment is needed to further define the option. The entrance pool located adjacent to the large pool below the Anchor Boulder would be 8 feet wide by 10 feet long. The hydraulic drop through the slots would be one foot. The overall fishway length would be 250 feet. The upstream end (or fish exit) would have a protective wall with bulkhead gate which would be closed during the non-fish migration windows to reduce the potential for damage to the fishway and maintenance.

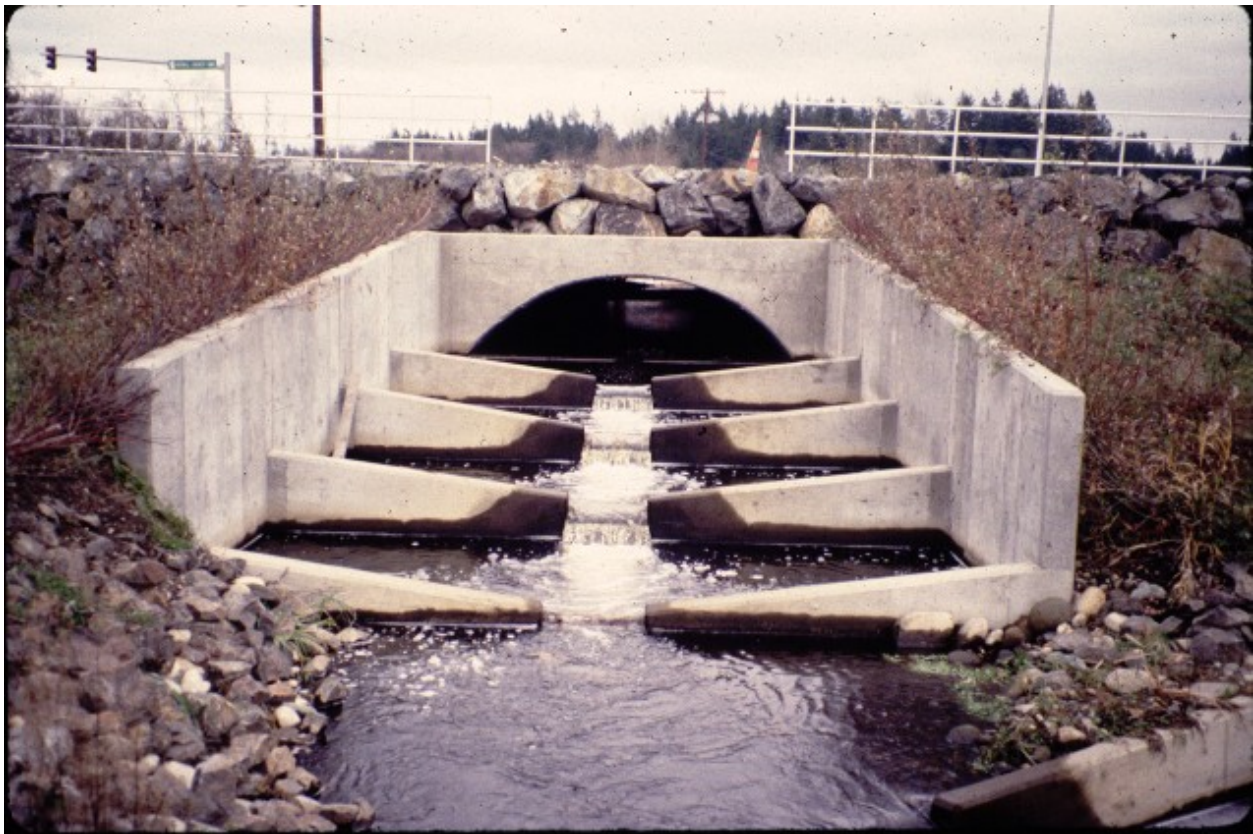
**Photo 12 – Pool and Chute Fishway at low flow (Silver Creek, Washington).**

This design option would remove a section of the existing dam and construct a concrete pool and chute fishway. The fishway would be 24 feet wide and have a high design flow of 120 cfs. Flows greater than 120 cfs would either pass over the existing dam with the use of stoplogs or divert through the irrigation diversion. An appropriate solution for a low head dam with a passage problem is a pool and chute fishway. Up to 100 cfs, all the flow would be in the fishway and there would not be false attraction. The fishway pool length would be 12 feet, with a vertical drop per weir of 0.8 feet and a slope of 6.7%. The fishway slope would be 6.7 percent. Design details of pool and chute fishway is provided in (Powers, 2007). At low flow the fishway would function as a pool and weir fishway and at high flow the water streams down the center of the fishway. An example of a 16 foot wide pool and chute fishway is shown in **Photo 12**.

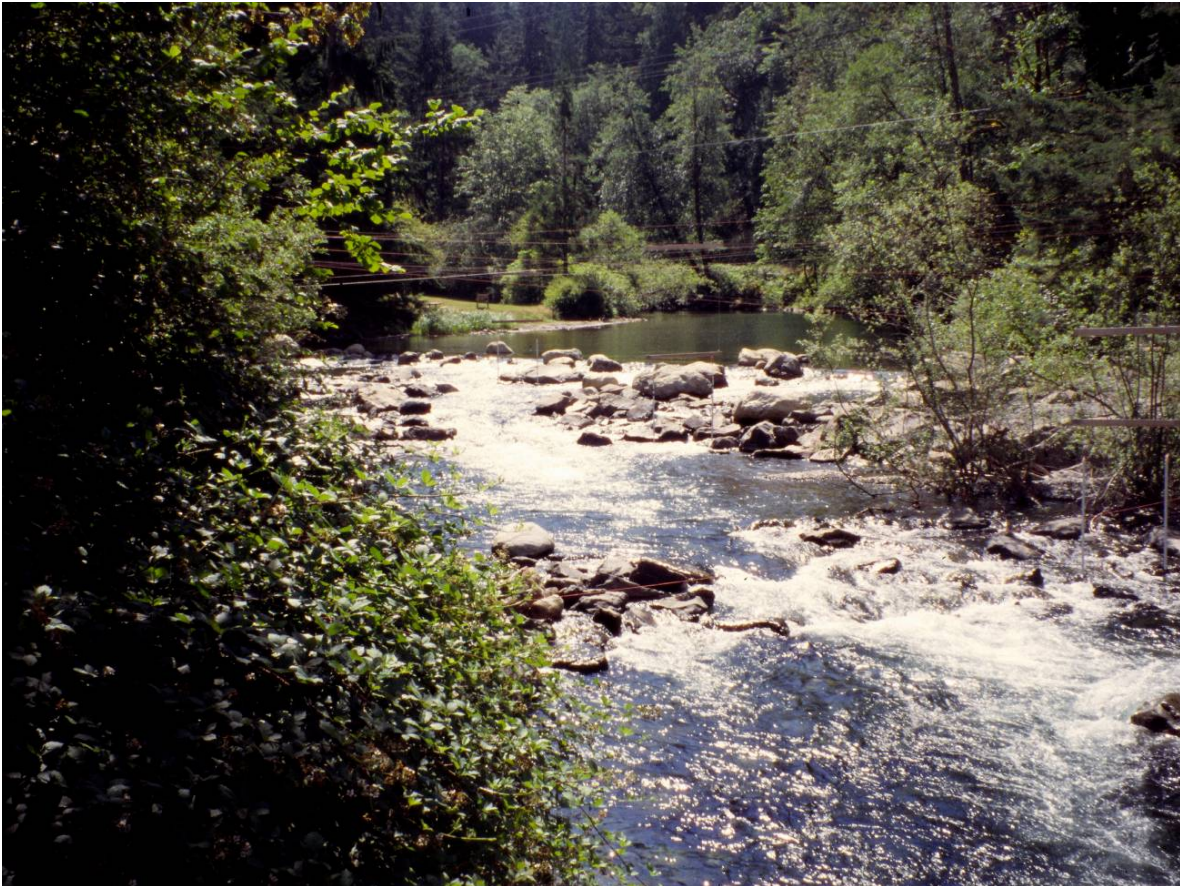
**Photo 13 – Cedar River Constructed Riffle backwatering a 6-ft high concrete diversion dam**

This design option would construct a series of riffles to backwater the existing concrete dam. An example of a series of constructed riffle is shown in **Photo 13**. The riffle would be 90 feet wide (channel width) and 35 feet long with a low flow thalweg in the center. The riffles would extend 210 feet downstream of the dam. The drop over each riffle would be one foot, but this one foot of drop would be in the form of water flowing over a 5 percent roughened channel with pools between the riffles.

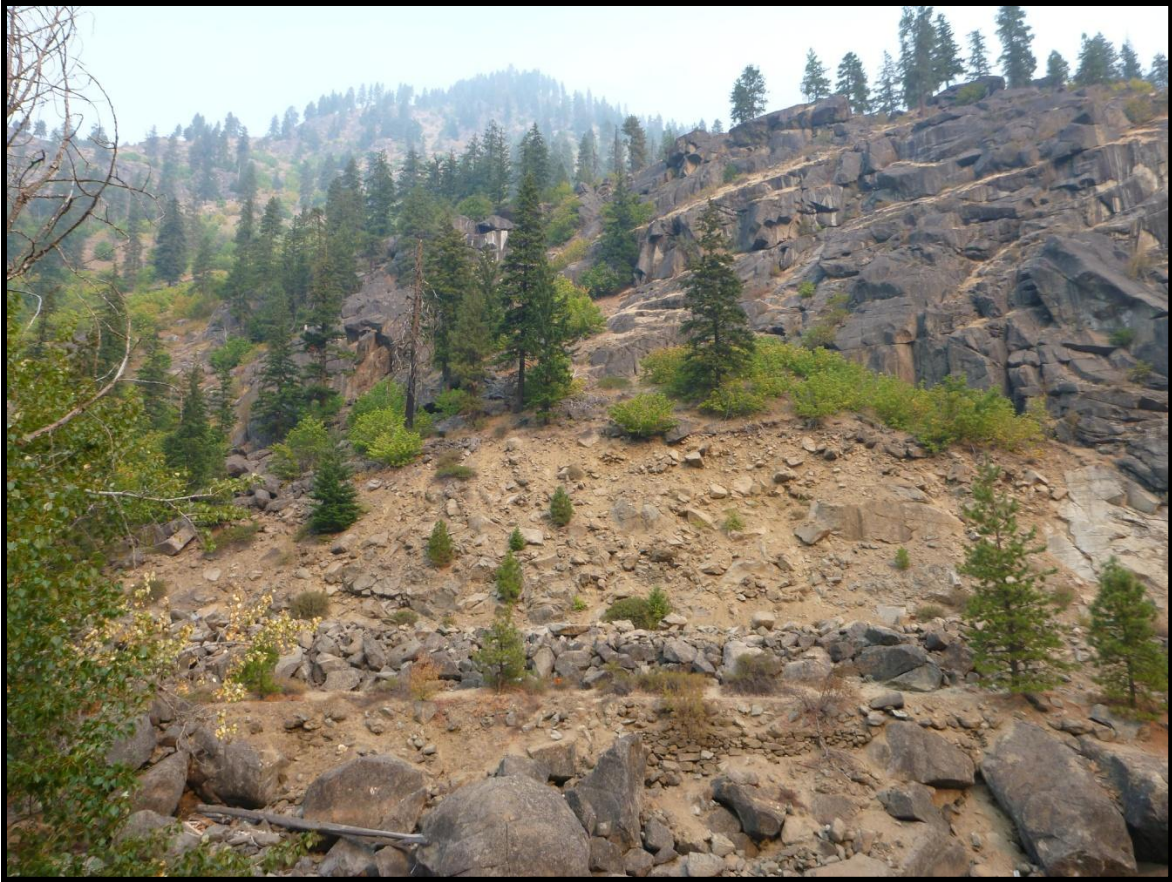
**Figure 3.** Colluvium in Forest Road 7600 cutslope above Icicle Creek and southwestern dipping joint planes of diorite bedrock in background.

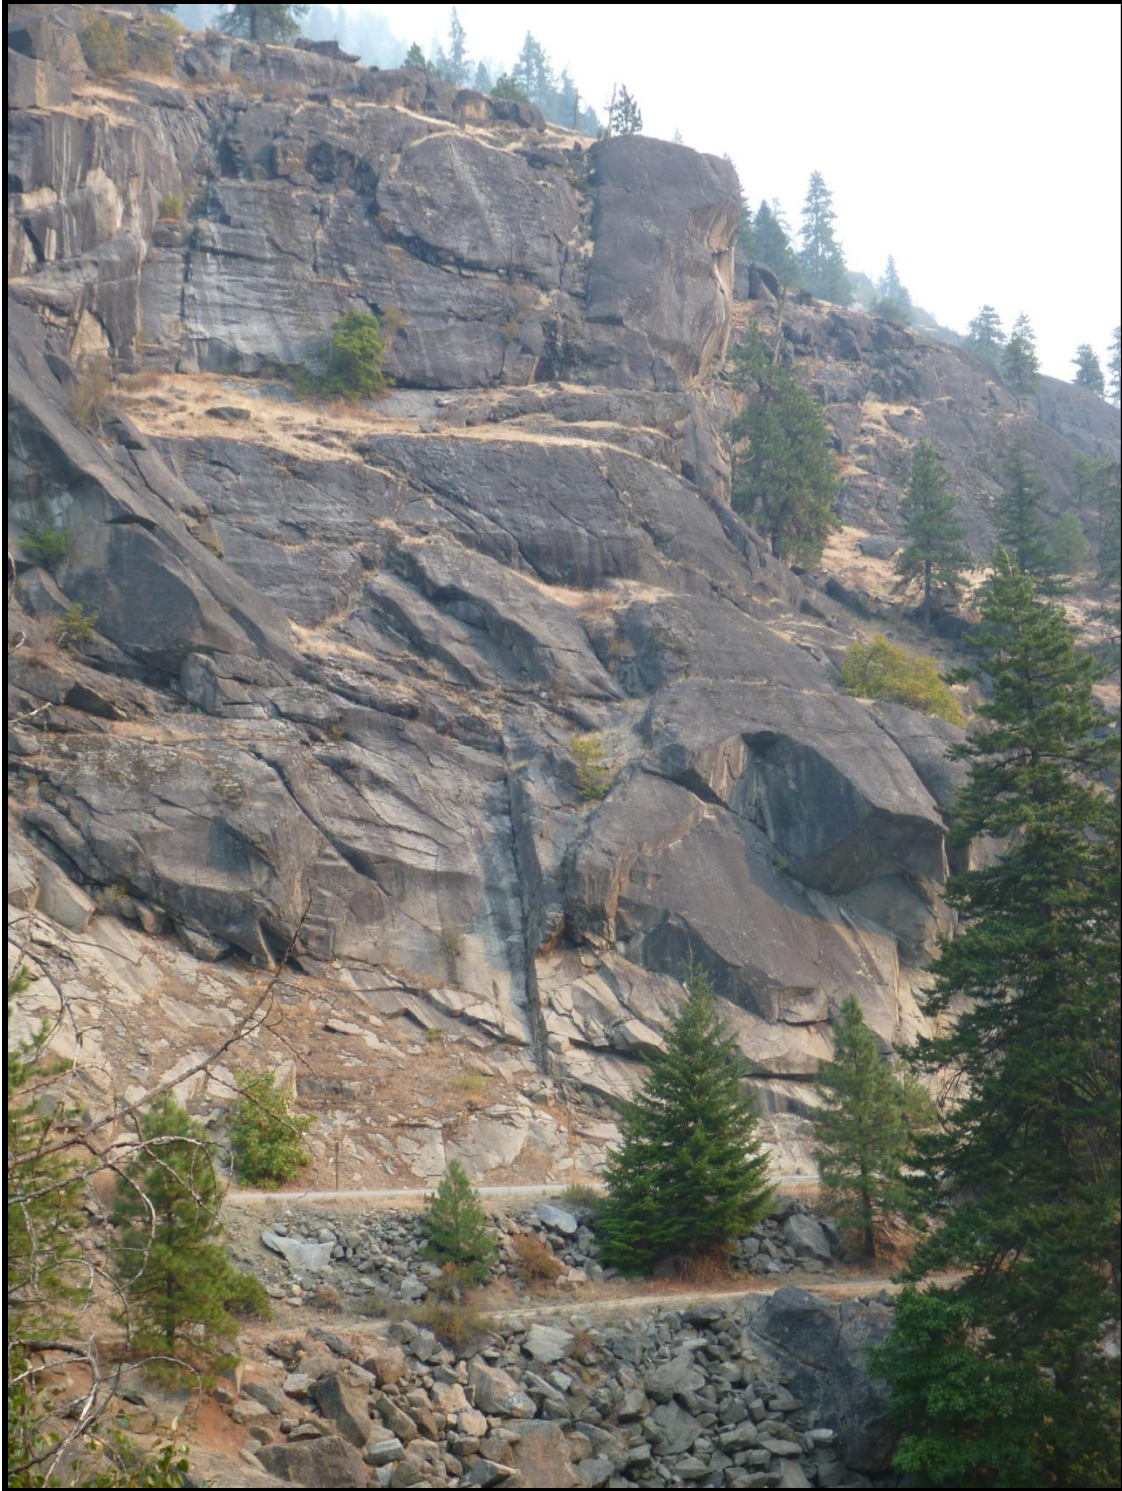
**Figure 4.**      Glaciated north valley wall of diorite and gabbro above Icicle Creek.

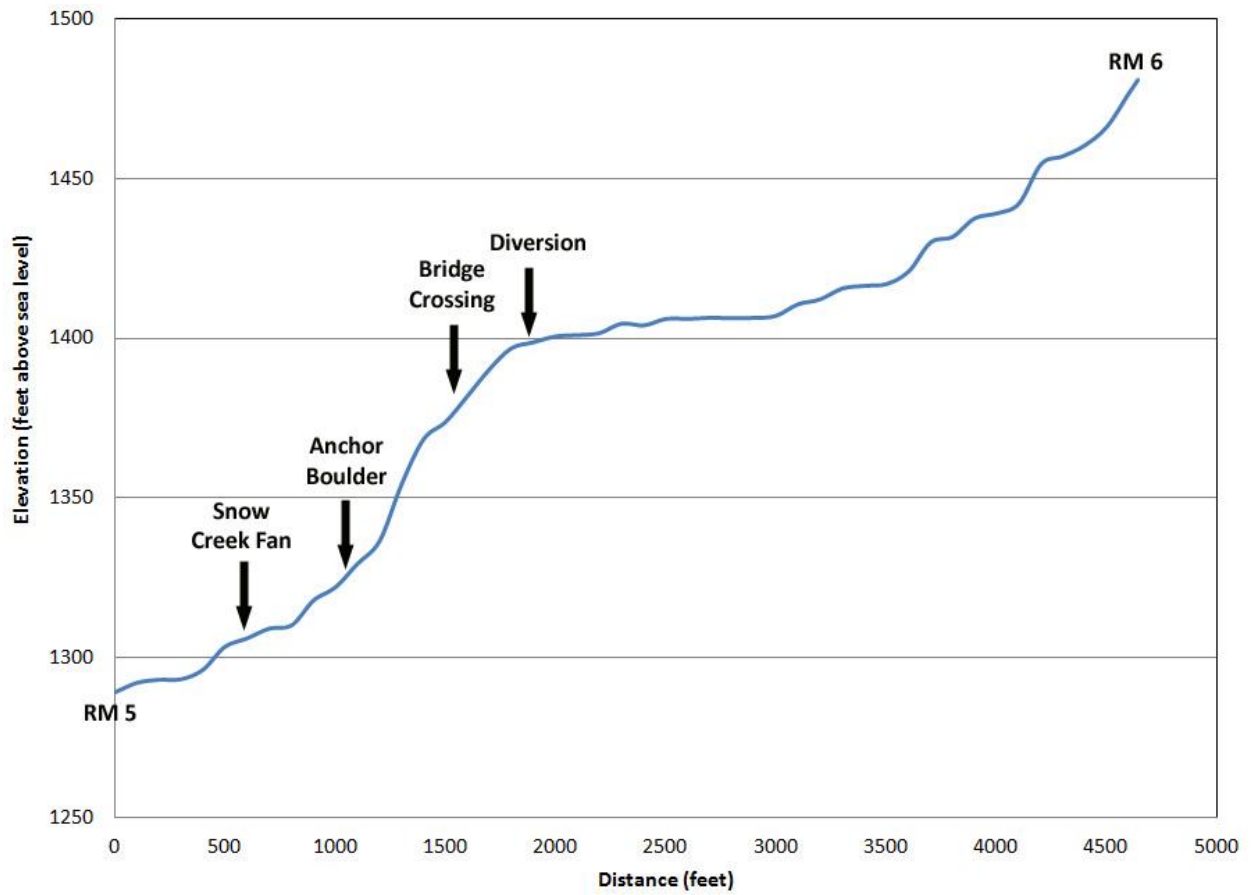
**Figure 7.** Longitudinal slope profile of Icicle Creek between River Mile (RM) 5 and RM 6.

A longitudinal slope profile of Icicle Creek was constructed from LIDAR elevation data to evaluate stream gradients (**Appendix C Figure 7**). The Boulder Field is about 1,000 feet in length with an average gradient of 8 percent. The reach above the Boulder Field extends for about 1,000 feet above the irrigation diversion at an average gradient of 1 percent. The constriction in valley width at the Anchor Boulder appears to have caused a significant accumulation of sediments that have influenced the channel gradient for about 2,000 feet upstream. The Snow Creek alluvial fan located at the bottom of the assessment area has moderated the gradient at its confluence with Icicle Creek, but does not appear to be having any significant influence on the upstream Boulder Field. Extrapolating the gradient of the channel above and below the influence of the Boulder Field suggests that without the Boulder Field, the average channel gradient could range from 4 to 6 percent. However, this conclusion assumes that the bedrock was scoured by glacial ice at a relatively uniform gradient without erosion resistant rock sills or dikes to act as knickpoints in the channel.

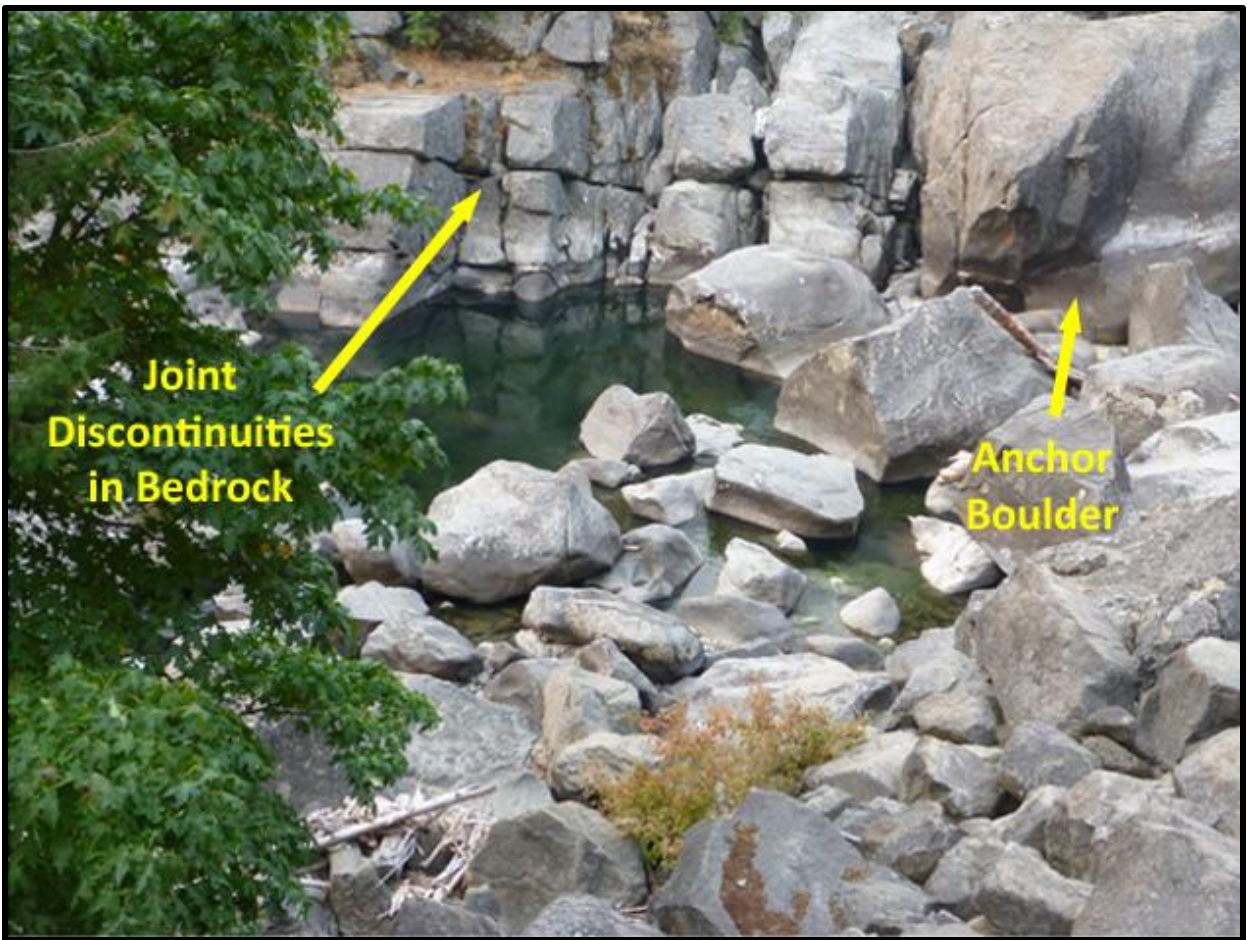
**Figure 8.** Joint discontinuities in the bedrock on the right bank of Icicle Creek in the lower reach of the study area.

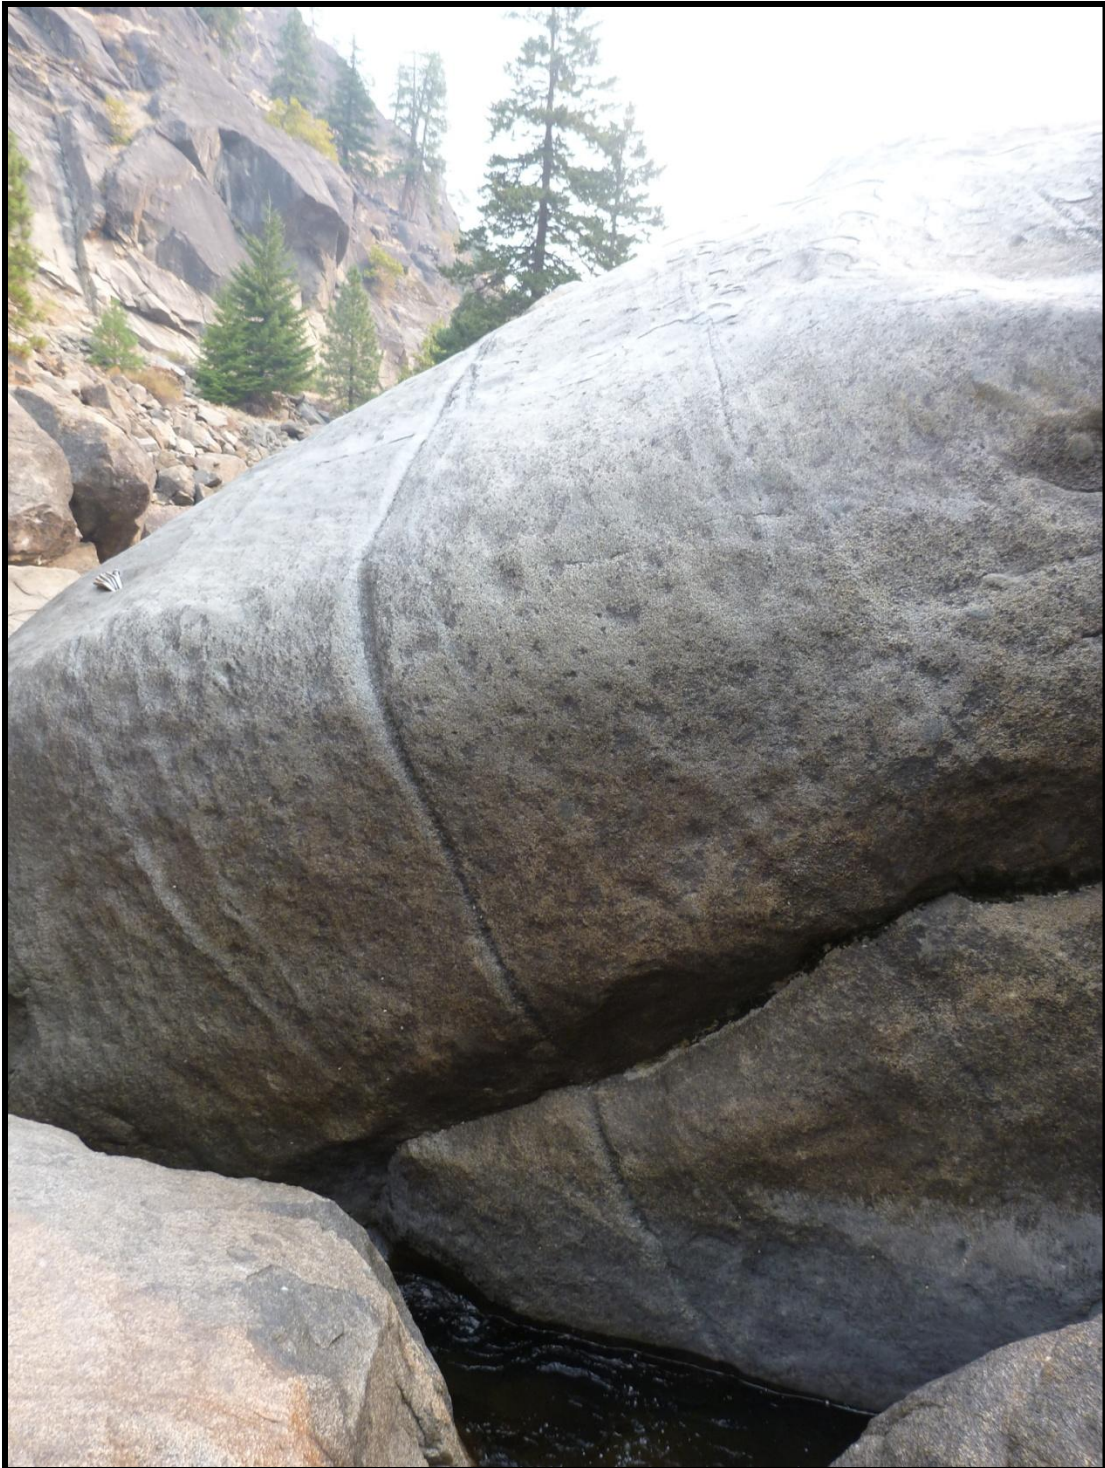
**Figure 9.** A vertical glacial groove and horizontal discontinuity on the upstream face of Anchor Boulder.
