# Icicle Creek Boulder Field Fish Passage Assessment

## Icicle Creek, Chelan County, WA

## FINAL May 2013

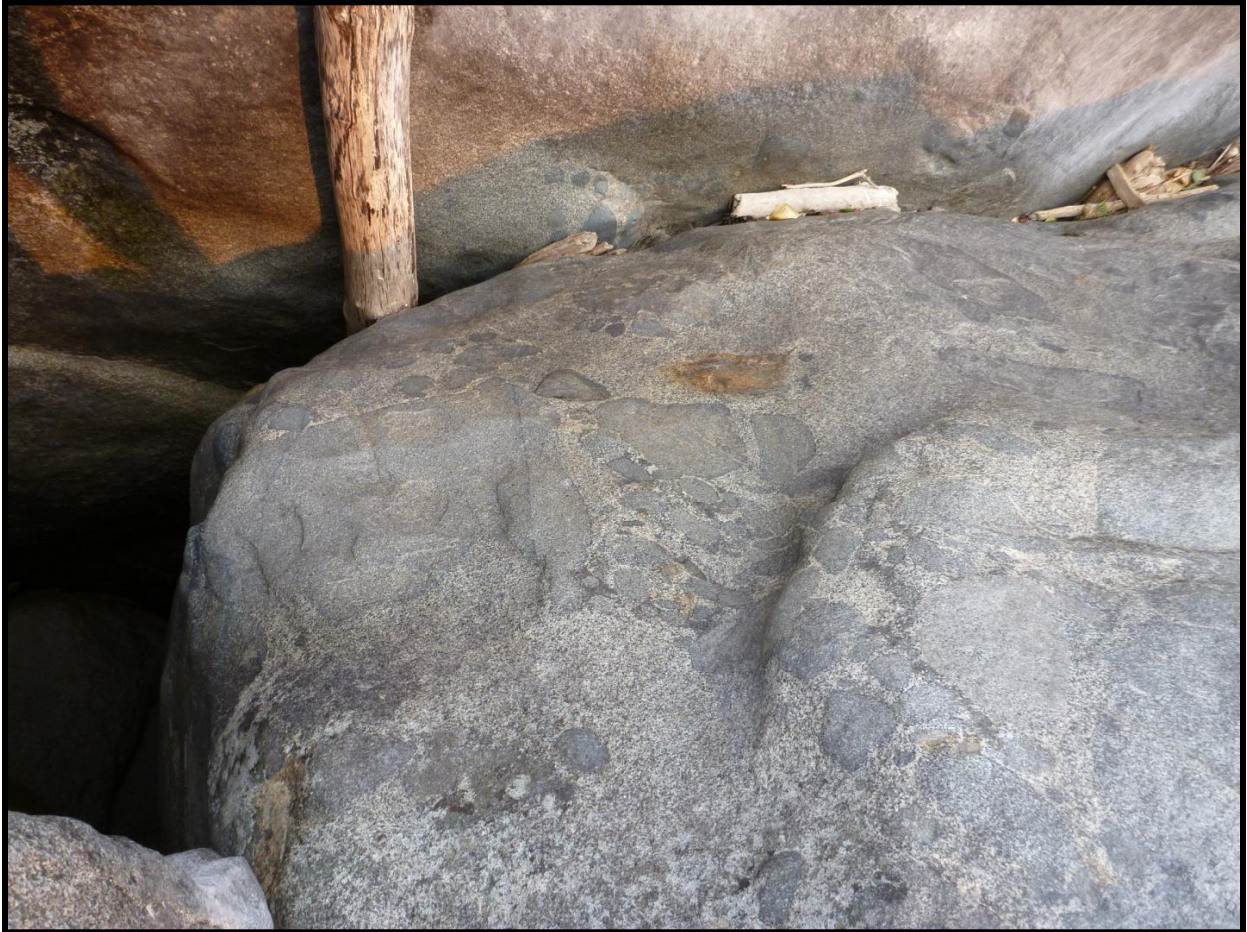
**Figure 10.** Gray inclusions in the bedrock on the right bank of Icicle Creek and in the Anchor Boulder.

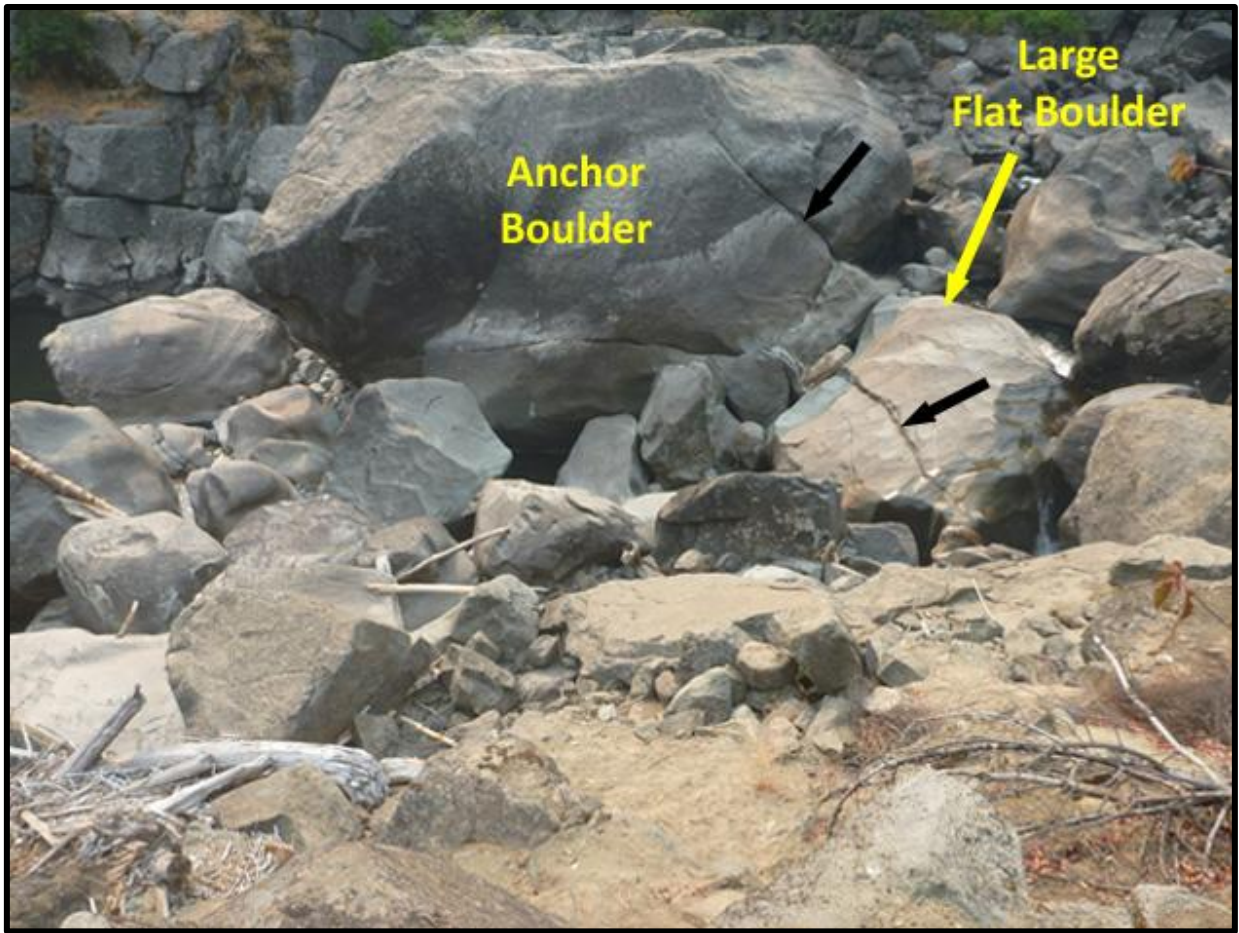
**Figure 11.** The north face of the Anchor Boulder and the adjacent large flat boulder showing the potential extension of joint discontinuities (*black arrows*).

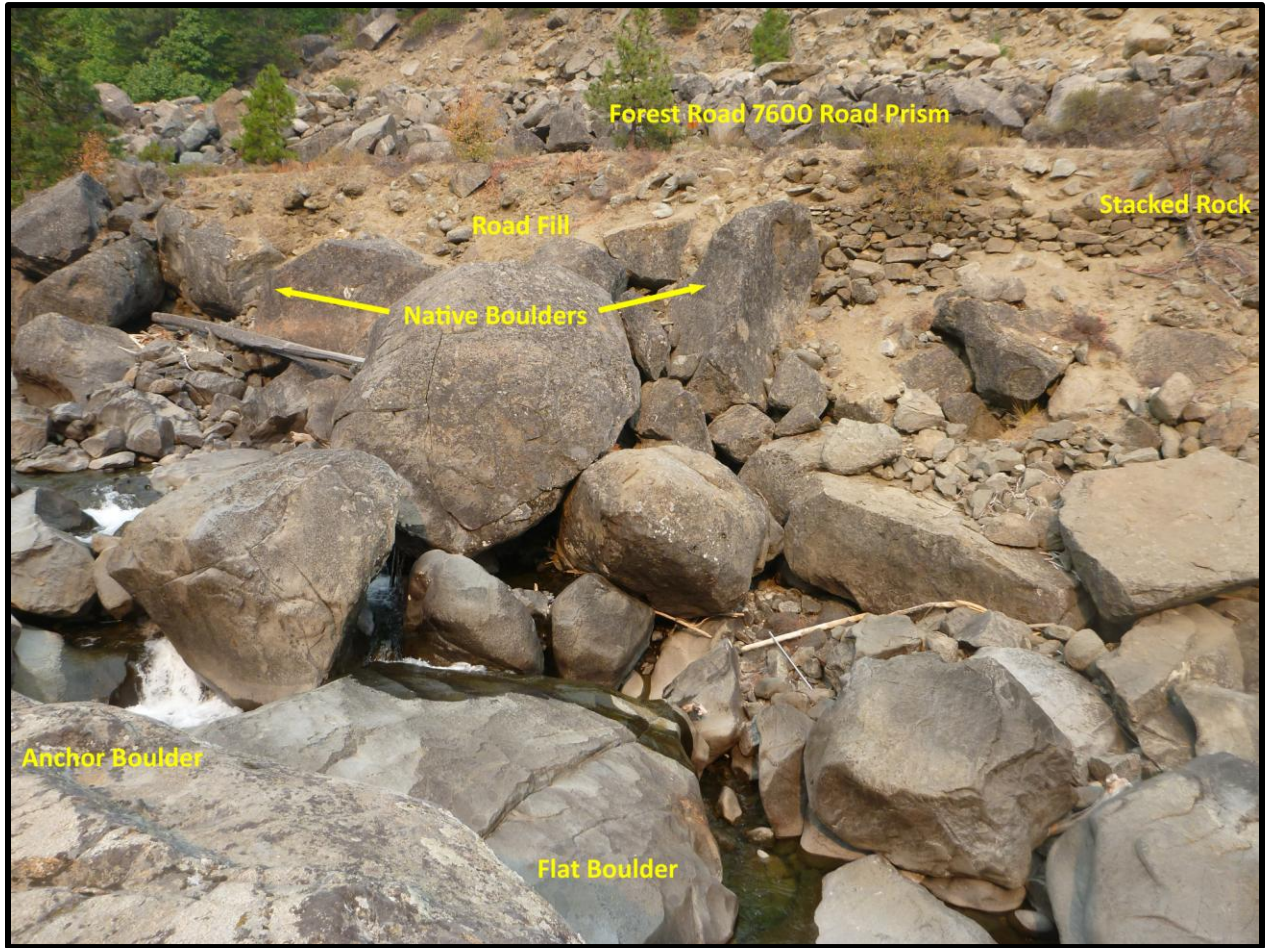
**Figure 12.** Large native boulders and anthropogenic rocks on the left bank of Icicle Creek across from the Anchor Boulder.

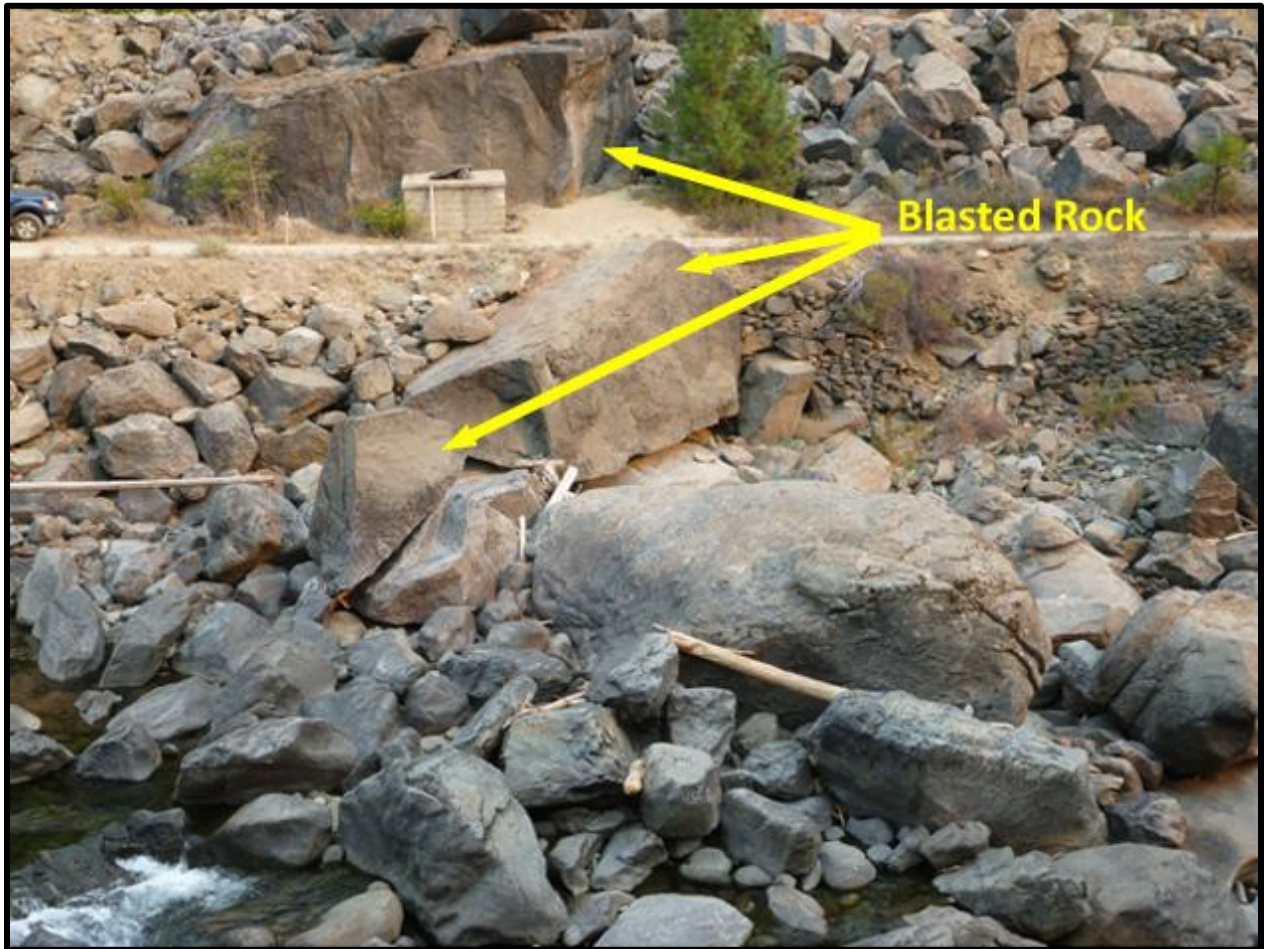
**Figure 14.** Large boulder blasted into three parts during original Icicle Creek road construction.

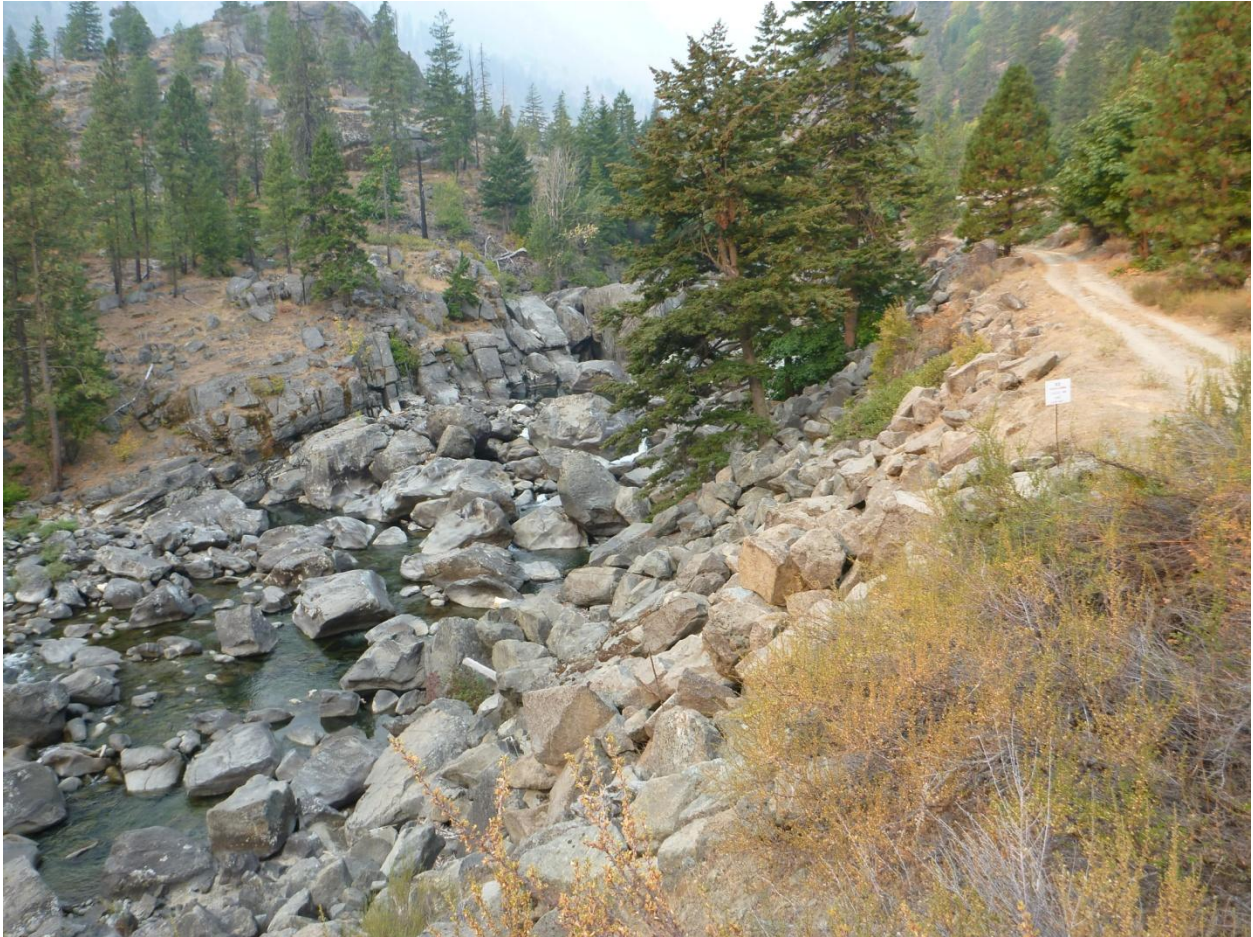
Figure A-1. Lower Reach of Icicle Creek study area below Anchor Boulder showing bedrock outcrop on the right bank and old Icicle Creek Road on left bank.

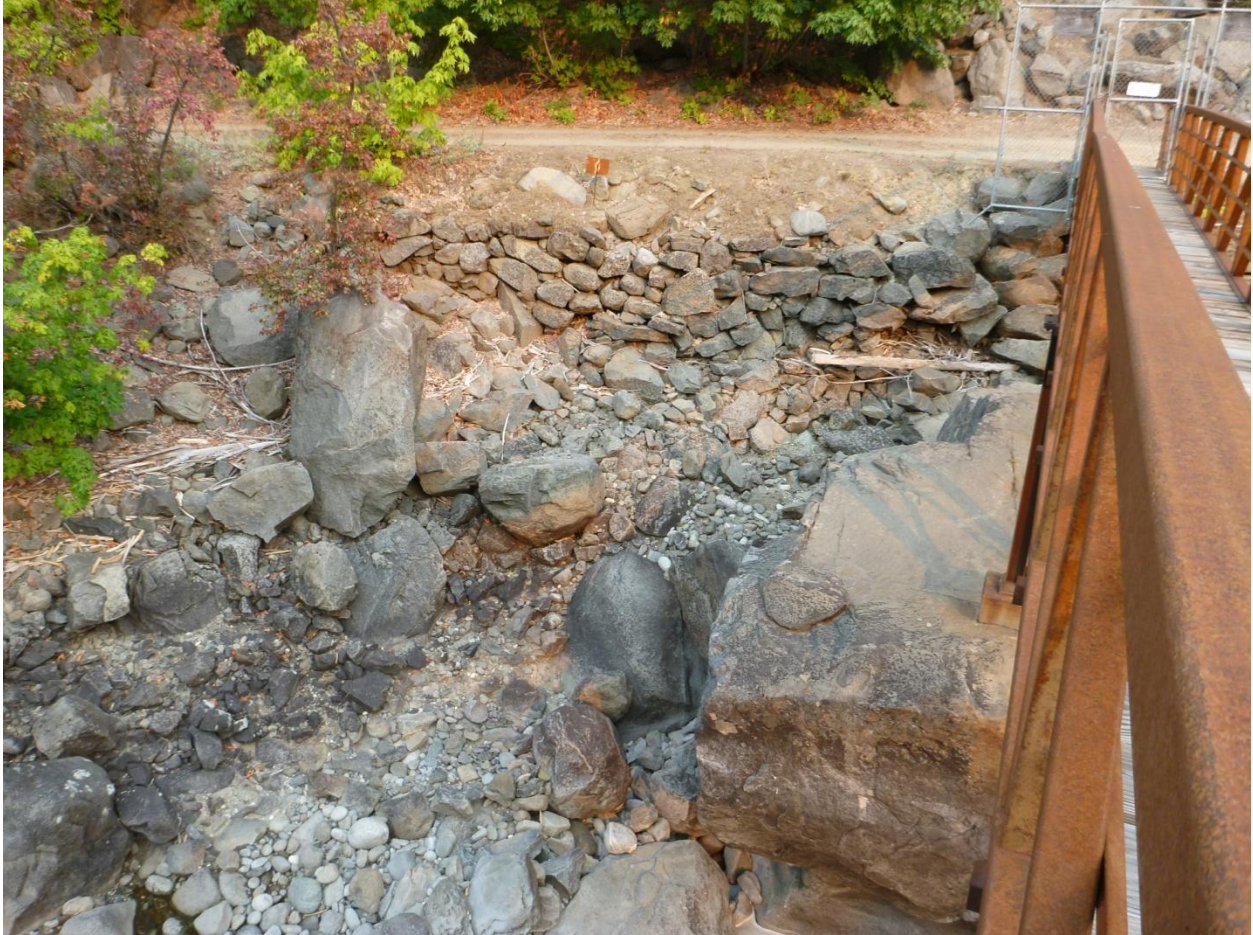
Figure A-2. Stacked rocks for old Icicle Creek Road prism on the left bank at the irrigation district bridge.

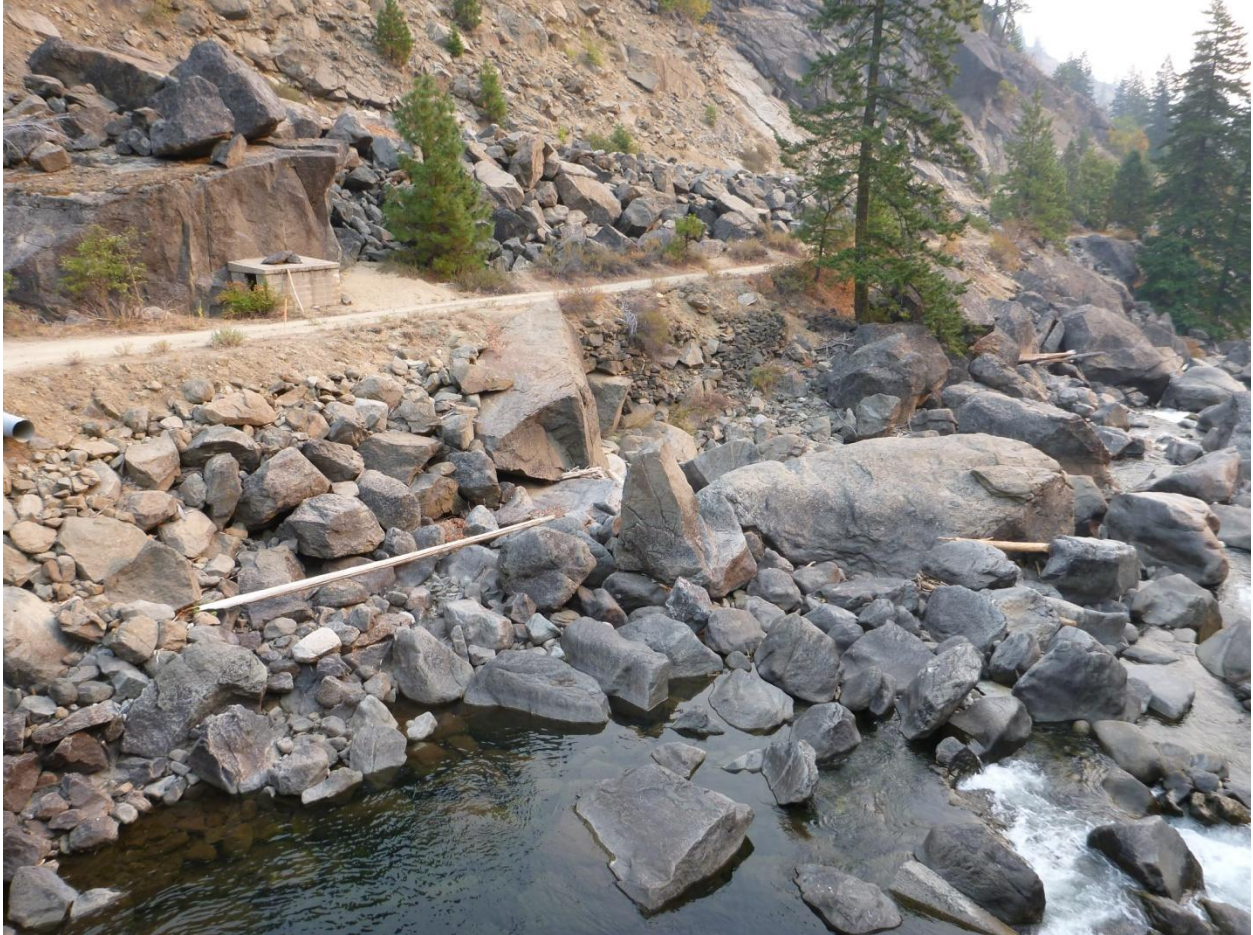
Figure A-3. Looking downstream in middle reach of Icicle Creek study area above Anchor Boulder showing left bank rocks and historical Icicle Creek Road.

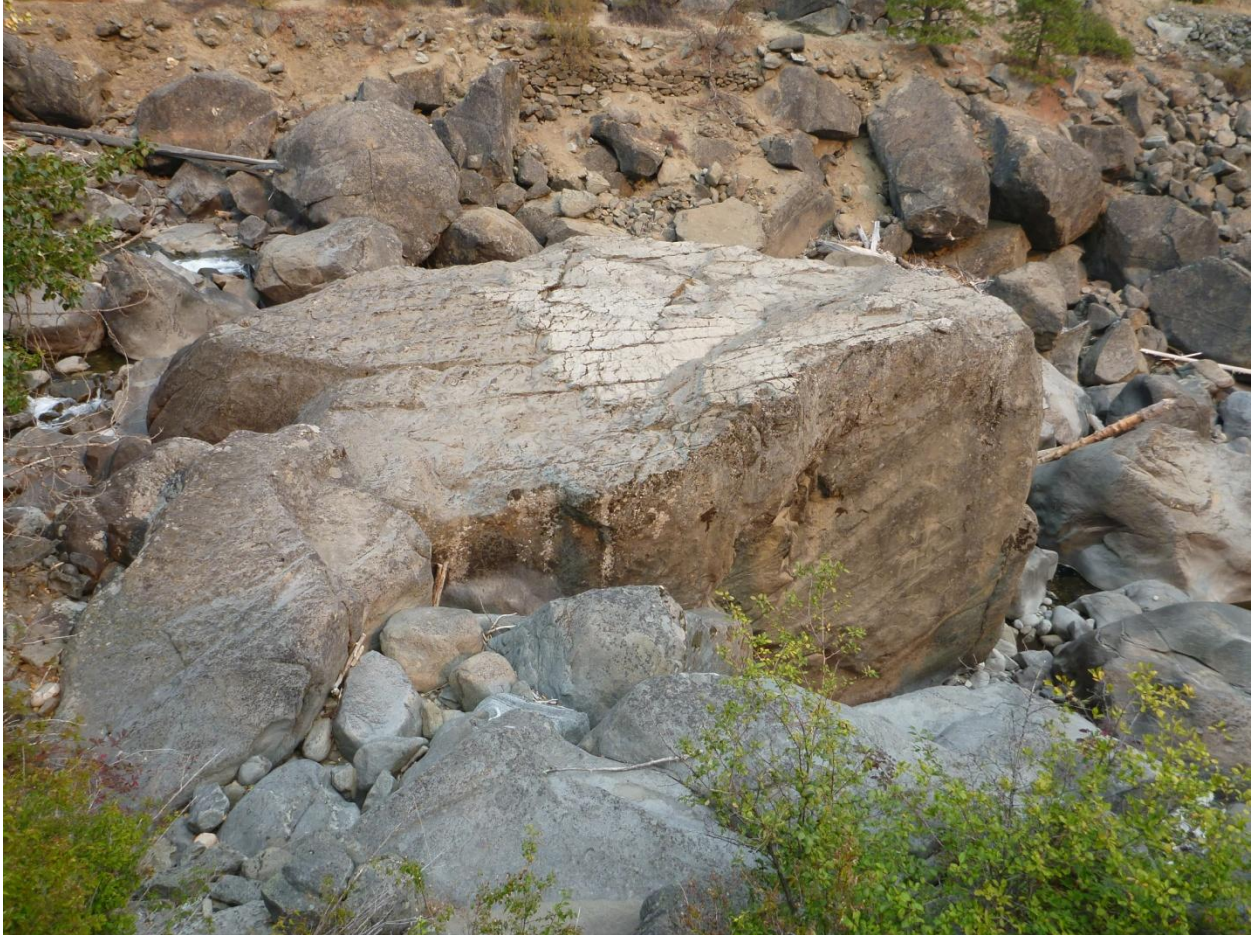
Figure A-4. Glacially polished top surface of the Anchor Boulder and adjacent gray bedrock on the right bank of Icicle Creek.

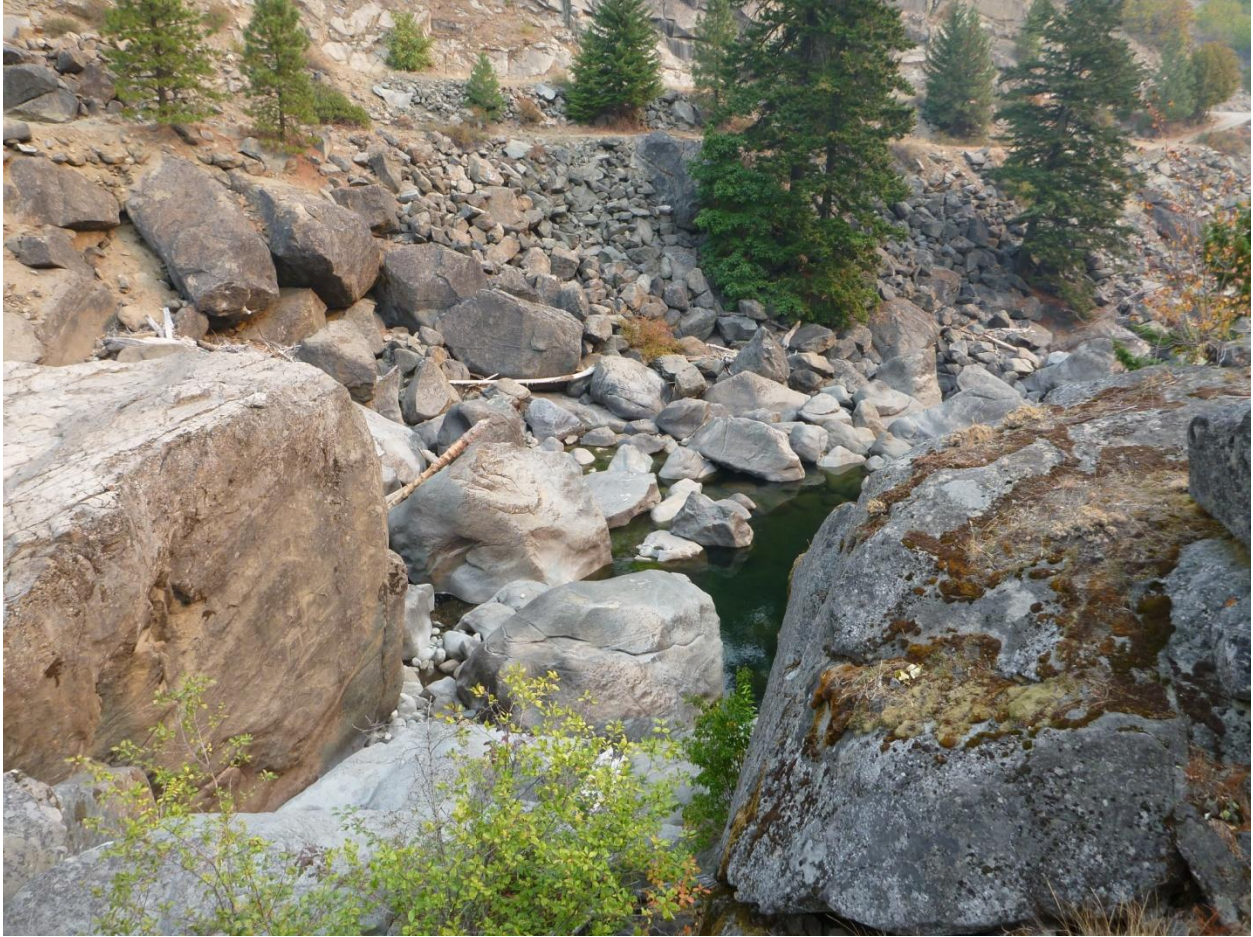
Figure A-5. Fluvial erosion of notch in bedrock at the Anchor Boulder on the right bank of Icicle Creek.

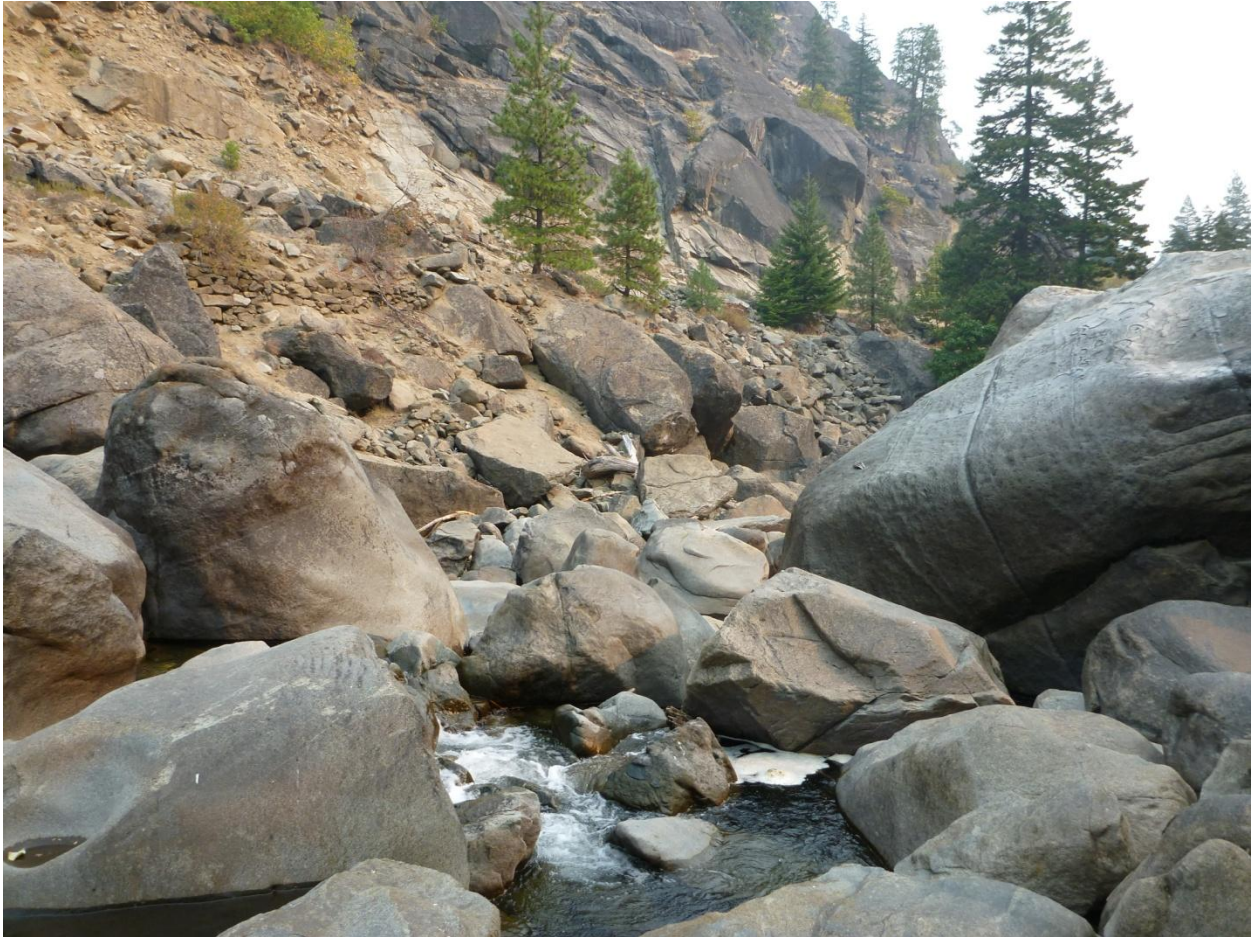
Figure A-6. Looking downstream in the middle reach of the Icicle Creek study area at the boulder field associated with the Anchor Boulder (*large gray rock with vertical groove on the right side of photograph*).

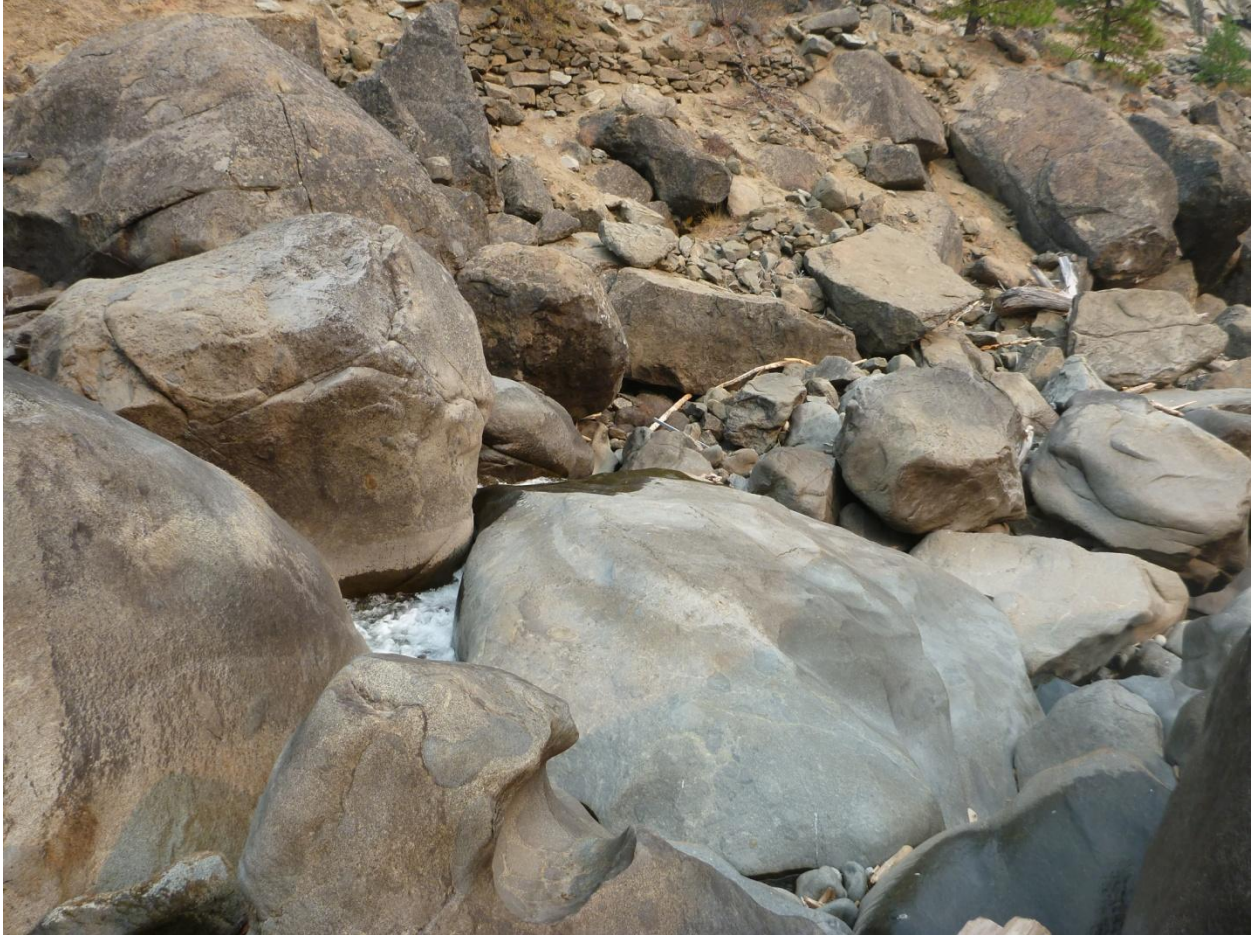
Figure A-7. Fluvially sculpted, flat boulder within Icicle Creek on the north side of the Anchor Boulder.

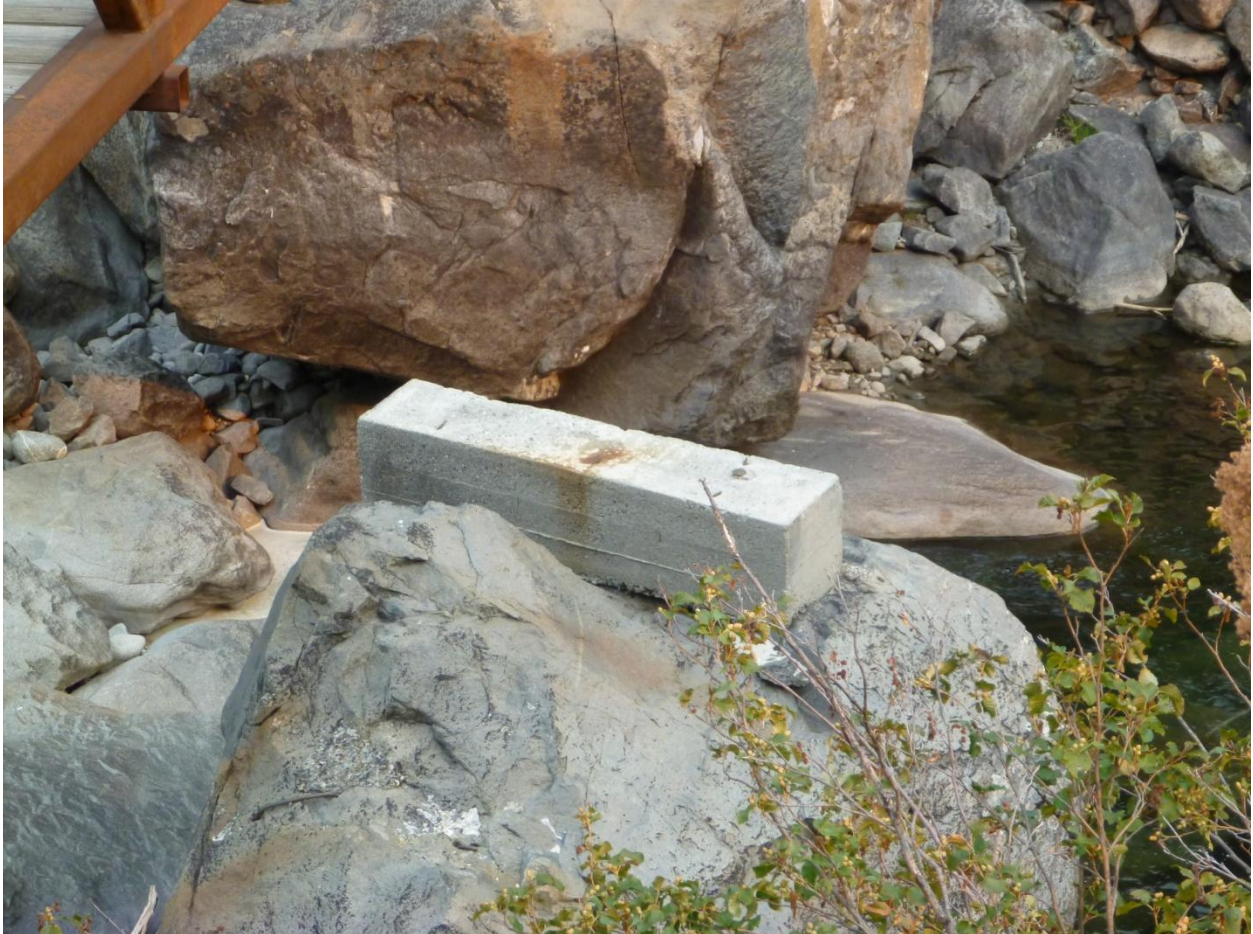
Figure A-8. Concrete block on boulder within Icicle Creek channel at the irrigation district bridge.

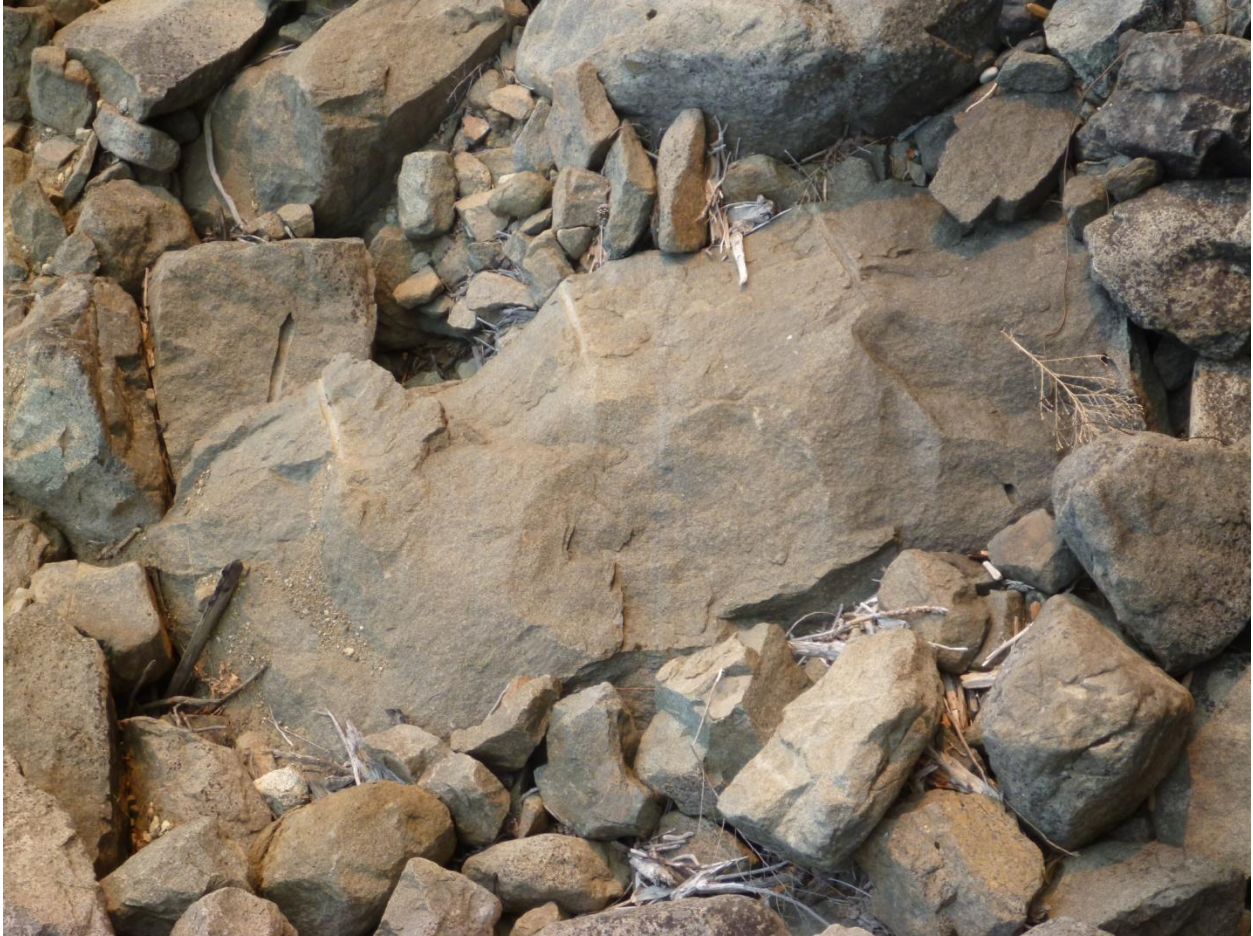
Figure A-9. Drill holes and grooves from blasted rock fragments in road prism along left bank of Icicle Creek.

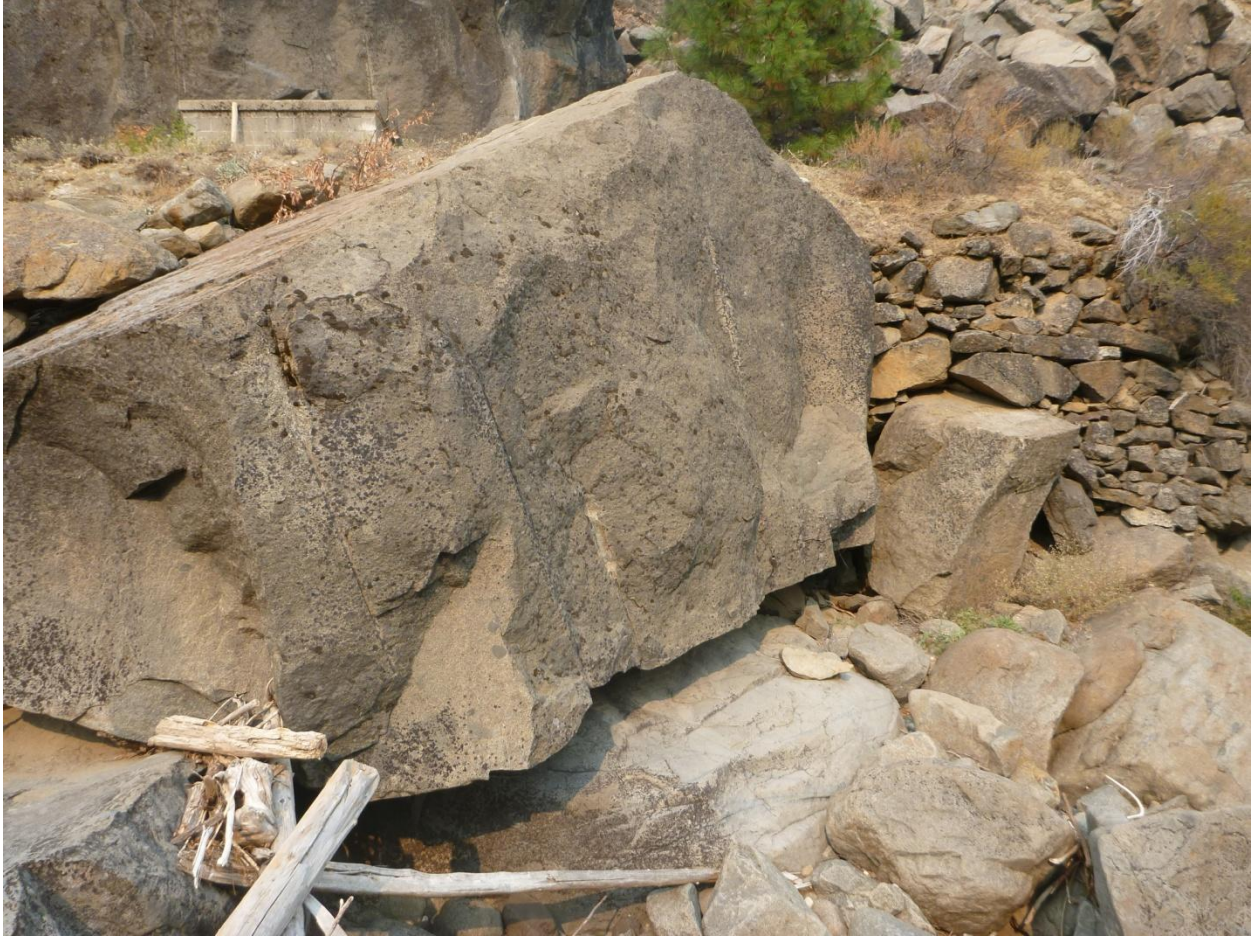
Figure A-10. Drill hole grooves in blasted boulder from road prism along left bank of Icicle Creek.

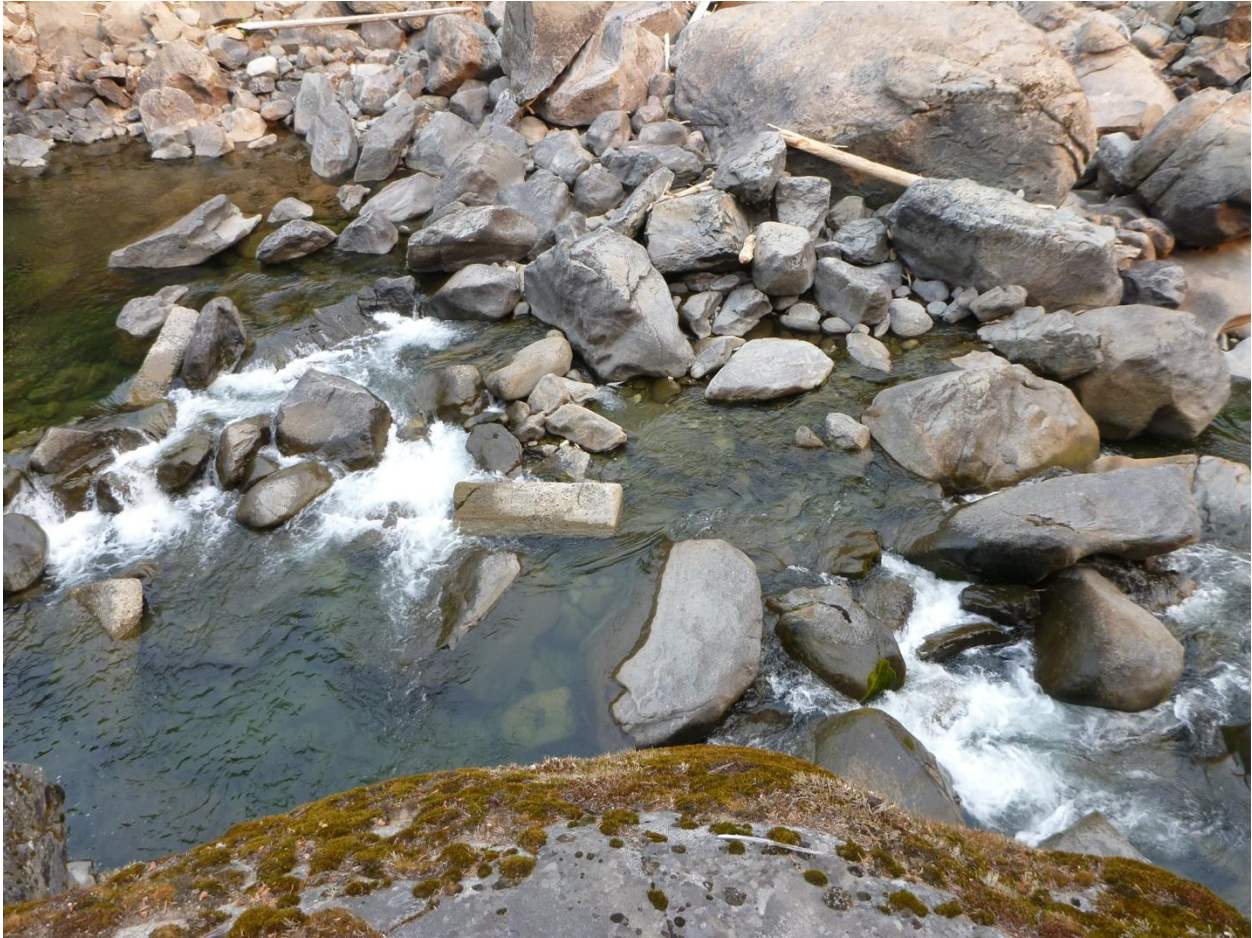
Figure A-11. Concrete blocks in middle reach of Icicle Creek study area.

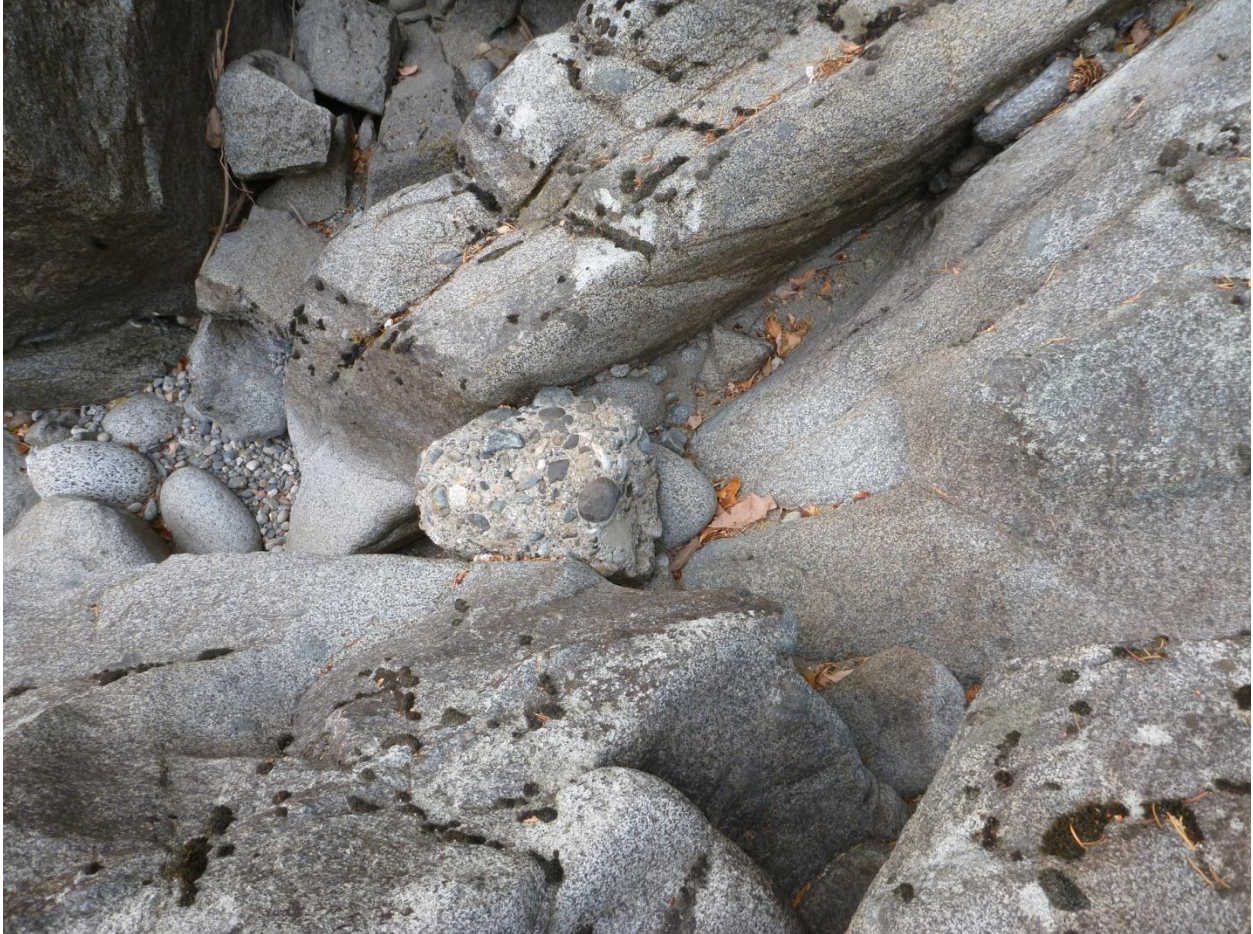
Figure A-12. Concrete block wedged between rocks on right bank of Icicle Creek.

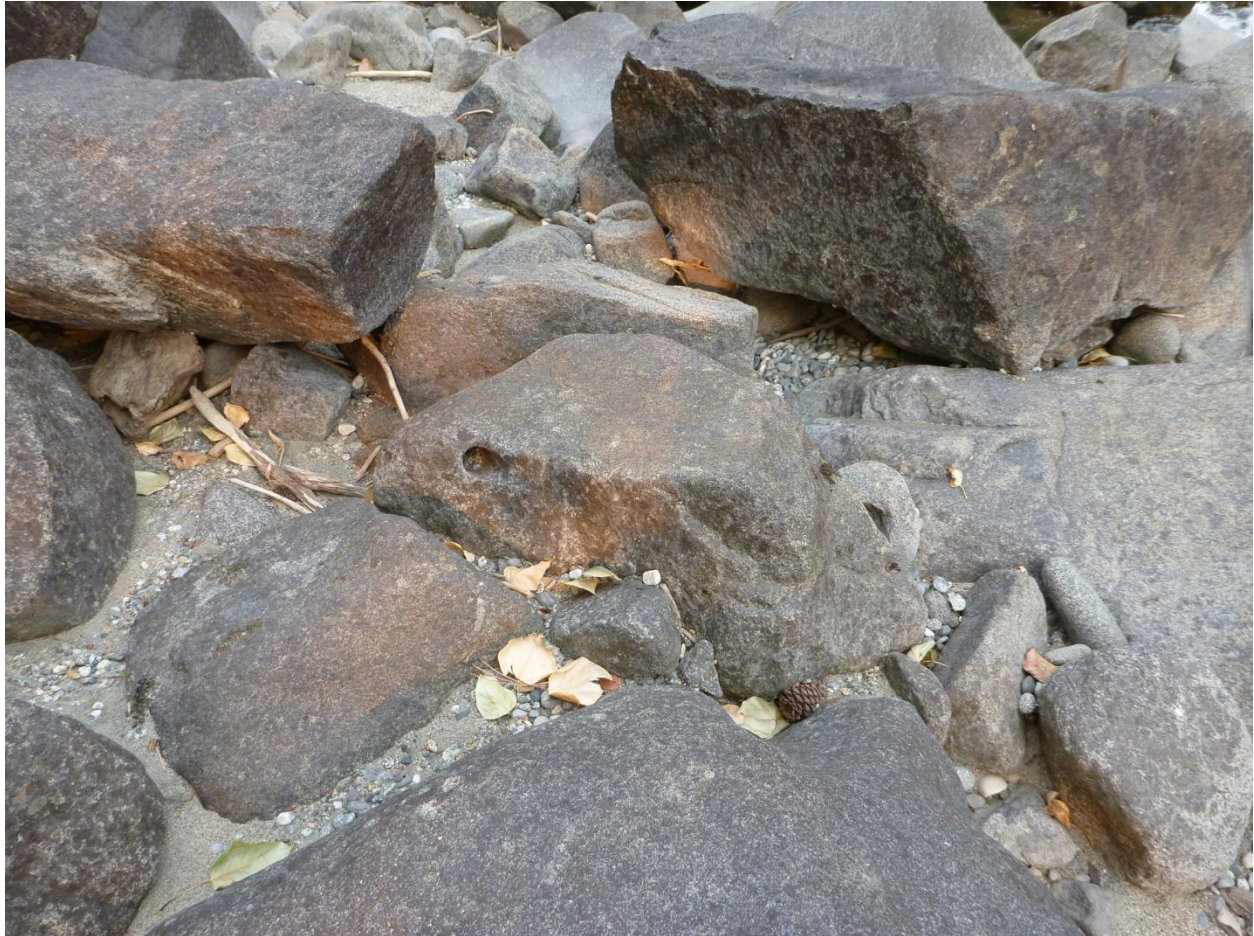
Figure A-13. Drilled rock in the Icicle Creek channel near the right bank upstream of the Anchor Boulder.

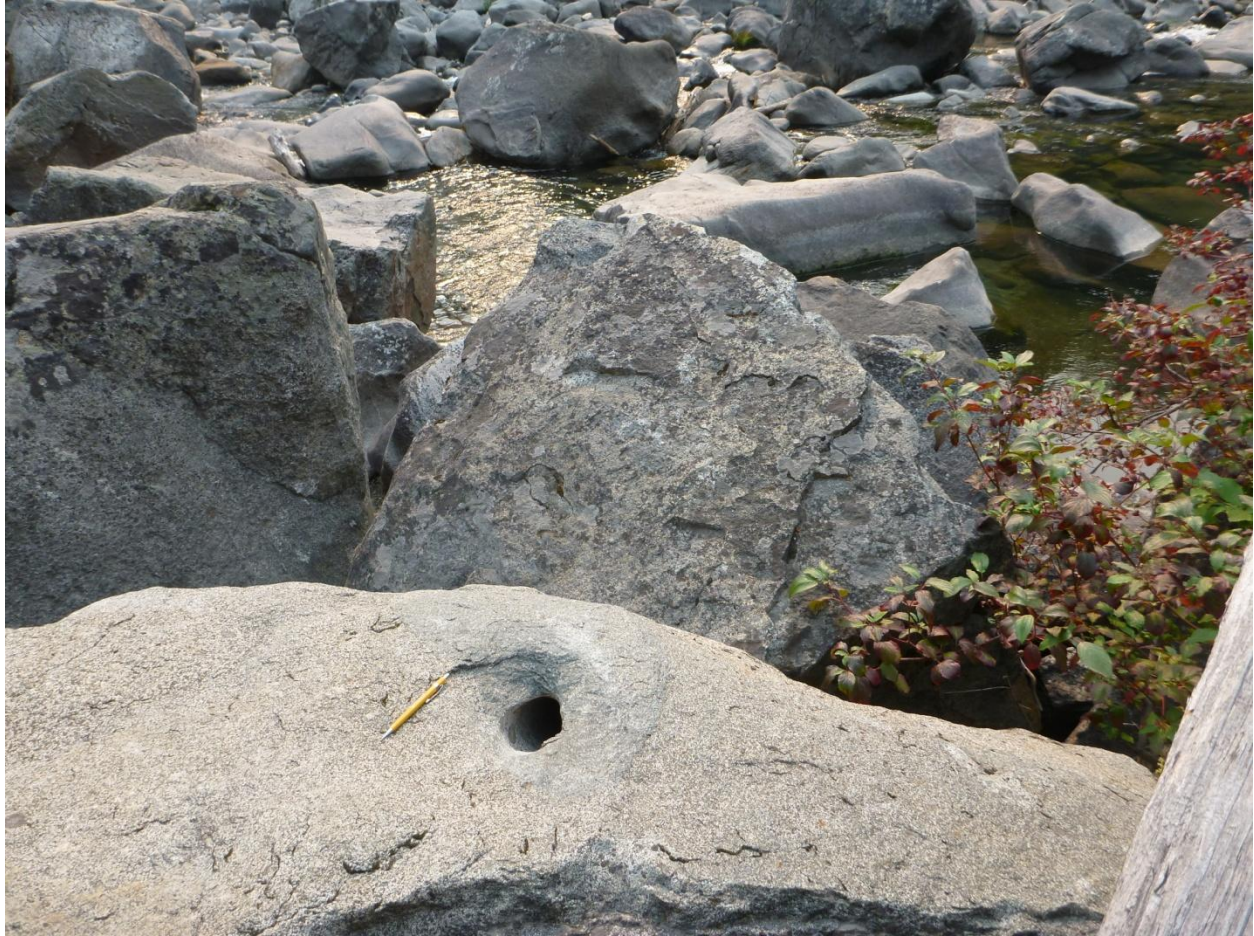
Figure A-14. Drilled rock on Left bank of Icicle Creek above the irrigation district bridge.

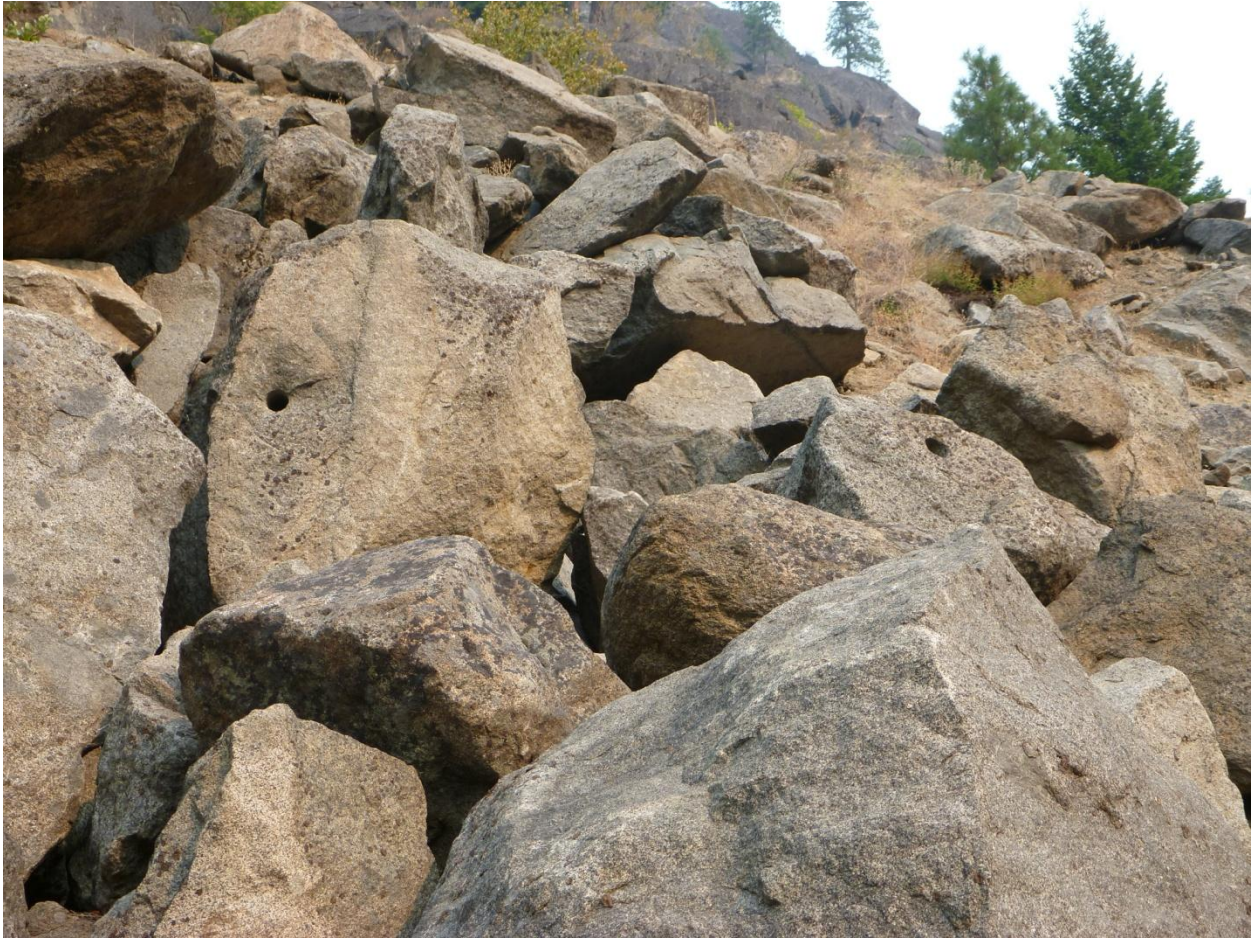
Figure A-15. Drill holes in rock sidecast along the old Icicle Creek Road in the lower reach of the Icicle Creek study area.
