# Icicle Creek Boulder Field Fish Passage Assessment

## Icicle Creek, Chelan County, WA

## FINAL May 2013

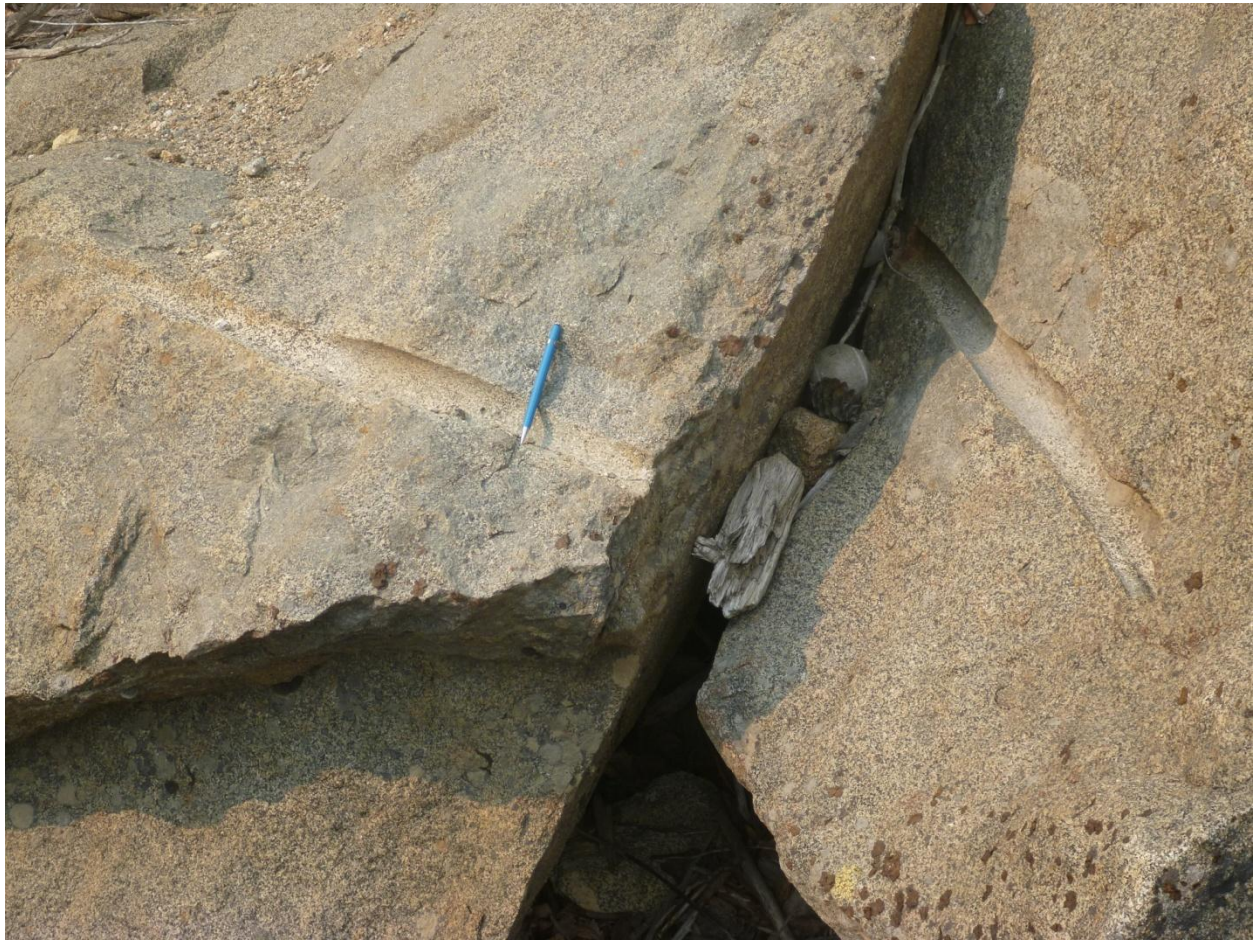
Figure A-16. Drill hole grooves in rock sidecast along the old Icicle Creek Road near the irrigation bridge.

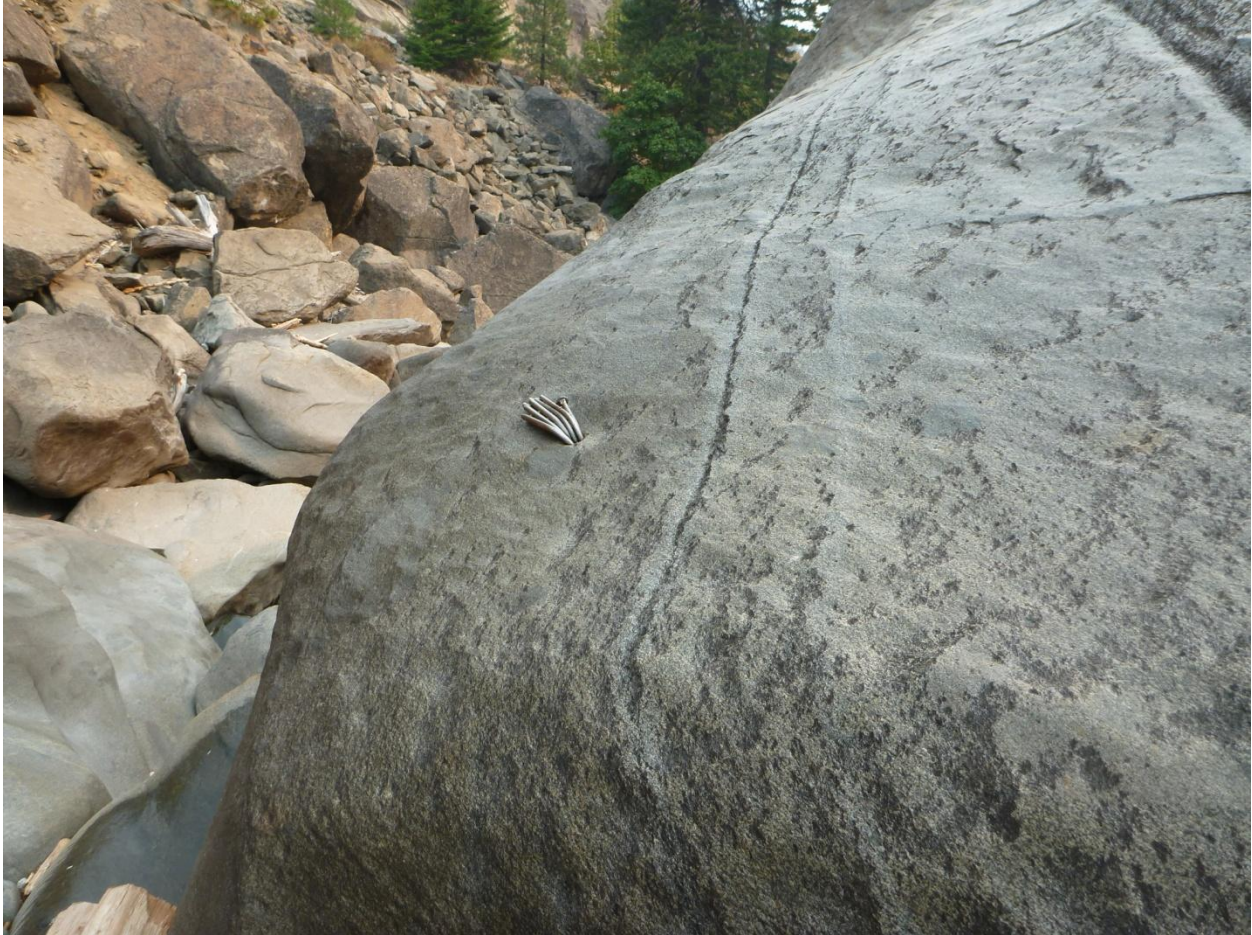
Figure A-17. Bent steel rods jammed into a drill hole on the north end of the Anchor Boulder.

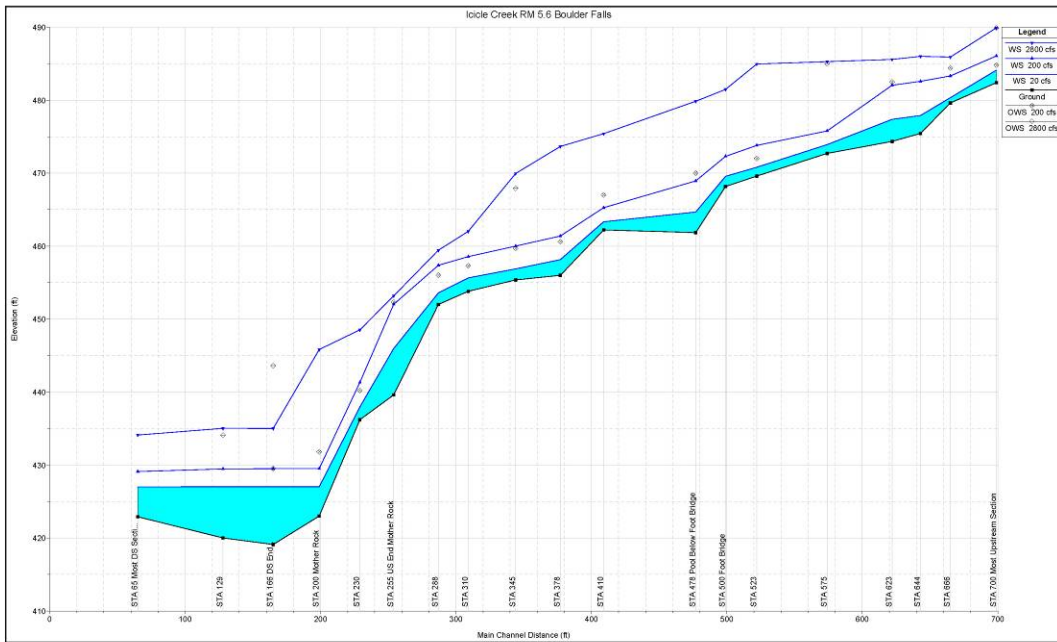
Figure 3. Iccle Creek HEC-RAS Velocities
