TECHNICAL MEMORANDUM

PROJECT #: 2512.01

SUBJECT: May 2020 Wetland Field Work Summary

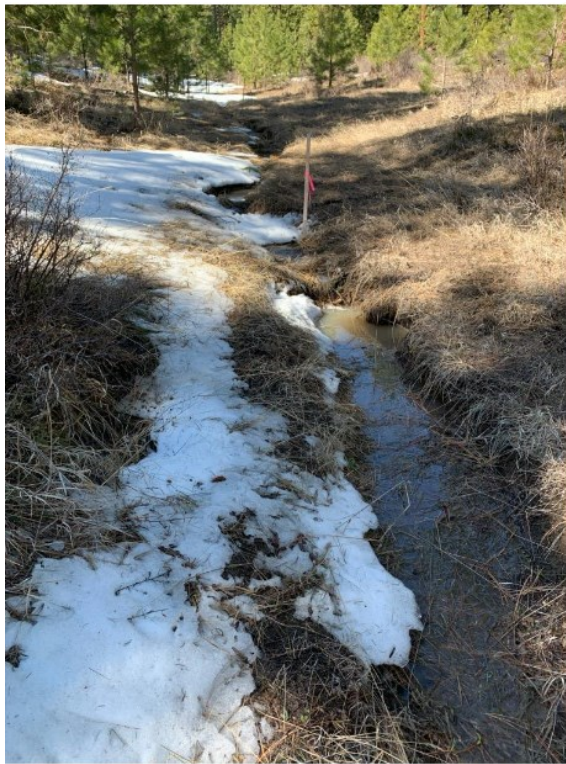
Growing Season Note: WR LLC photos from 2019 and 2020 (2020 photos are provided in Figures 4, 5 and 6) document that there typically is snow on the ground at these locations and flowing surface water (from snow melt) in late April (documented on April 22, 2019 and April 17, 2020). Elevation on Wheeler Ridge ranges from about 3,600-3,800 ft. Therefore, the growing season is assumed to start no later than April 22 in most years; and hydrology must persist at least 21 days into the growing season (into mid-May) in most years, under normal circumstances, in order for an area to meet the minimum hydrology duration requirement needed to be regulated as wetland.

Figure 6. Ns West, April 17, 2020

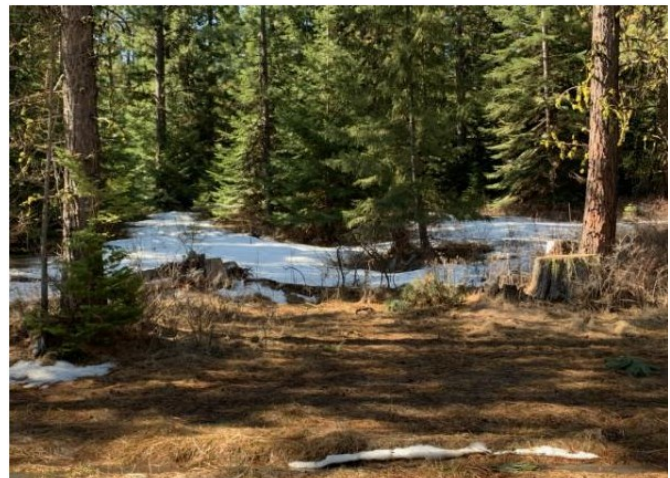
Figure 4. At Wetland C, April 17, 2020

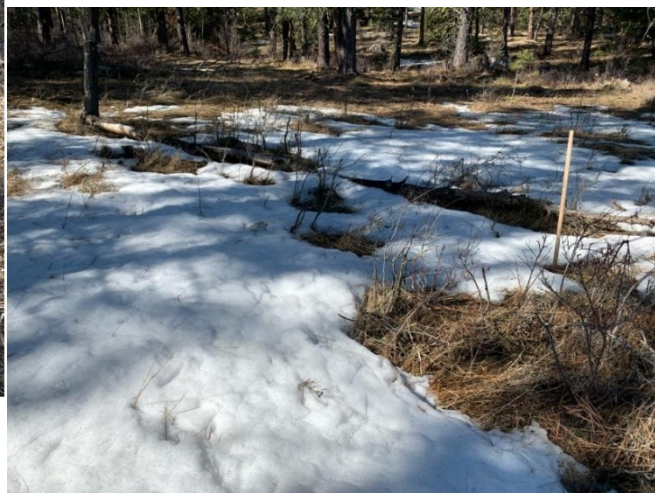
Figure 5. At Wetland B, April 17, 2020

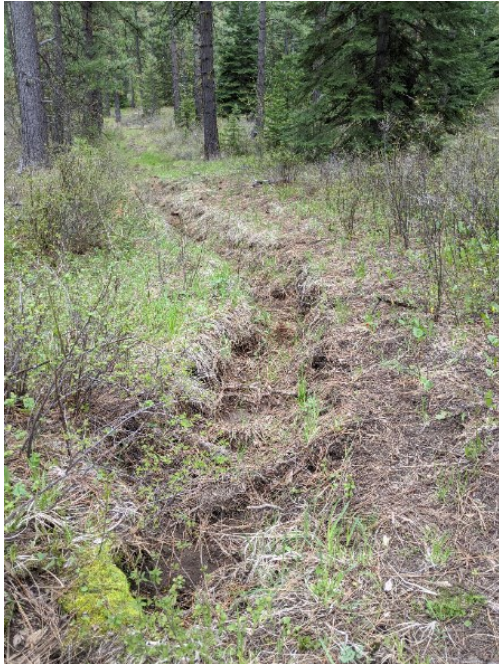
Ns North is a seasonal stream with periodic severe erosion scouring along the channel (Figure 7 and 9). In some areas, the erosion channel is over 8 ft deep, undercutting adjacent root systems (Figure 8). There was no continuous flow in most sections of the stream during the May 12, 2020 site visit. However, there were 2-3 locations where subsurface flow is visible in deep holes in the stream bed – possibly where trees uprooted in the past. That flow continues below the surface. These holes in the stream bed areas are not vegetated, and do not have hydric soils (Figure 10).

Figure 9. 2020 photo: Showing dry flow path of Ns North on May 12, 2020.

It is proposed to restore and enhance this Ns North stream channel, with special attention paid to stabilizing severely eroding sections to reduce downstream erosion impacts. The compacted road crossing would be restored during that stream restoration process, and hydrology would no longer be trapped upslope of the crossing. However, if this small wetland is to be buffered under current conditions, it is likely to rate as a Cat III wetland, mostly due to surrounding habitat conditions, which would assign a 75 ft wetland buffer rather than 50-ft stream buffer in the crossing area.

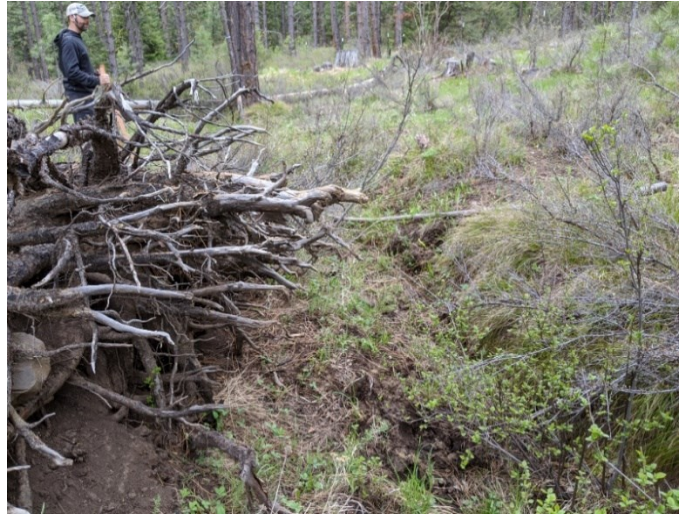
Figure 8. 2020 photo: Downed tree creating hole in channel base.

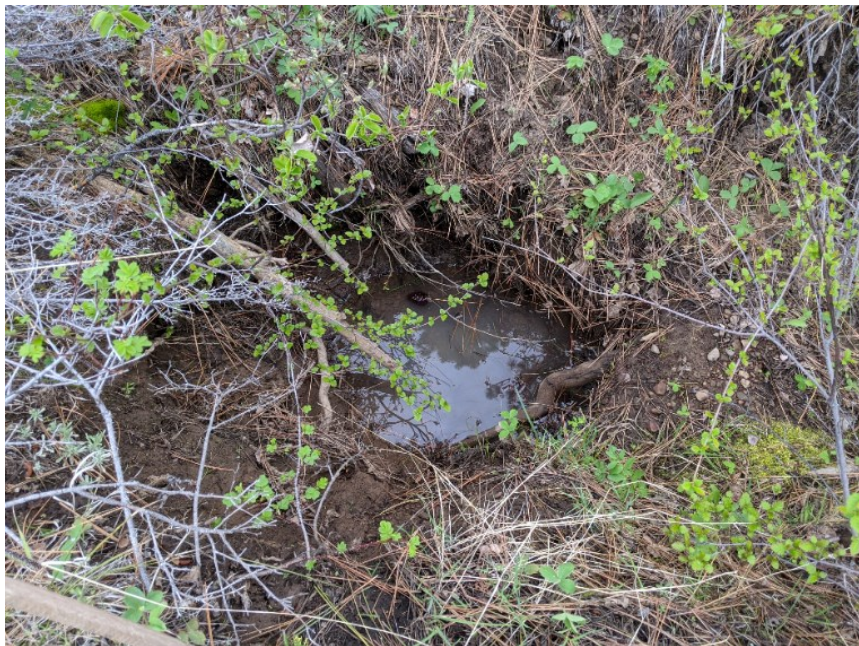
Figure 10. 2020 photo: Showing deep hole in stream bed, base is about 2 ft below stream bed and about 5 ft below surrounding grade.

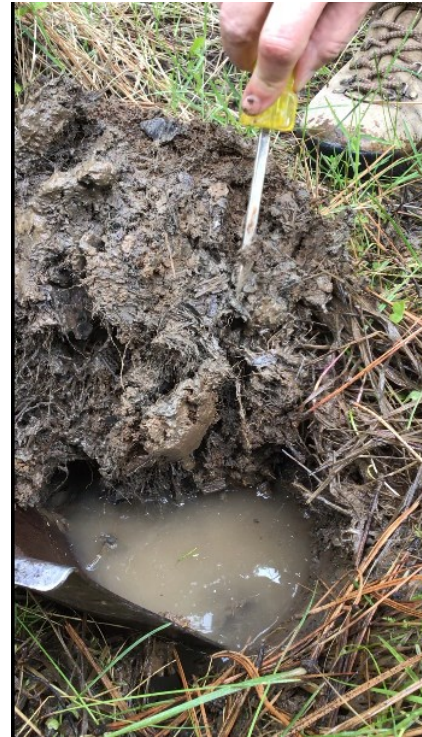
At one location (WP 015), an old logging road or ATV trail crosses the Ns North stream channel and dams stream flow, creating a small wetland area upslope of the crossing about 10 ft long and 2 to 3 ft wide. The soils are disturbed, mixed with wood chips and gravel, and saturated to the surface upstream of the crossing only. Soil characteristics meet Indicator F3 requirements (Figure 11).

This appears to be the area that Perteet identified as a potential wetland along the Ns North stream channel. The area upstream of the crossing was so small that the seasonal hydrology conditions were not apparent during the October 2019 site visit, when the channel and vegetation was dry, and the crossing area looked like the rest of the dry Ns stream bed.

Figure 11. 2020 photo: F3 indicator at WP 015 above, and full wetland extent shown below.

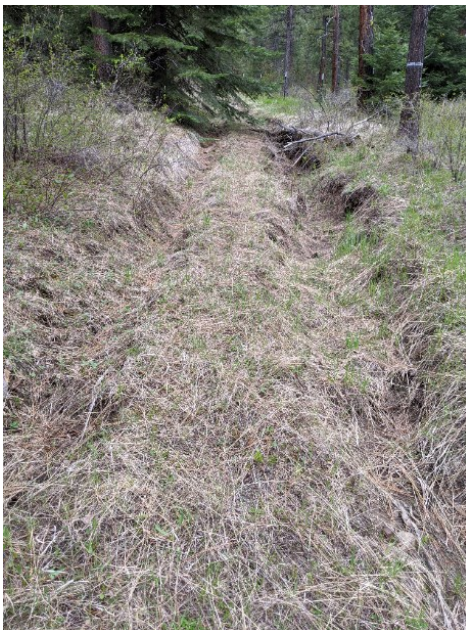
Ns West is a seasonal stream with severe erosion along most of the current flow pathway (Figure 13) due to the stream flow jumping from its natural channel into an adjacent logging road within a few hundred feet of the start. Its headwater area was noted by Pertteet as being potential wetland (Figure 12). It is proposed to restore the stream to its original channel and install erosion control methods to eliminate this severe erosion and sediment problem, which impacts downstream wetlands and streams.

Figure 13. 2020 photo: Ns West flow in road ruts

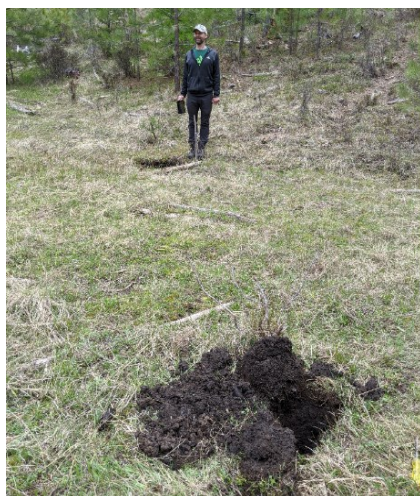
The soil profiles at two different locations in the lowest elevation spots in this headwater stream area are described below. Neither soil profile had hydric characteristics. Furthermore, during the May 12 site visit, there was no surface flow or surface water in the Ns West stream channel or in the headwater area (Figures 14 and 15). There was standing water in road ruts at a couple of places, but soil pits dug directly adjacent to those areas (described below) showed that there was no groundwater within 19+ inches of the soil surface.

Figure 14. 2020 photo: Appearance of "potential wetland area" at start of Ns West.

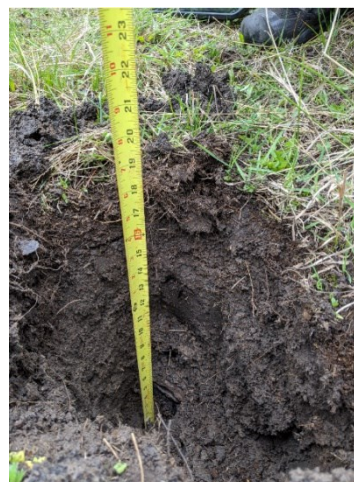
WP 020 (directly adjacent to rut with standing water)							
Layer depth	Layer matrix color	% cover	Redox features color	% cover	Type	Location	Texture
0-9 in	10YR 2/2	100%	None	NA	NA	NA	SiCL (heavy)
9-14 in	10YR5/4	100%	None	NA	NA	NA	SiCL (heavy)
Comment: No hydric soil characteristics. No hydrology within 14" of the soil surface.

Figure 15. 2020 Photo: Over-excavation of Soil pit at WP 020, shows no hydrology within 19+ inches on May 12, 2020.

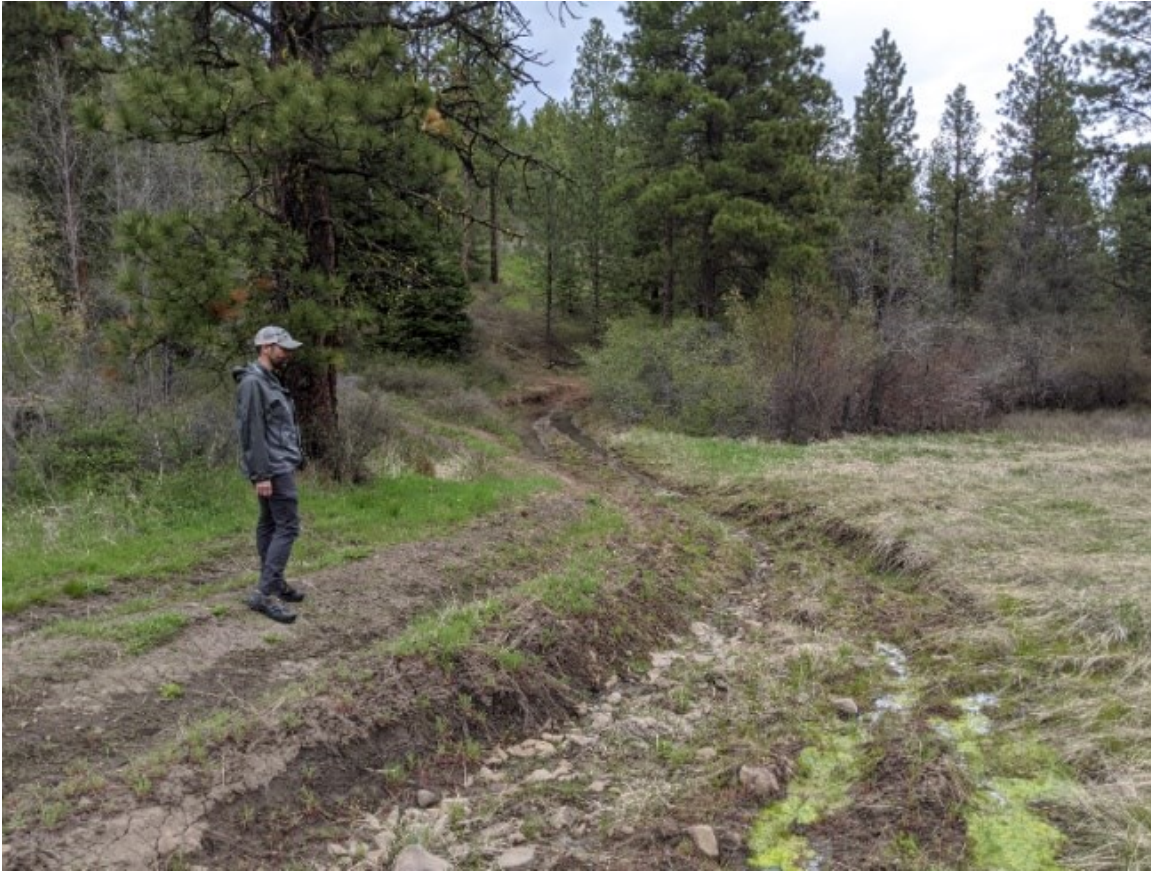
Figure 17. 2020 Photo: View of mud bog disturbance from the south. Raised area to right has the two small wetland depressions.

We note that this entire area is slated for restoration, and will be designed to eliminate the mud bog, and replace the currently severely disturbed confluence area with a PEM/PSS wetland / stream complex. Figures 17, 18 and 19 show conditions around the mud bog as the two small wetland depressions on the raised area east of the mud bog.

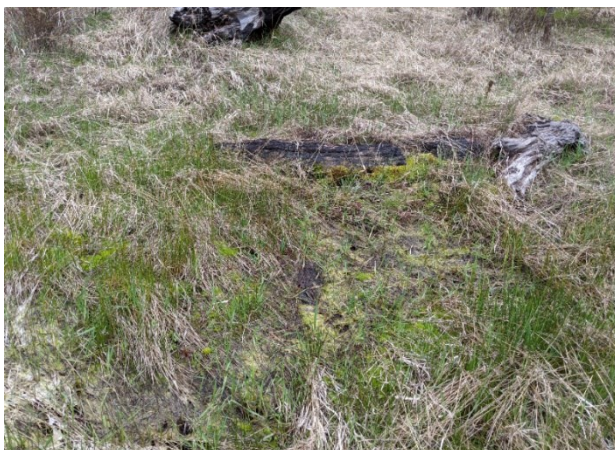
The terrace surface east of the mud bog shows past evidence of ATV traffic – tire tracks leading up onto the surface and ruts within the surface. This condition is common throughout this area – a result of ATV users trying to find other ways around the mud bog when water is too deep. There are two spots on the surface where it appears ATVs were stuck in the past, each creating a small depression. One depression is 9x9 ft, and the other is 15x12 ft (WP 028). Both of these spots have wetland conditions -- current hydrology at or near the surface; hydric soils (Indicator F6) and hydrophytic vegetation (grasses plus one type of rush – too young to ID). None of the rest of the surrounding surface has hydrology within 12 inches of the surface or hydric soils.

Figure 19. 2020 photo: 15 x 12 ft wetland depression

These two areas, if regulated as wetlands, would be expected to rate no higher than Cat III, and as such, would have 75 ft buffers. These buffers are entirely embedded within overlapping buffers from WL-A (from the south and east), WL-B (from the west) and the Ns/Np stream confluence (from the north).

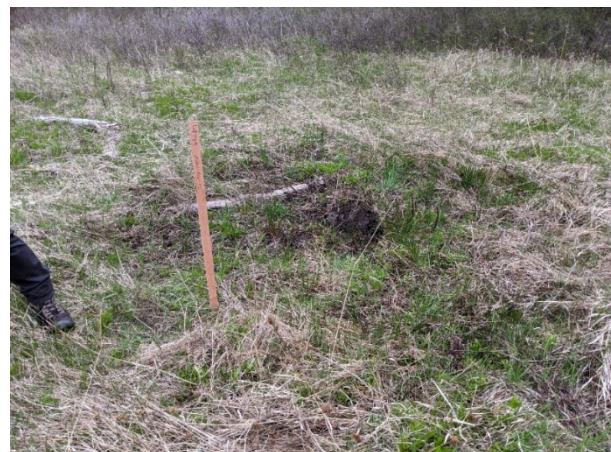
Figure 18. 2020 photo: 9 x 9 ft wetland depression

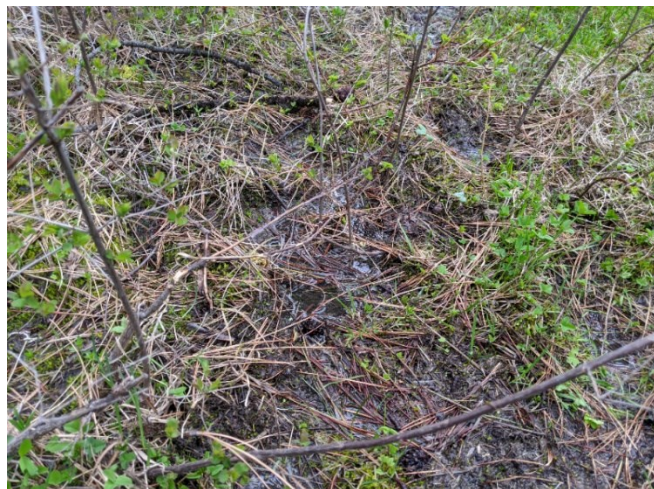
Wetland C – mostly PEM vegetation -- is fed by a groundwater seep from the south that surfaces once the slope flattens. The change in slope is essentially the edge of the wetland, and there was current hydrology at the surface in WLC during this May 12, 2020 site visit (Figure 21), matching what was documented during the first May 2018 site visit.

Figure 21. 2020 Photo: Surface Hydrology in WL-C on May 12, 2020.

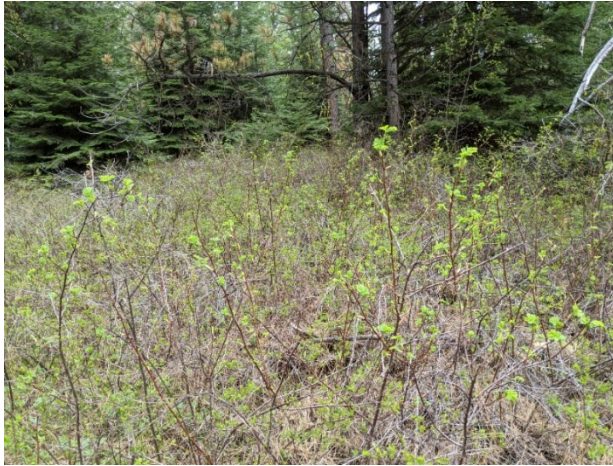
The area just upslope from WL-C has different vegetation – transitions abruptly to a mixture of snowberry and wild rose (Figure 23). The soil profile in this shrubby area is similar to what we documented and observed at the start of Ns West – a very deep, dark colored, silty clay loam soil profile, but with no hydrology, no redox concentrations or any other Hydric soil indicators within 14 “ of the soil surface (Figure 22).

Figure 23. 2020 Photo: View of shrubby area upslope from

Perteet thought that the shrubby area upslope from WL-C might be wetland, likely due to the presence of wild rose, and ranunculus in the forb class. However, the slope drives hydrology at that location, and only the flat areas at toeslope had current hydrology in May 2018 and 2020. The area upslope is not wetland.

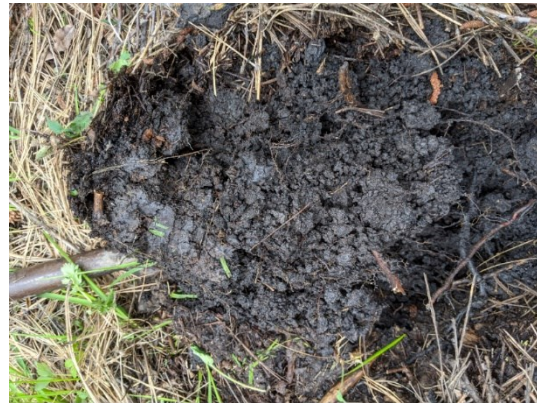
Figure 22. 2020 Photo: Soil pit in shrubby area, very dark colors, but no hydrology, and no redox concentrations or depletions within 14 in of surface.

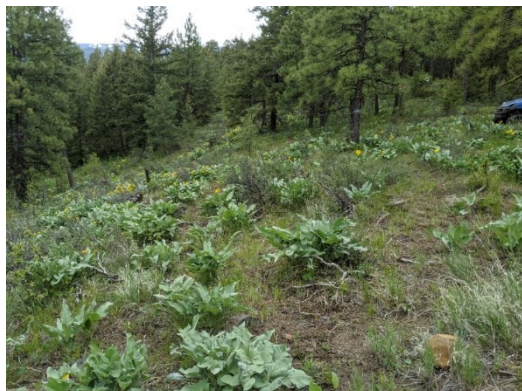
Neither is there any Ns stream within 50 feet of the eastern boundary. That area slopes at a relatively steep angle to the SE, and there was no swale feature or evidence of a flow pathway along the eastern boundary (Figure 26).

Figure 26. 2020 photo: Sloped area in vicinity of mapped Ns stream. No stream corridor in the

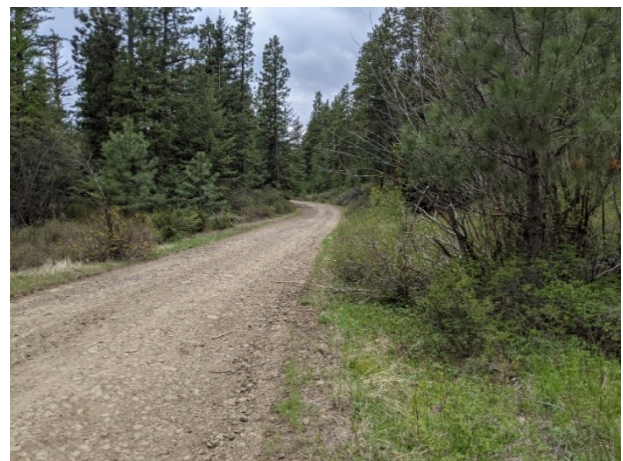
Figure 24 (extracted from Figure 2 on Page 2 above) and Figure 25 show the SE corner of Section 17 where three sections of Ns streams are mapped. None of these streams would have buffer impacts to the proposed orchard area in any case. However, two of the mapped streams crossing the southern boundary and SE Section corner are in the same location as existing roads (Figure 25 and 27). There are no streams with current flow (on May 12, 2020) at these locations, aside from the stream possibly being the roadside ditch. There was no flow in the roadside ditch either.

Figure 27. 2020 photo: Road crossing SE corner of Section 17.

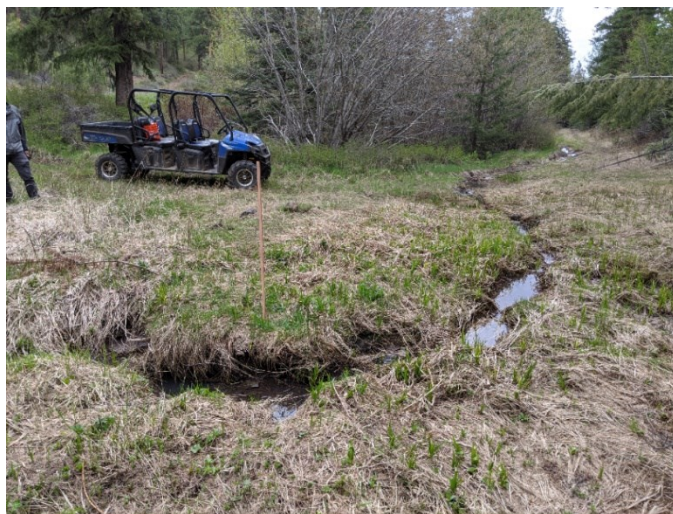
Figure 28 shows locations of 7 riparian wetlands associated with the Np stream corridor. In most cases, these wetlands are no more than 10 feet wide and less than 30 feet long along one or the other side of the incised stream. Three of the wetlands are forested; two are scrub-shrub with forested perimeter, and two are emergent. There is only one wetland with more than 2-3 quaking aspen trees inside the wetland. In most areas, where aspen are present, they are in the upland buffer area adjacent to the stream, or in one location, they are on an upland island between two branches of the incised stream. In most locations, the forested wetland is dominated by red alder. All of these wetlands are more than 300 feet from the nearest orchard area. No impacts to these wetlands are proposed, aside from restoration of the PEM wetland and stream channel at the far western stream crossing visible near the lower left corner of Figure 28, and shown in Figure 29. There are no aspen at that location.

Figure 29. 2020 photo: Showing proposed wetland enhancement area at crossing.

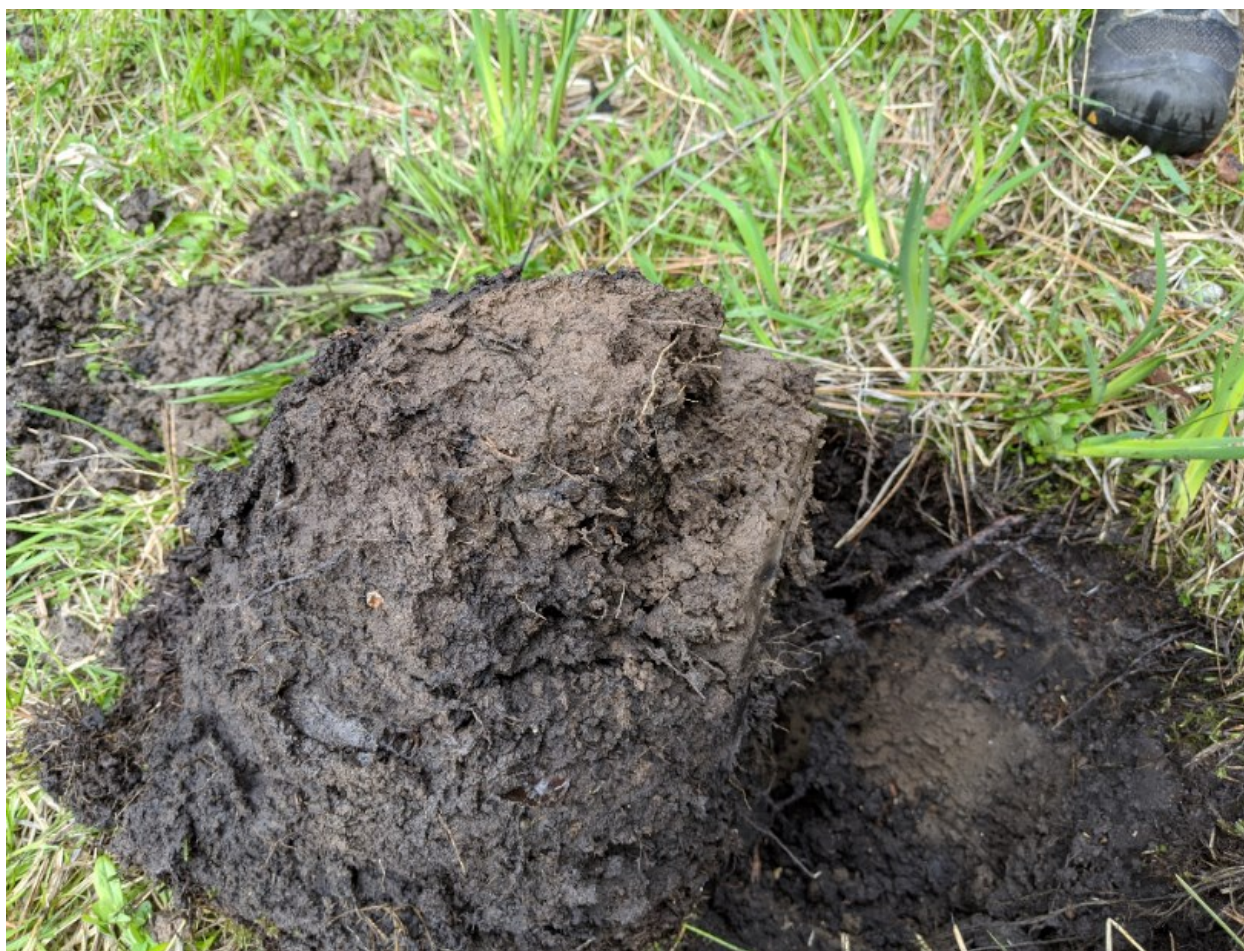
Figure 30 shows the unforested area, and a logging road extending to the SSW into the trees (see GPS paths). Soils pits were dug at several locations in the open area and formally documented at three locations, walking along a transect along the centerline of the area from upslope to downslope. The soil characteristics were very similar to what we observed and documented previously at WL-C and at the end of Ns West – the same dark-colored, deep, silty clay loam soil with no hydrology in the upper 14+ inches and no redox features. Soil color became increasingly brown with depth, rather than gray (Figure 31).

WP 140 Farthest downslope in old log deck area, which should be wettest							
Layer depth	Layer matrix color	% cover	Redox features color	% cover	Type	Location	Texture
0-6 in	10YR 2/2	100%	None	NA	NA	NA	SiCL (heavy)
6-14+ in	10YR3/3	100%	None	NA	NA	NA	SiCL (heavy)
Comment: No hydric soil characteristics. No hydrology within 13" of the soil surface.

Figure 31. 2020 photo: Soil Profile at SP 140 – no redox concentration or depletions; no hydrology within 14 inches of the soil surface.

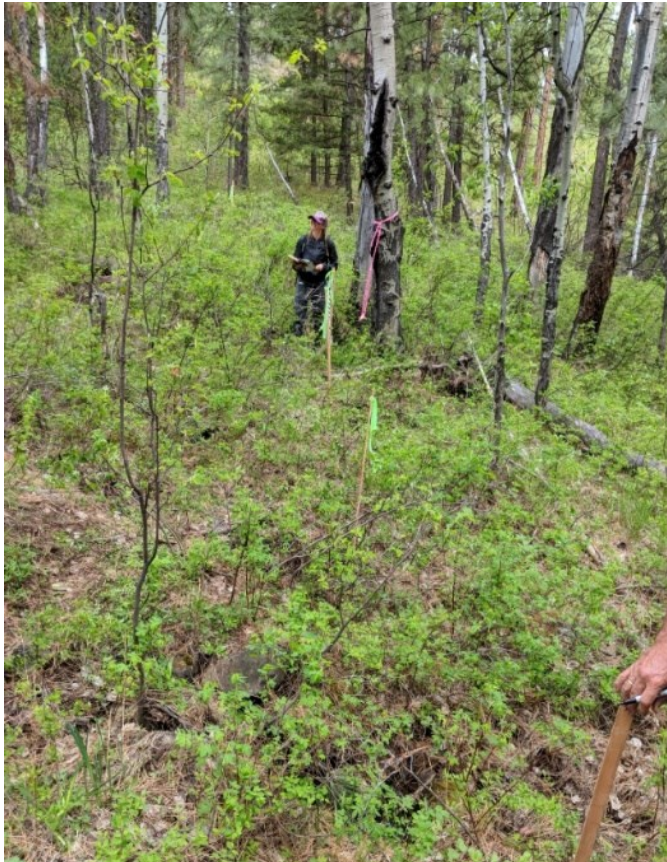
Figure 32 shows a flag on a tree at the southern property line. The wetland stakes are visible in a line from the person in the distance to the foreground. Clearly, the area between the two people is dominated by short shrubs, but also clearly, the surrounding upland is forested and includes some aspen, along with other trees. Figure 33 shows a similar condition.

Figure 32. 2018 photo. Flag hung on tree is at wetland edge, and other trees are all upslope, outside of the wetland. Wetland is dominated by short shrubs and herbaceous plants. Stream system marked by green-flag stakes is barely visible under shrubs.

I did explain this issue previously, but because this Field Data Form has created confusion, I have replaced it with data collected near WP 020 (May 2018 waypoint). I provide this substitute and more representative paired plot as an attachment in the Appendices below.

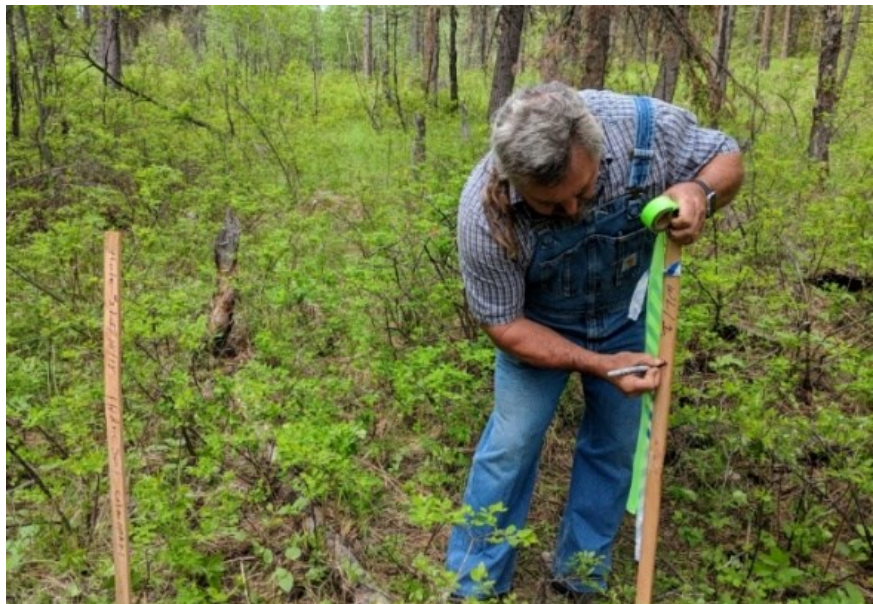
Figure 33. 2018 photo: Marking wetland edge and location of paired sample plots.

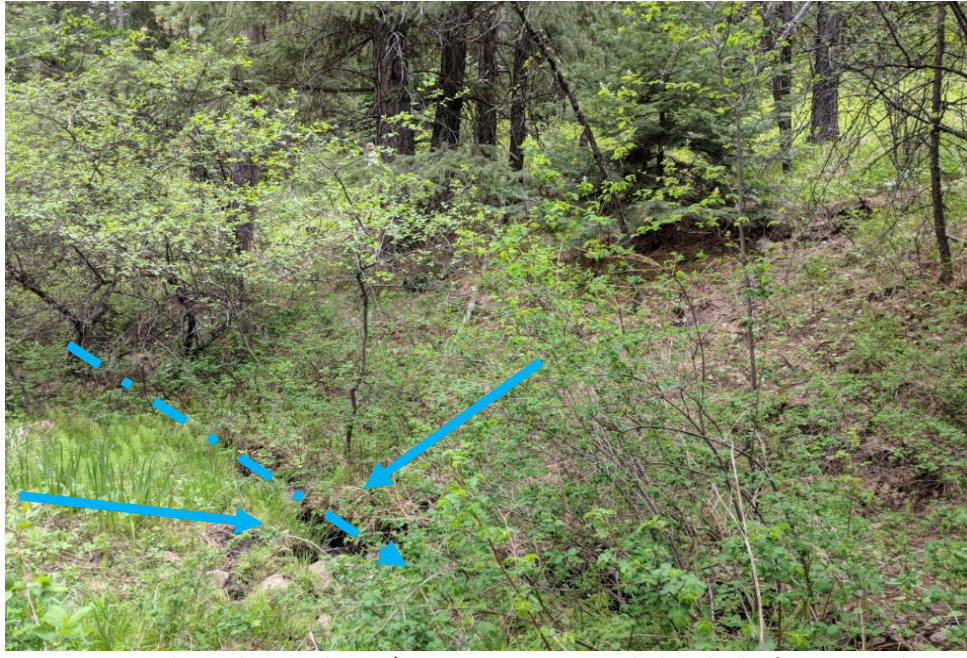
Figures 34 to 36 below show terrain in the area around the wetland, and how it affects hydrology.

Figure 34. 2018 photo: Showing the PSS/PEM WRU A system, with sloped sides flowing into the stream channel, and no floodplain.

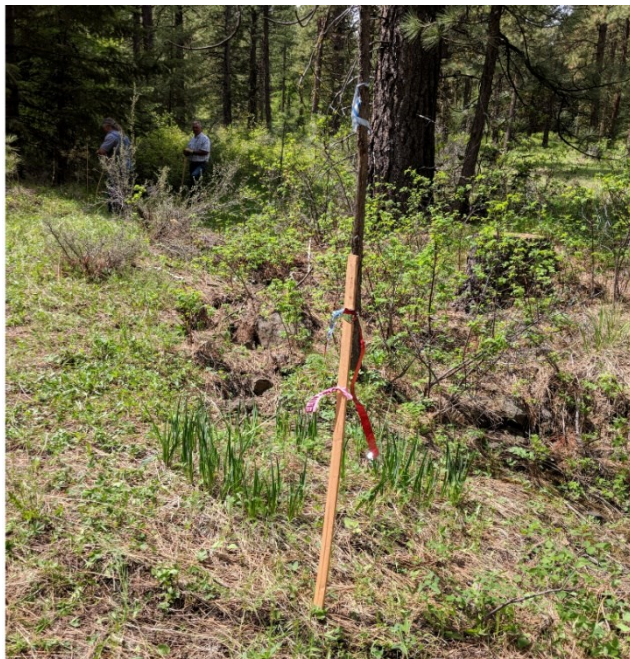
Figure 35. 2018 photo: Another example of the incised WRU A stream with narrow strip of sloped PSS/PEM wetland on either side.

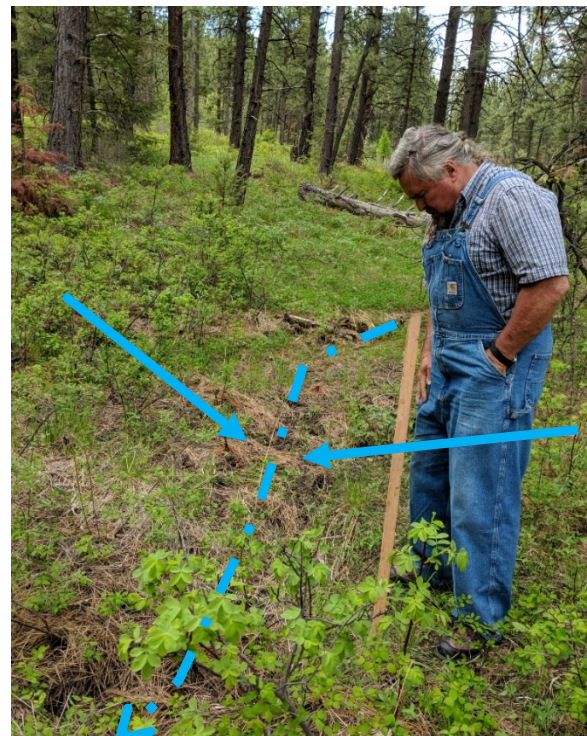
Figure 36. 2018 photo: Showing a typical view of WRU A PSS/PEM stream/wetland system. Herbaceous and small shrubs; sloped sides concentrating into incised flow pathway. Minimal over-bank flow floodzones.
