SLIDE RIDGE

A public safety project
APWA 2022 Project of the Year Submission

Chelan County Flood Control Zone District
Division: <\$5 million
Category: Disaster or Emergency Construction/Repair

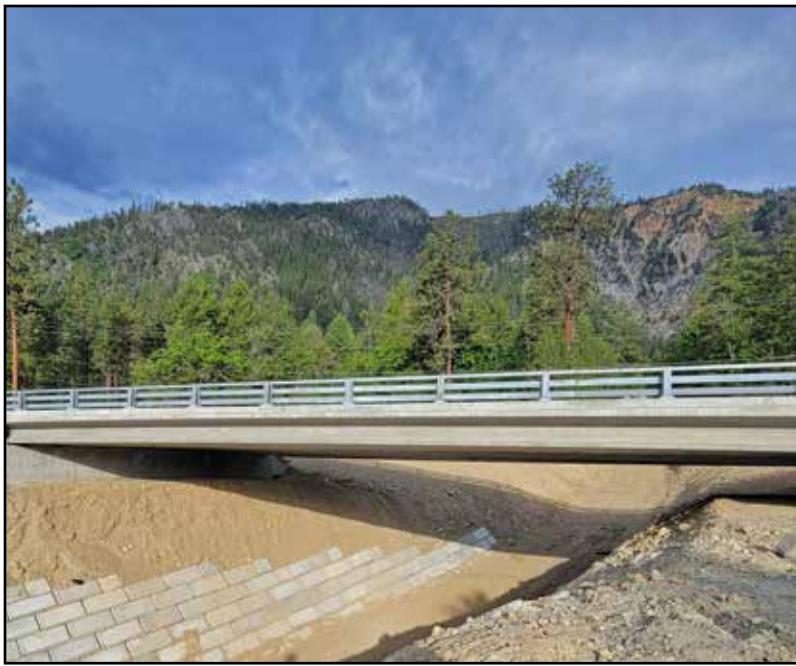
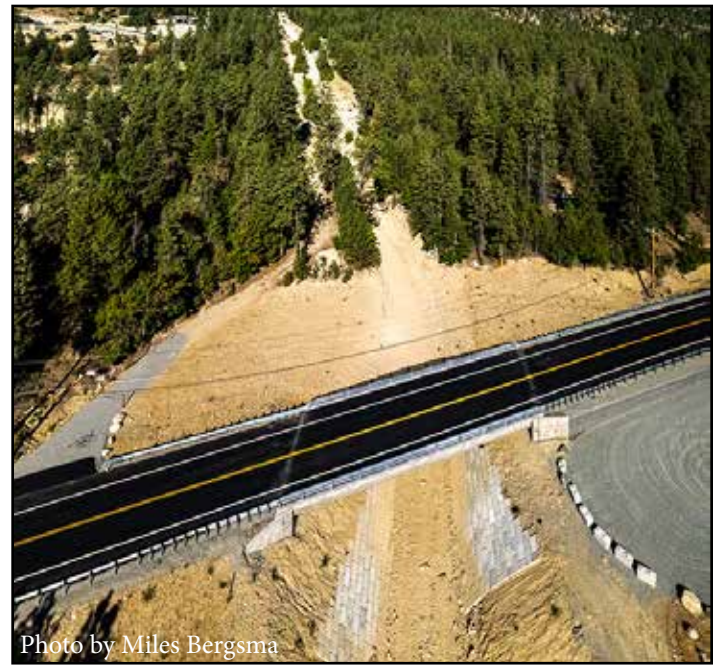
In their place is a 108-foot long, single-span bridge that has been built over the earthen channel, allowing mud

and debris flows to freely pass under – not over – the roadway. The channel from the bridge to Lake Chelan also has been re-engineered and rebuilt. Construction started in June 2021 and was completed in July 2022. The project was paid for in part with a \$1.3 million grant from FEMA. Remaining costs were paid for by the newly formed FCZD.

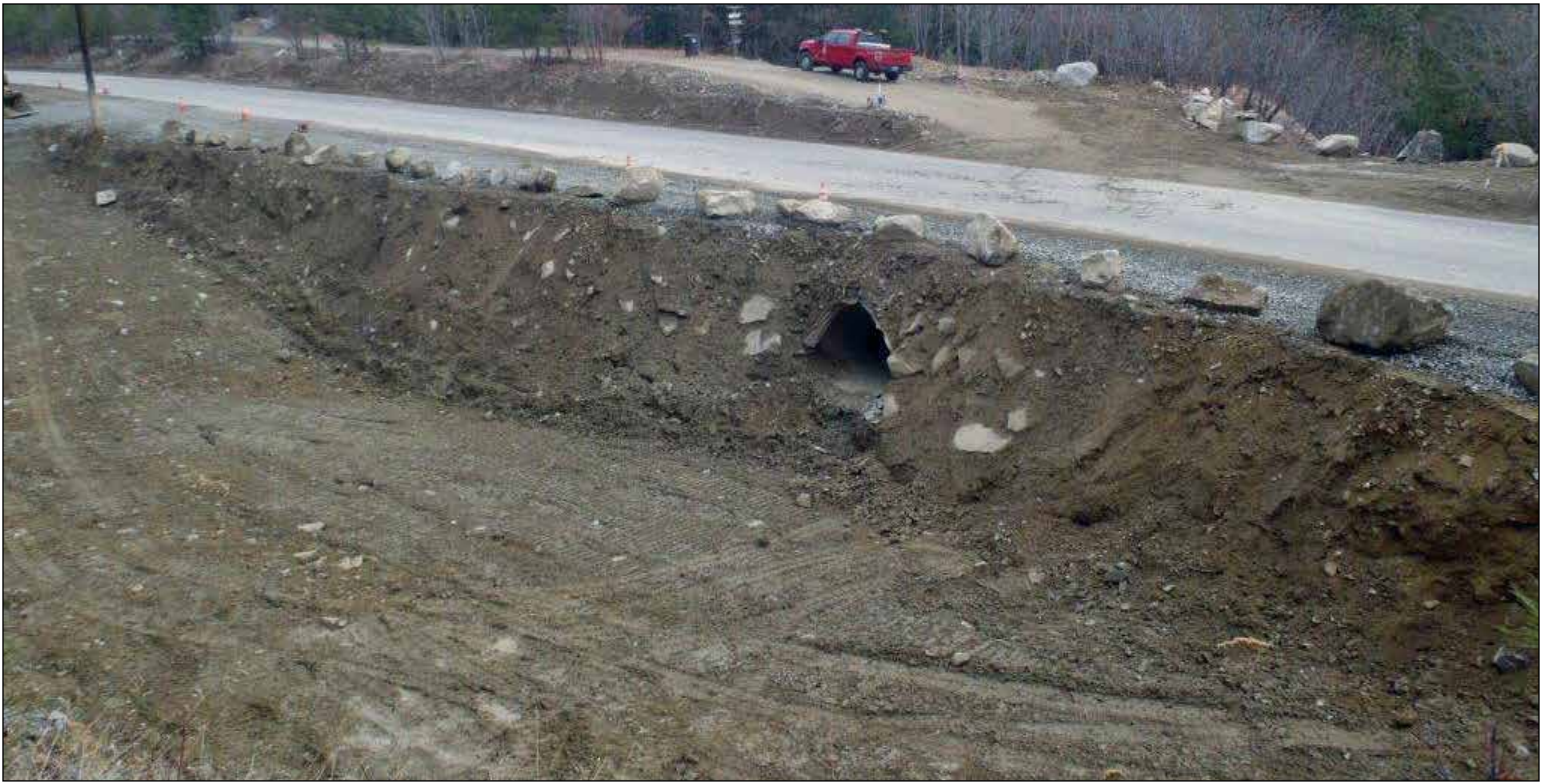
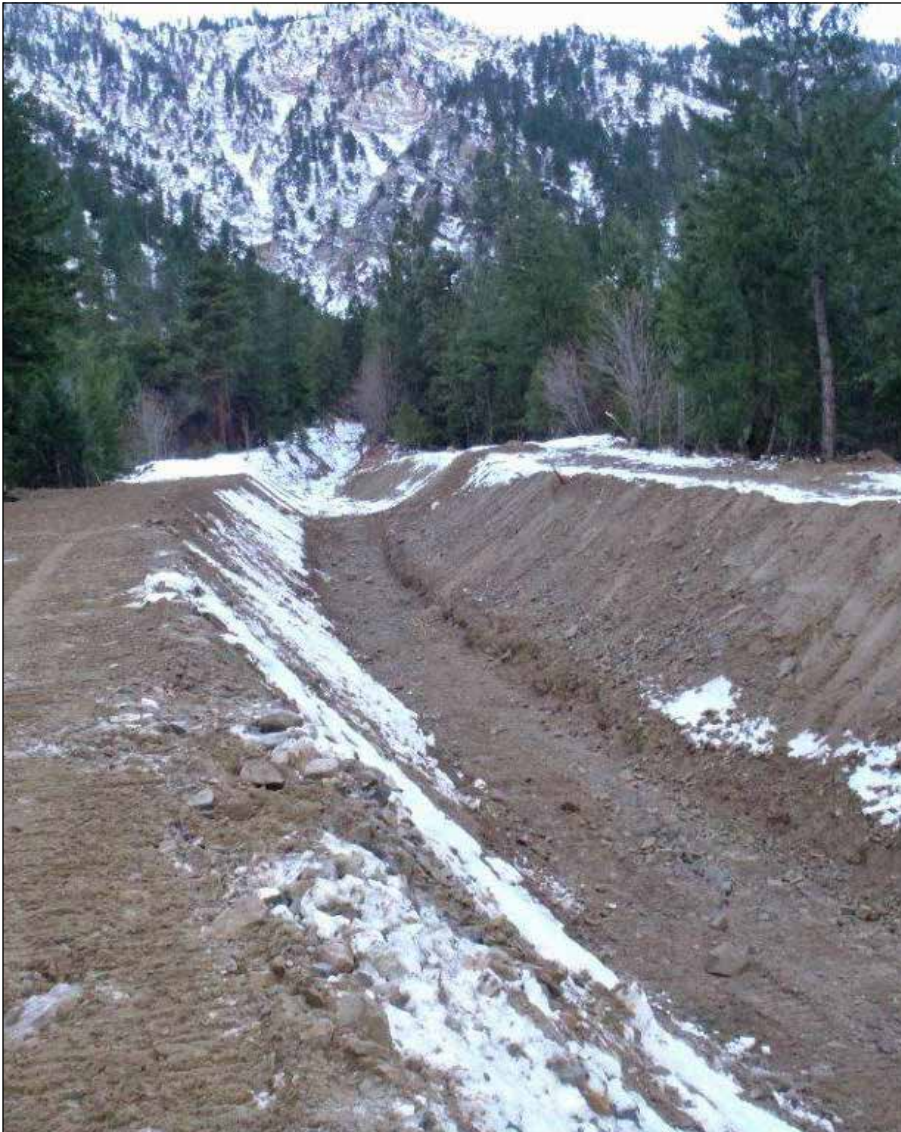
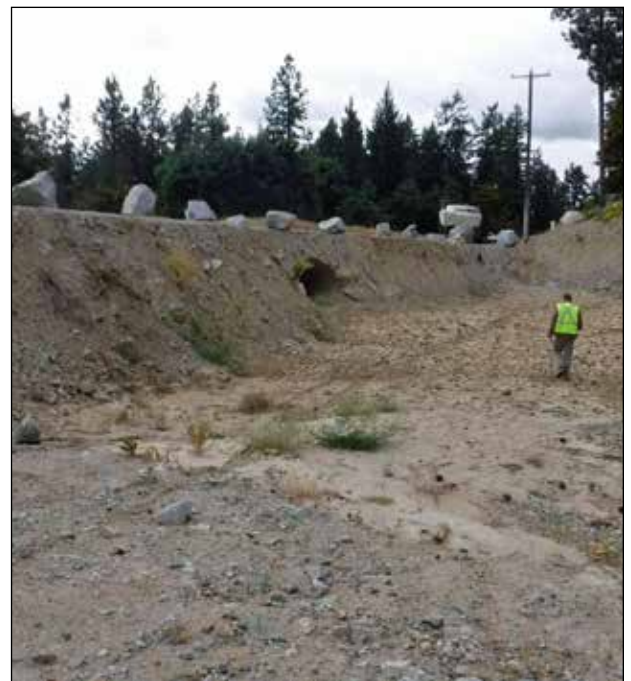
— Before Photos —

In 1995, an earthen engineered drainage channel was constructed in the slide area of Slide Ridge. The drainage channel conveyed material to a stilling basin on the west side of South Lakeshore Road (top photo), where a 72-inch corrugate metal culvert was intended to convey material under the roadway to the east (right photo) and down the lower portion of the channel (left photo). During large storm events, the volume of material frequently overwhelmed the culvert and caused it to fail. This caused material to backup, fill the stilling basin and flow on top of South Lakeshore Road, thereby stranding people north of the culvert and emergency access into the area.
