SLIDE RIDGE CULVERT REPLACEMENT PROJECT

Bridge Feasibility Report and Alternatives Analysis: Appendix A-F

July 2020 | Final Report

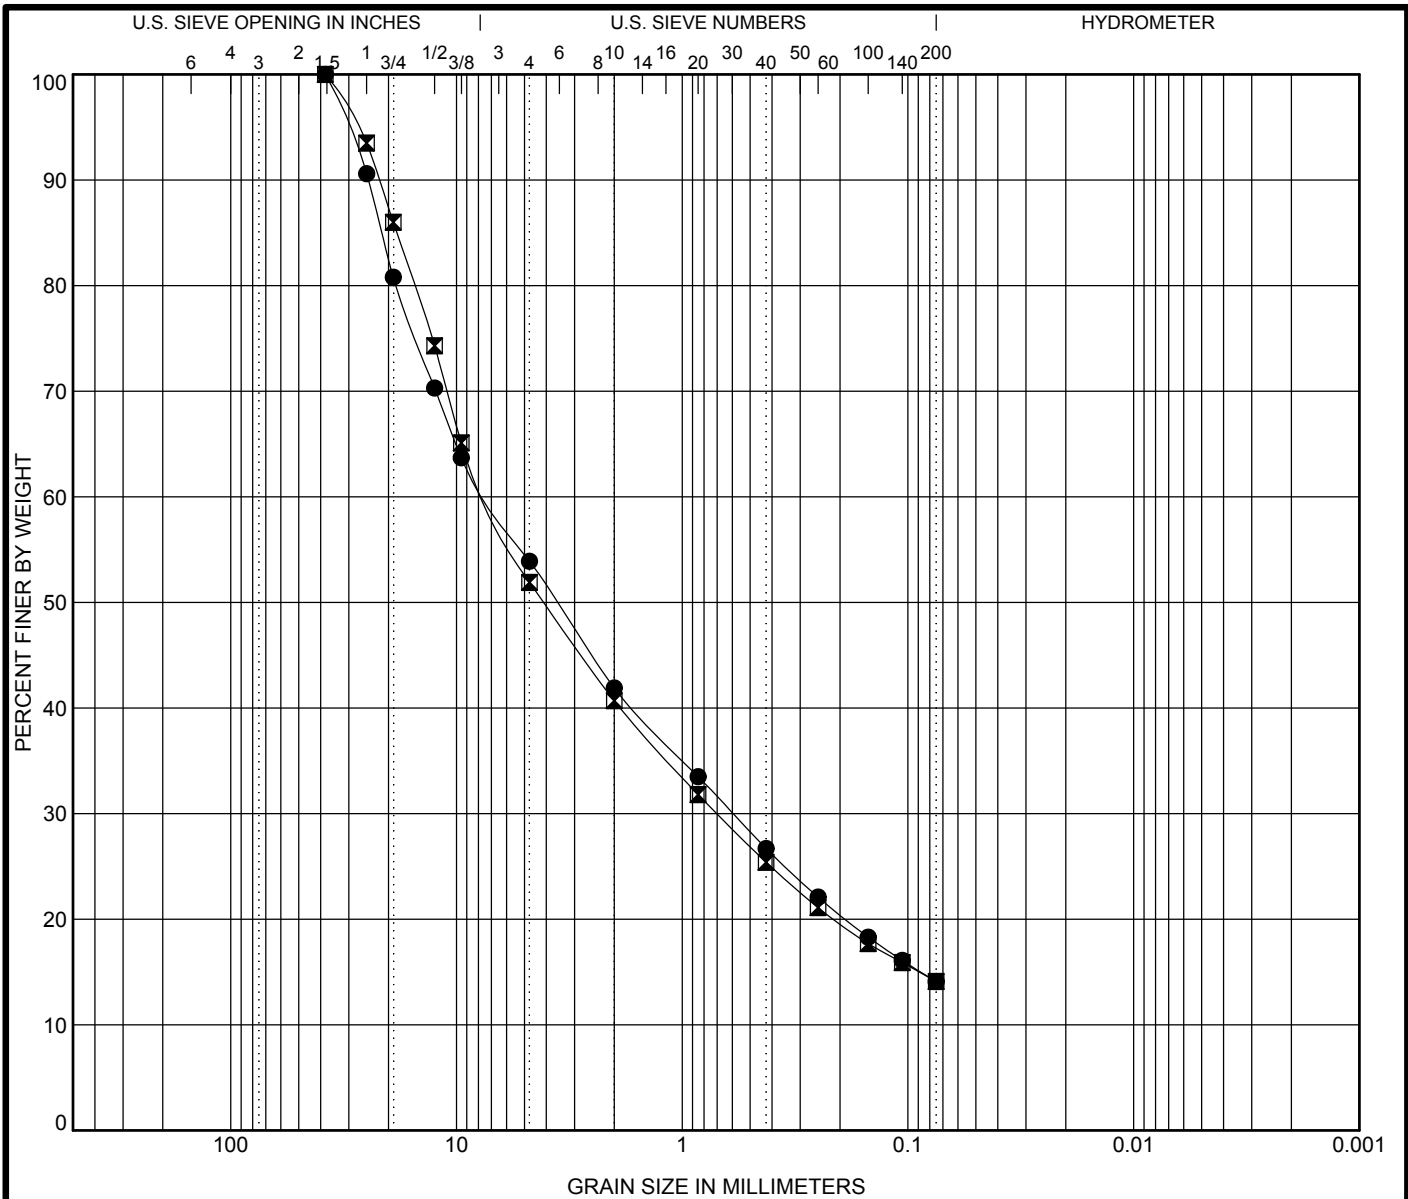
COBBLES	GRAVEL		SAND			SILT OR CLAY
	coarse	fine	coarse	medium	fine

Specimen Identification	Classification	LL	PL	PI	Cc	Cu
● PG-1 @ 25.0 ft.	SILTY GRAVEL with SAND(GM)	NP	NP	NP		
☒ PG-2 @ 25.0 ft.	SILTY GRAVEL with SAND(GM)	NP	NP	NP

Grain size analyses are presented on Figure B-1. Moisture contents are included on the logs of test borings in Appendix A.

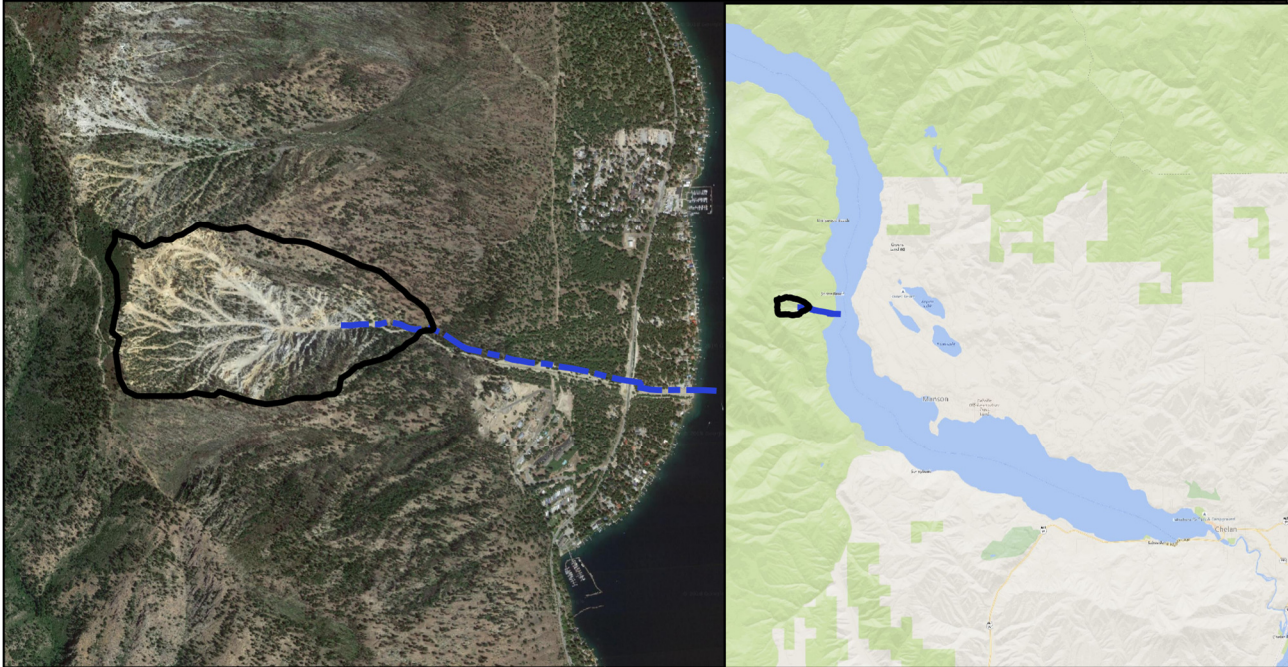
Figure 1. General location of Slide Ridge basin and project site. The upper basin boundary (black) and channel (blue) are shown in both the local map on the left and the area map on the right.

The project site is located along S Lakeshore Road on the southwest side of Lake Chelan, where the Slide Ridge debris flow channel crosses the road (Figure 1). The road provides the only year-round access to properties located uplake (north and west) along the south/west shore of Lake Chelan. Slide Ridge is also labeled “Granite Slide” on many historic and topographic maps.

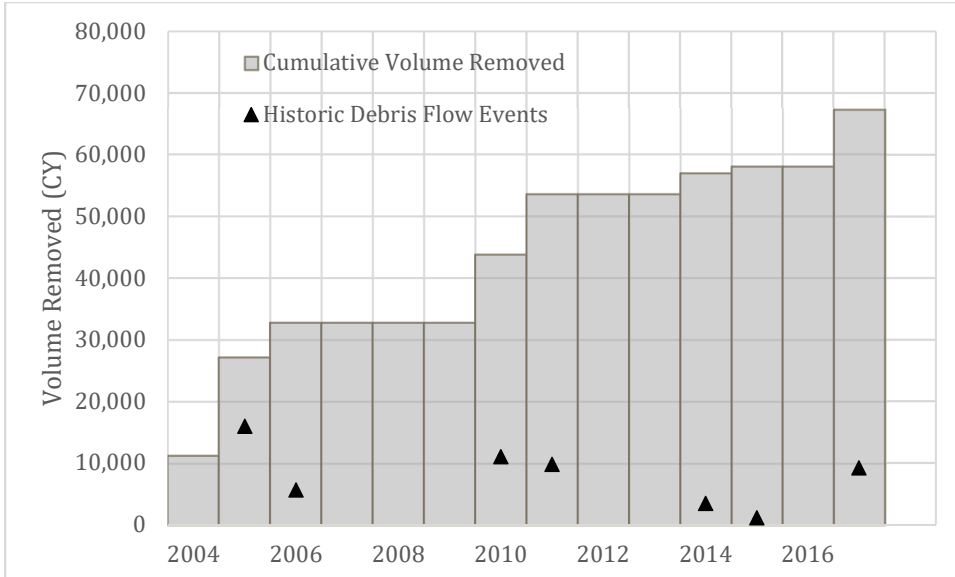
Figure 2. Historic debris flow volumes (adjusted) at S Lakeshore Road.

The average annual debris removed by Chelan County over the last 15 years is about 4,000 to 4,500 CY. The largest single debris event was in 2005 and was over 1.5 times larger than the recent October 2017 debris flow event. A few select photos showing the scale of the 2005 and 2017 events are provided in Appendix B. Two of the eight events were contained in the debris basin, while six events overtopped the road. The events and cumulative total volume removed since 2003 are plotted in Figure 2.

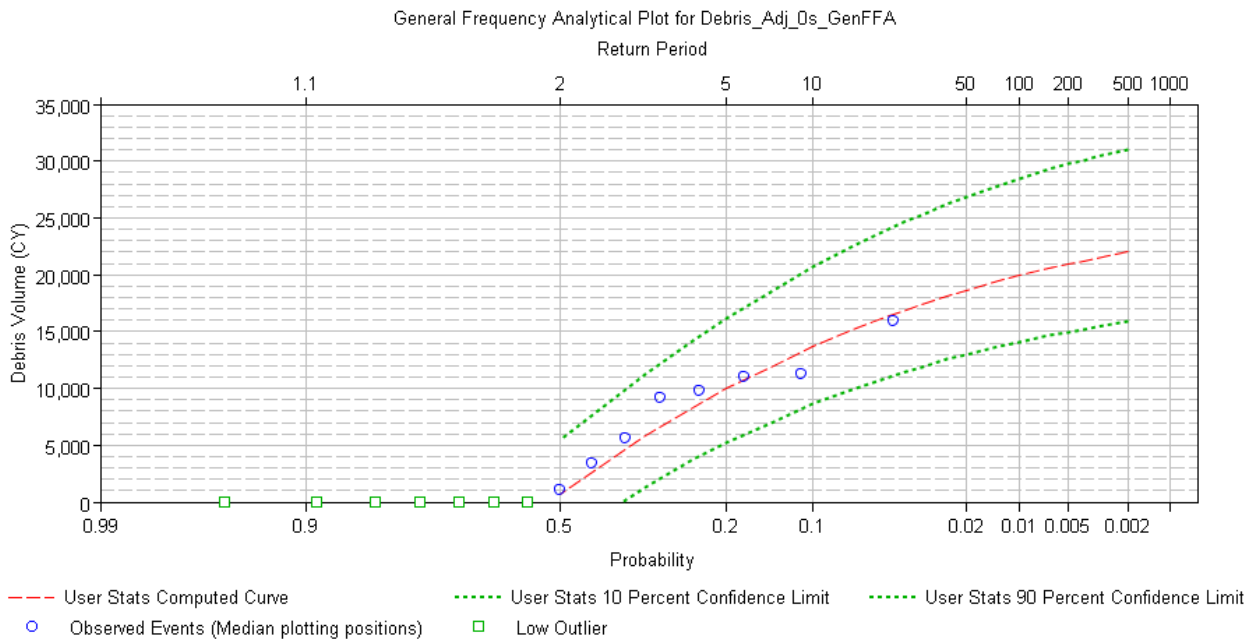
Figure 3. Frequency analysis of annual debris flow volume removed by Chelan County at S Lakeshore Road.

There are no debris flow cleanouts reported for about half of the years in the record, as the basin was only cleaned out 8 of the 15 years. Therefore, the frequency curve has been fit beginning at a 2-year return period corresponding to about a 50% chance that no debris cleanout will be performed in a given year. The largest recent historic event has been estimated at 14,000 to 16,000 CY in 2005 and would be a 20 to 25-year event. The 4,000 CY existing debris basin provides approximately a 3-year level of service.

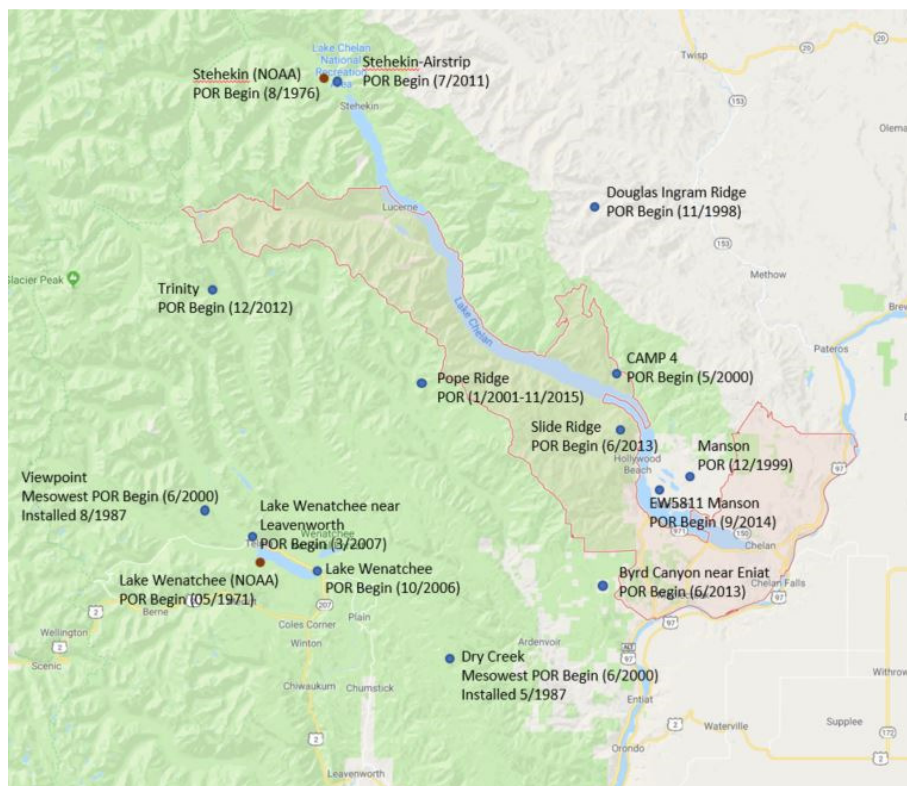
Figure 4. Rain gage locations in the vicinity of Slide Ridge site. Slide Ridge gage (center right of figure) is just north of the basin at the top of the ridge, with the best representation of rainfall. Manson gages are at lower elevations than Slide Ridge.

Rain gage records in the vicinity of Slide Ridge were analyzed to determine if a correlation exists between observed rainfall and debris flow volumes. Three nearby rain gages were selected as the likely most representative rainfall record for Slide Ridge basin. Each rain gage captures rainfall during storm events differently due to spatial variation, and thus the nearest gages were selected as shown in Figure 4: Slide Ridge (SRDW1), Camp 4 (CMFW1), and Pope Ridge (PPRW1). The rain gages also have varying record lengths and only the Camp 4 gage had recorded data as far back as the 2003 historic event.

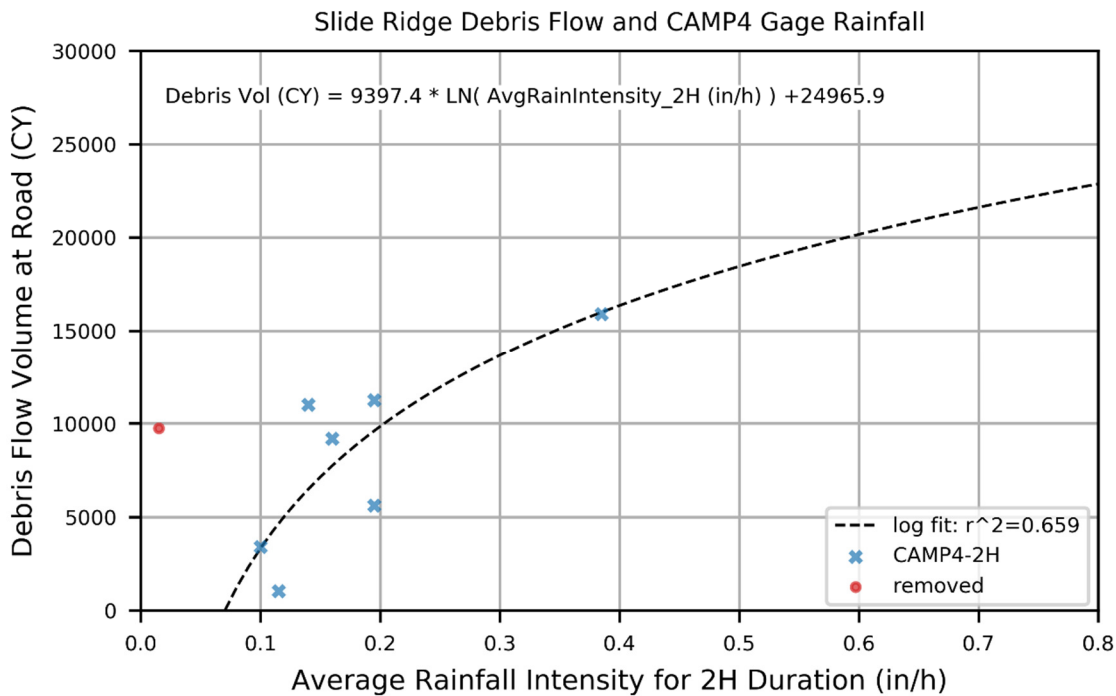
Figure 5. Regression equation for Slide Ridge debris flow volume based on Camp4 rain gage intensity (at 2 hour duration). The 2011 event did not appear to be captured by the Camp4 gage and was removed from the fit.

Statistical tests were performed to evaluate how well correlated the rainfall amounts were to the historic debris flow volumes. The tests showed the Camp 4 rain gage to provide the only statistically significant results, with the 2-hour rainfall duration showing the highest correlation (for both Spearman and Pearson tests). The Slide Ridge rain gage record is too short to develop reliable correlation, and the Pope Ridge gage was poorly correlated with the debris flow record. A regression curve was fit to the Camp 4 rain gage data for the 2-hour rainfall intensities as shown in Figure 5. The regression and threshold curves allow for predicted rainfall to be translated into an estimate of the potential for large debris flow volumes, though this has not been tested and should be viewed as approximate.

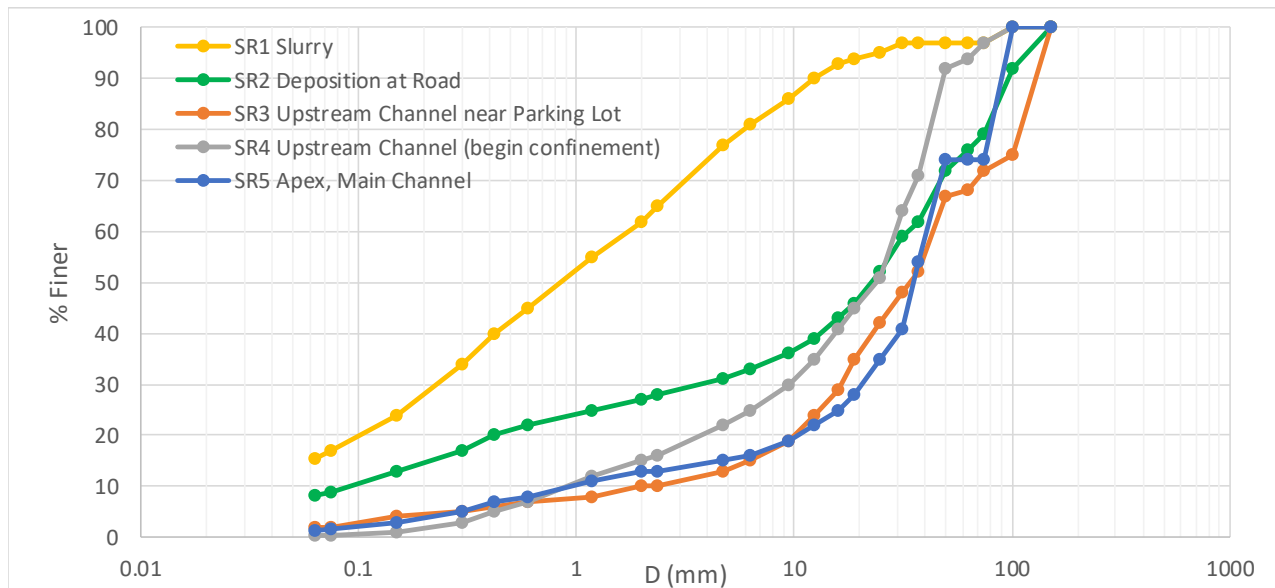
Figure 6. Grain size distributions for slide ridge samples SR1 to SR5.

- Smaller debris flow events occur and run to varying lengths. These events loosen debris in the upper basin, transport to the apex, and some may deposit debris within the flow channel and behind check dams. These small events create readily available material for large debris flow events to transport the road.
- Debris flows at Slide Ridge maintain a low water content, likely 15 to 30% water by weight during typical events.

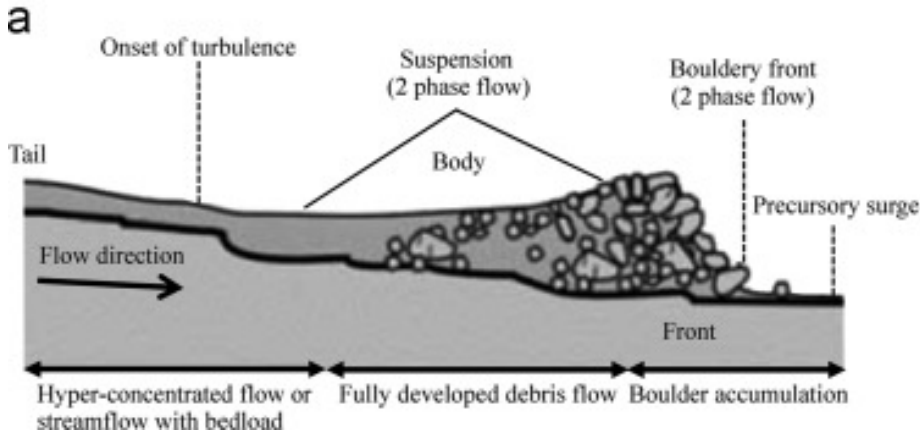
Figure 7. Diagram of typical debris flow (Pierson 1986).

Figure 7 and Figure 8 diagram a typical debris flow snout and show an actual debris flow snout. Note the accumulation of boulders in the snout and the low flow in the channel preceding the debris flow.

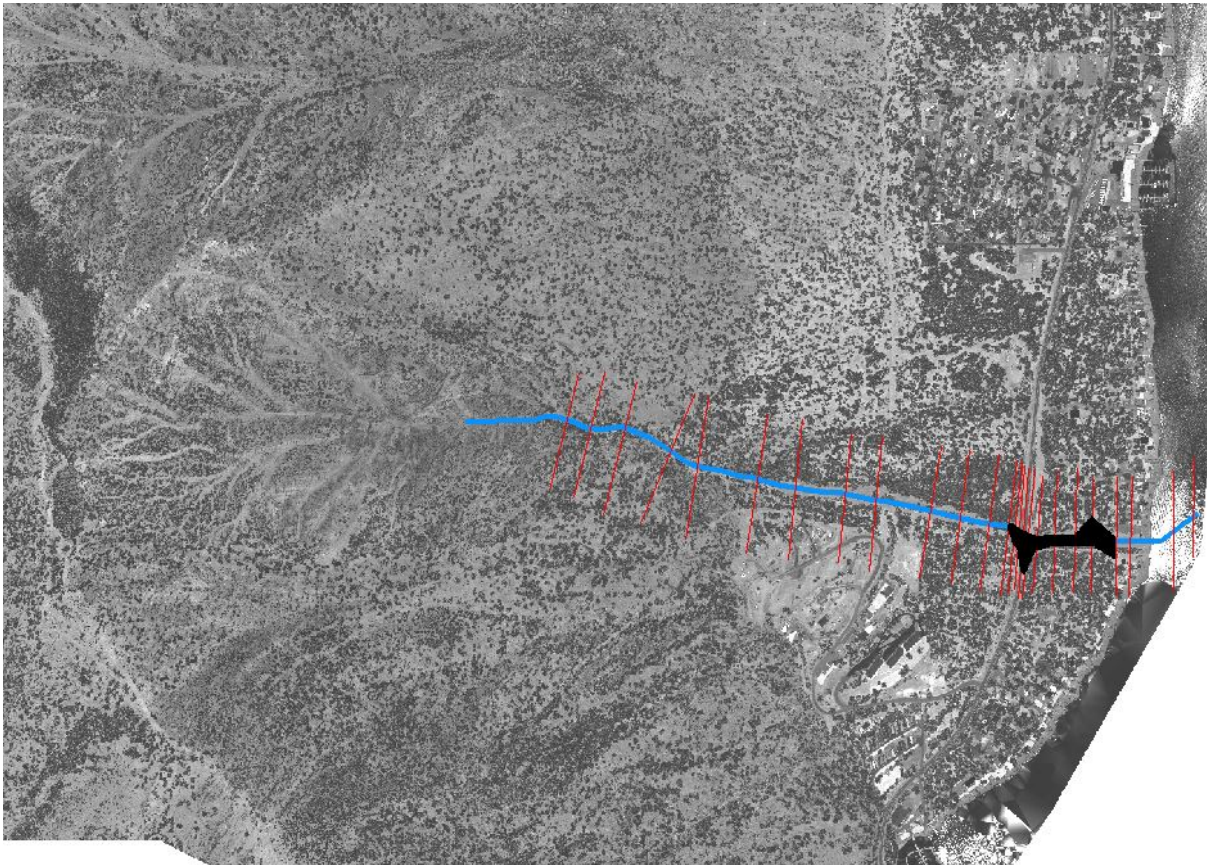
Figure 9. DFLOWZ model cross sections (red) and simulated deposition for the October 2017 event. The model predicts a large amount of deposition at the debris basin and road as occurred during the event.

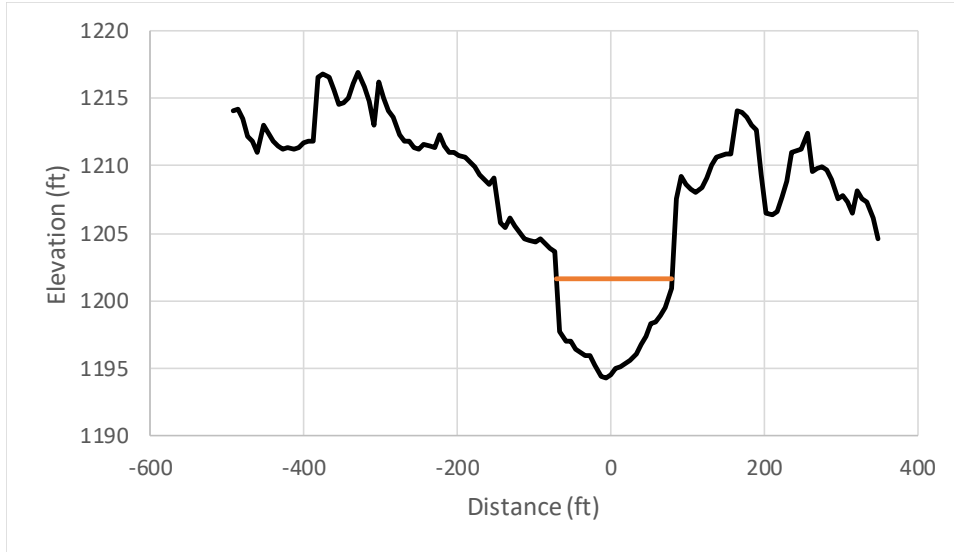
Figure 10 shows a cross section immediately upstream of the debris basin with results from the October 2017 calibration. The orange line is the depositional area predicted by the DFLOWZ model. Depositional volume was calculated from the cross sections.

Figure 10. DFLOWZ model simulated result for cross section immediately upstream of the existing debris basin for the October 2017 event.

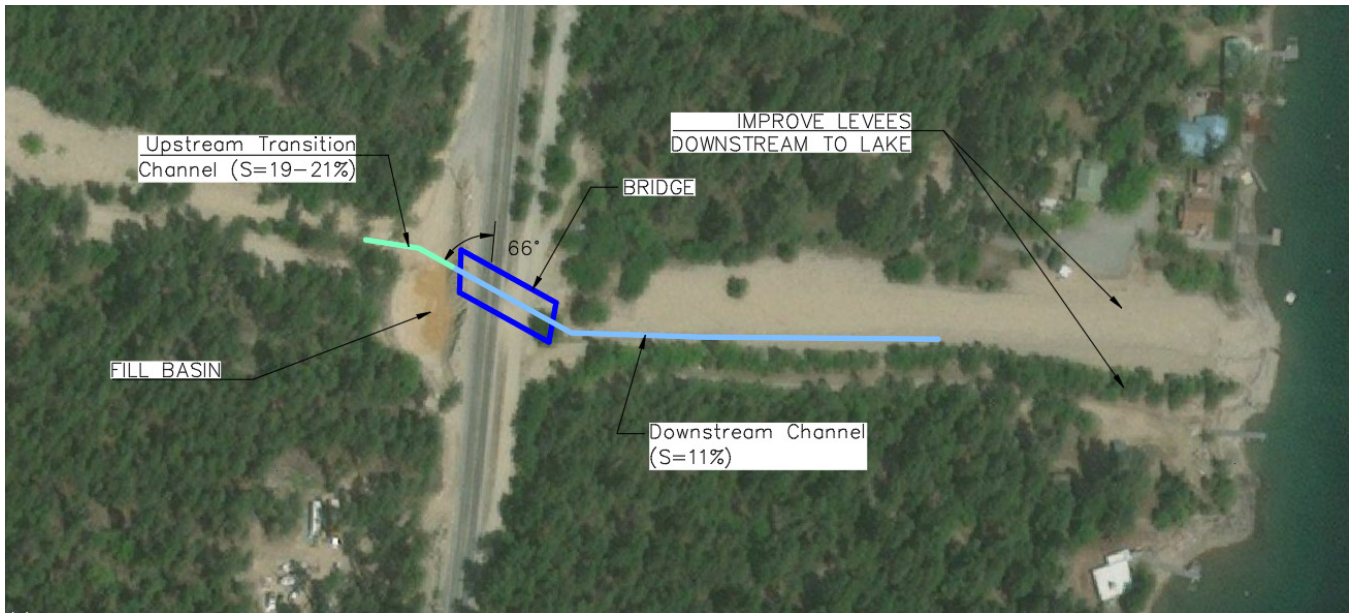
Figure 12. Conceptual layout of proposed improvements for conveyance alternative.

Excavation and maintenance will still be required with this alternative, as we anticipate that smaller debris flows may not runout to the lake and would require excavation to maintain the channel geometry. If this alternative is chosen, then the check dams should be reconsidered with a management strategy, and freeboard should be evaluated in the upstream and downstream channels.

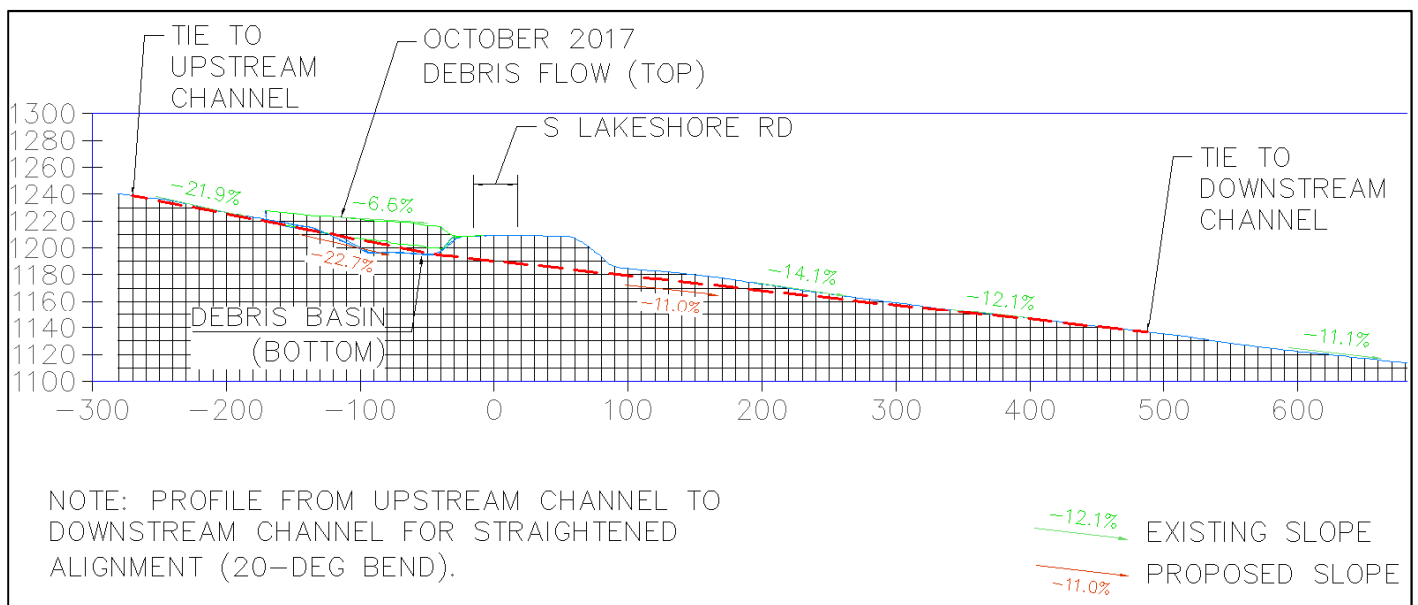
Figure 13. Profile along proposed channel alignment showing conveyance alternative. Dimensions are feet.

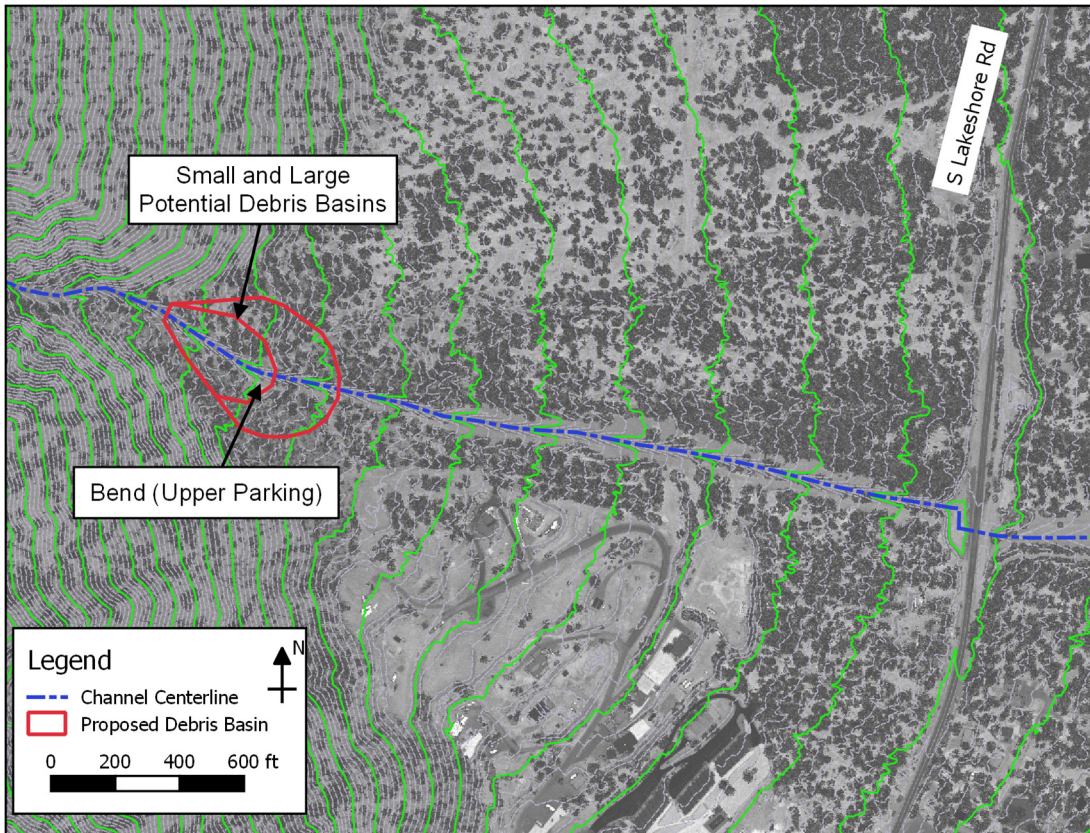
Figure 15. Conceptual Layout of Proposed Improvements for Conveyance Alternative.

A large debris basin could be constructed near the upstream end of the conveyance channel. Just below the apex where this would be located is a typical management strategy as it allows debris flows to be captured from a known location, without relying on the conveyance channel to contain all events. This location was previously proposed in the 1993 EIS. Figure 15 shows the approximate location with two potential sized basins. The basin would need a large footprint to contain the debris flows given the steep slopes in the area. Alternatively, a series of smaller basins could be used. The slopes of the fan are 20-30% in this area and that steepness relative to the top angle of the deposited debris flow results in the large area requirement. Debris breakers come in many forms and could be applied either within a single basin, or at the outlet of a series of basins.

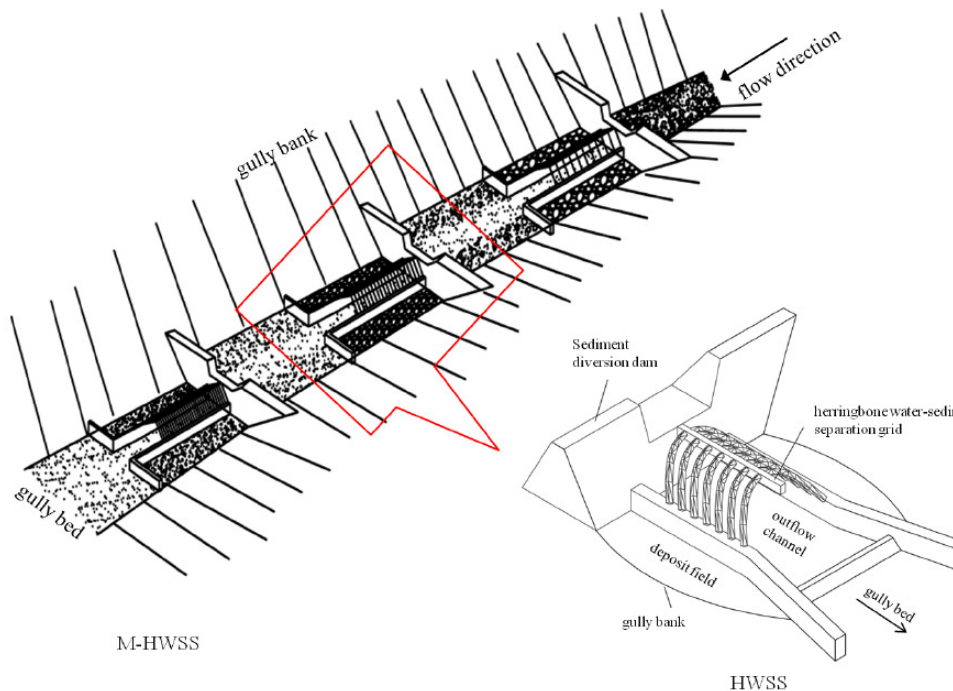
Figure 16. Conceptual water sediment separation system, from Xie et al (2016).

As an alternative to retaining all the debris during an event, systems have been designed that capture only the largest particles allowing the remaining debris flow to have increased water and sand content. This results in longer runout distances for the remaining debris flow. The herringbone style debris breaker shown in Figure 16 could be placed in the upstream channel or at the existing basin and would extract and retain only the larger portion of the particles in the debris flow. A rough estimate is that about 4,000 CY of 1-ft or larger material would reach the road during a 100-year event. If that was extracted and retained, and coupled with a new road crossing, the remaining debris would be much more likely to be conveyed to the lake. This alternative should be considered as fairly experimental, however is promising and could be incorporated with other alternatives to increase performance.

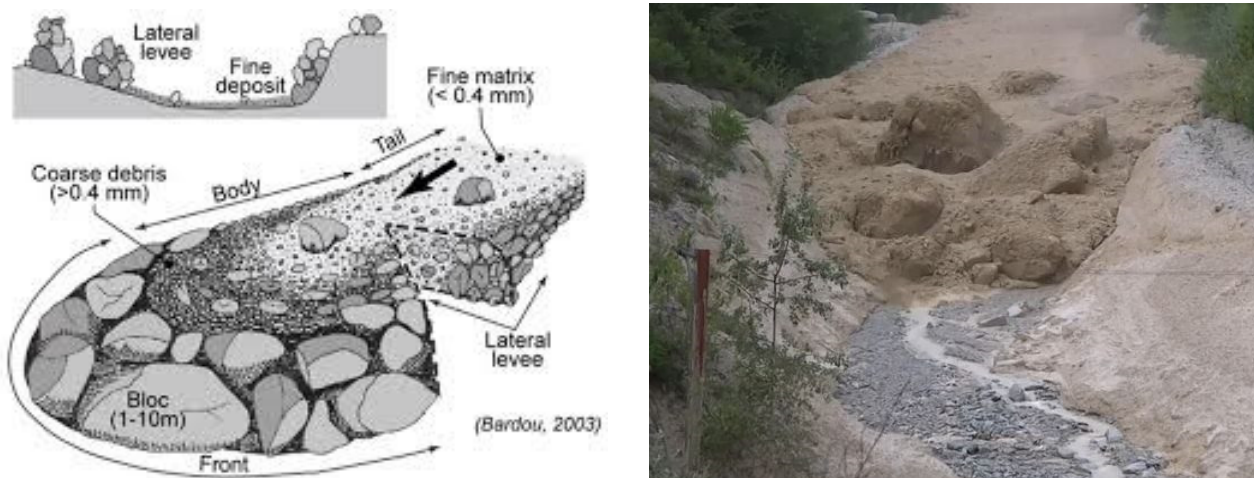
While the likelihood of boulders impacting the bridge is low, the size and velocity of boulders during a debris flow could result in substantial damage if impacting a typical bridge. We recommend the bridge design consider some form of impact protection at the upstream low chord.

Figure 17. Debris flow schematic (left, Bardou 2003) and image (right, Petley 2016) showing boulder location at snout.

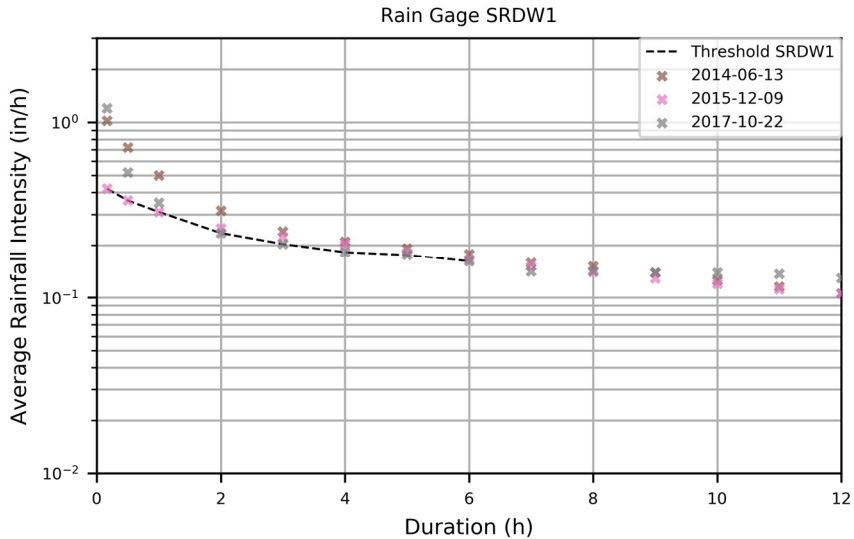
Figure A1. Duration plot of debris flow events for Slide Ridge rain gage.

Rainfall durations from 10-minutes to 12 hours are plotted in figures below. Figures A1 to A3 are colored by event. Figure A4 combines all the results to a single plot for comparison.

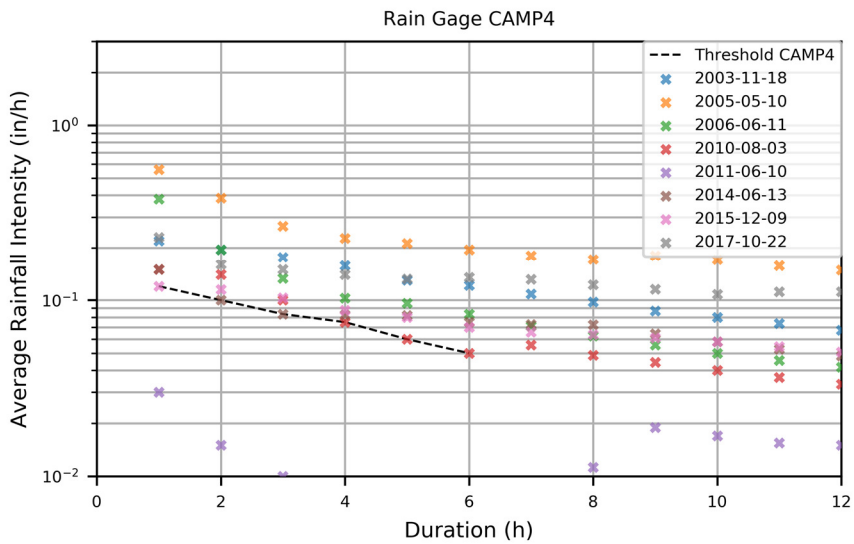
Figure A2. Duration plot of debris flow events for Camp4 rain gage. 2011 event was not captured well, and may have been a more localized thunderstorm, thus it was removed from determining the threshold.

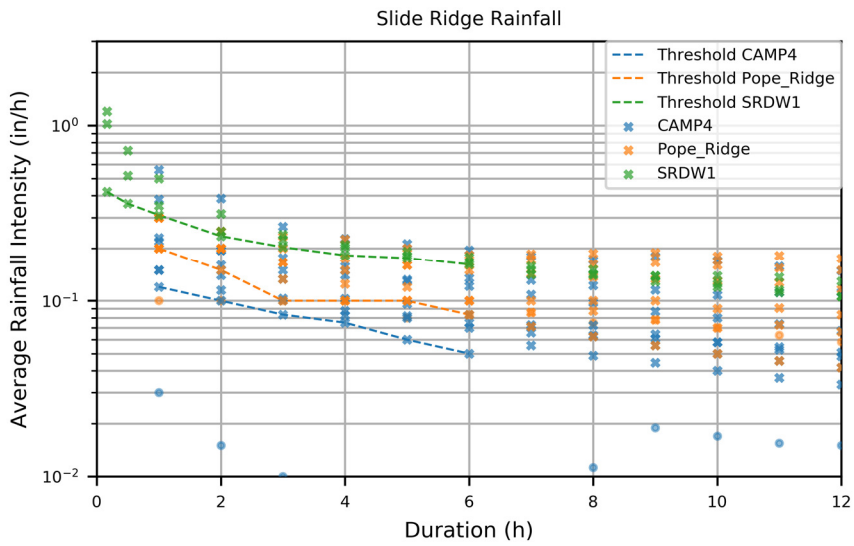
Figure A4. Duration plot of debris flow events for all 3 rain gages. Each 'x' represents a historic event at a given duration, while the 2011 Camp4 event is excluded and shown as 'o'. The calculated minimum rainfall thresholds for each gage are shown as dashed lines.

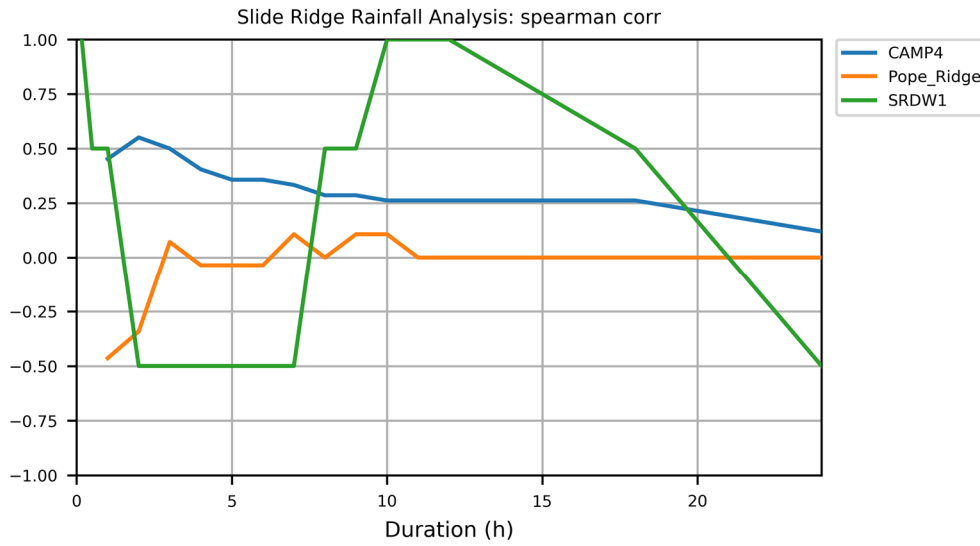
Figure A5. Spearman Correlation plot of Slide Ridge rain gage analysis. Spearman correlation values closer to 1 or -1 indicate stronger correlations. Camp4 gage is best correlated at 2-hour duration. Pearson correlation showed similar results. Slide Ridge gage doesn't have a long enough record for reliable statistics.

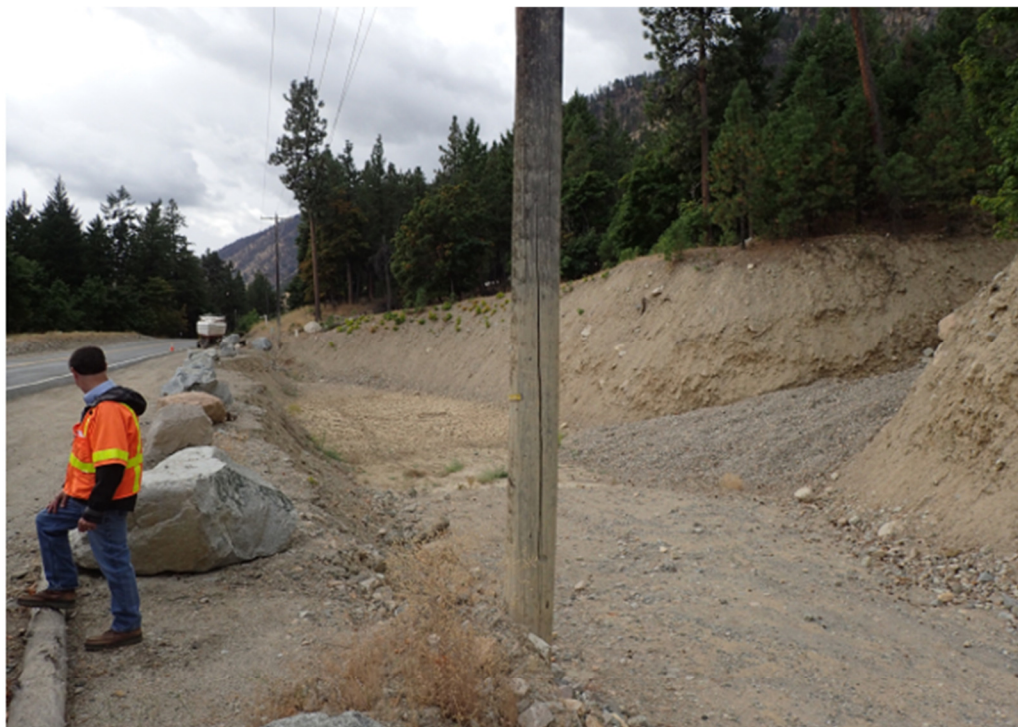
Pre October 2017 event. Notice the small debris flow that had previously reached the basin.

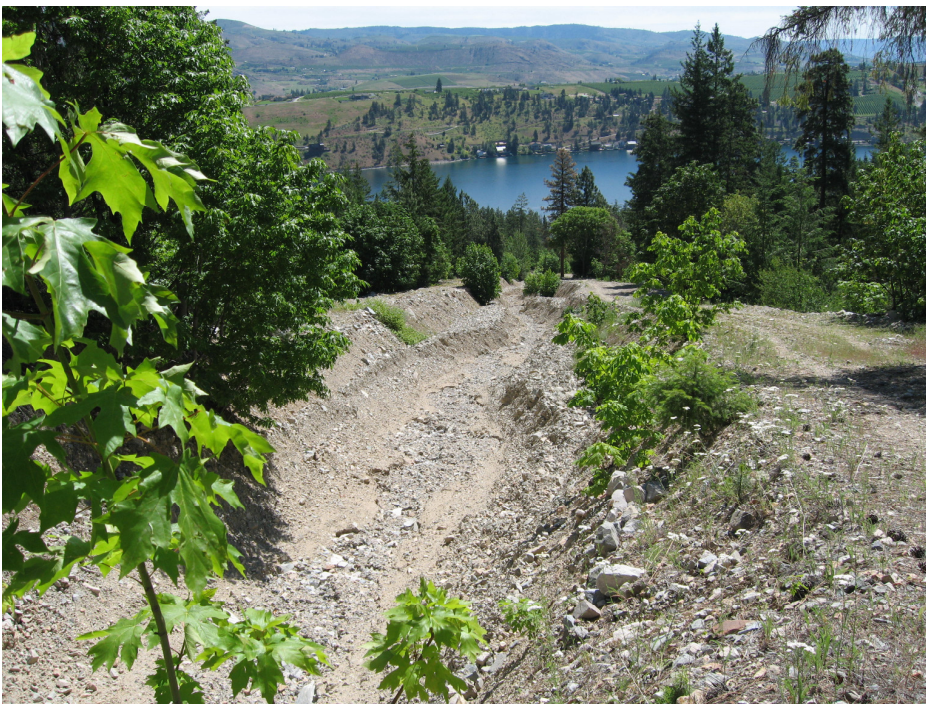
June 14, 2010 photo showing multiple debris flows with storage in upper channel. Taken about mid-way upstream from road to channel bend.

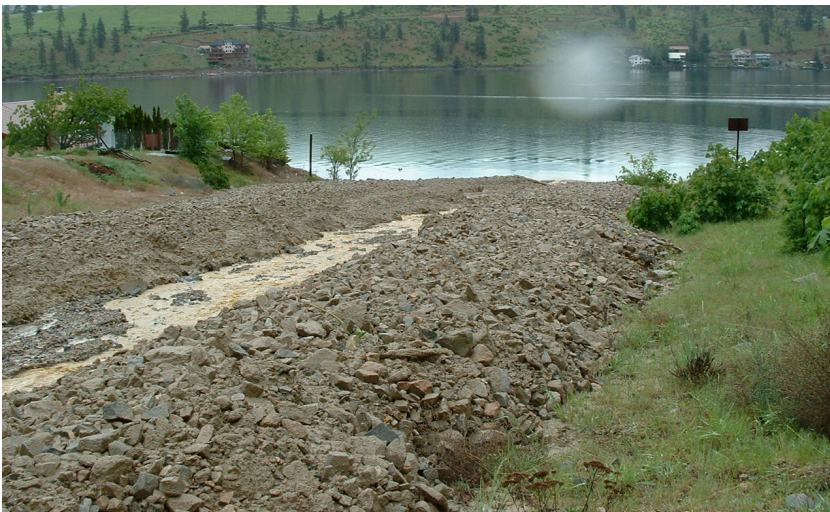
May 10, 2005 is the largest event in last 15 years. Debris flow ran all the way to the lake in the downstream channel.

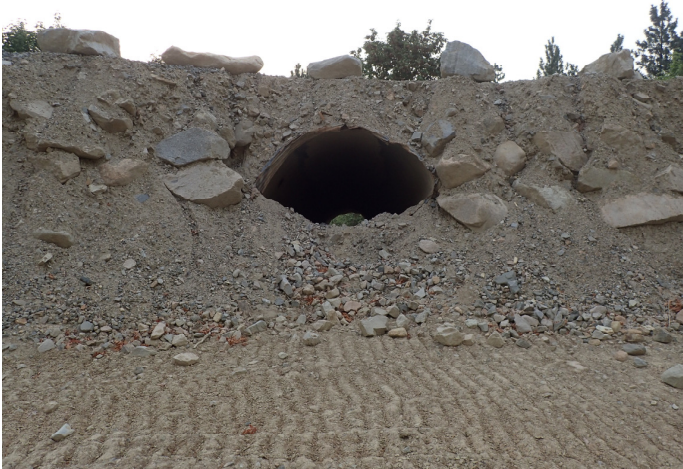
2018 August, looking at inlet of primary culvert from debris basin.

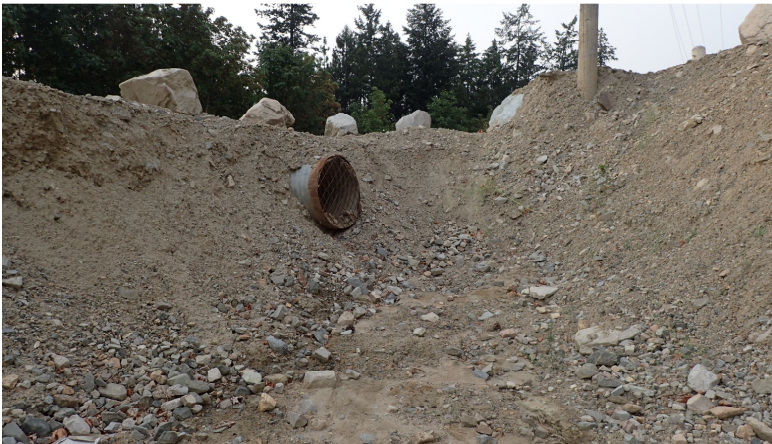
2018 August, viewing south to the 48" overflow culvert at the south end of the debris basin.

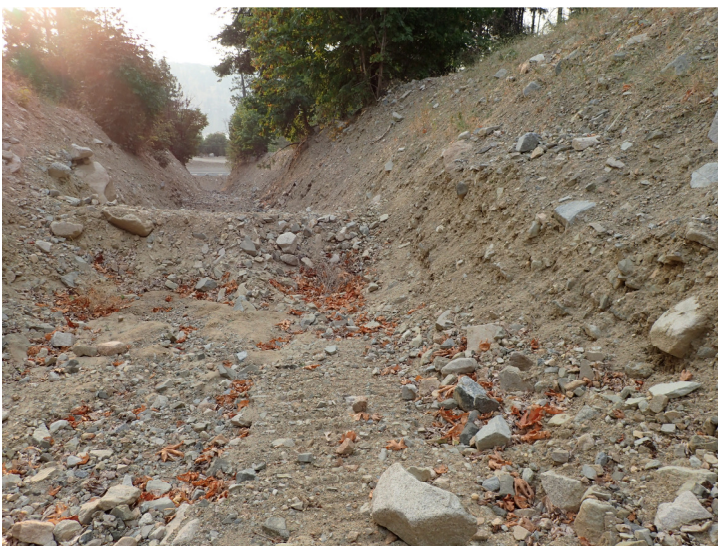
2018 August, viewing downstream at a check dam. Typical channel conditions for post-maintenance, prior to and debris deposition.
