Lower Icicle Creek Reach Level Assessment

Prepared for:

Icicle Valley Chapter of Trout Unlimited
8158 East Leavenworth Road
Leavenworth, WA 98826

26 January 2005

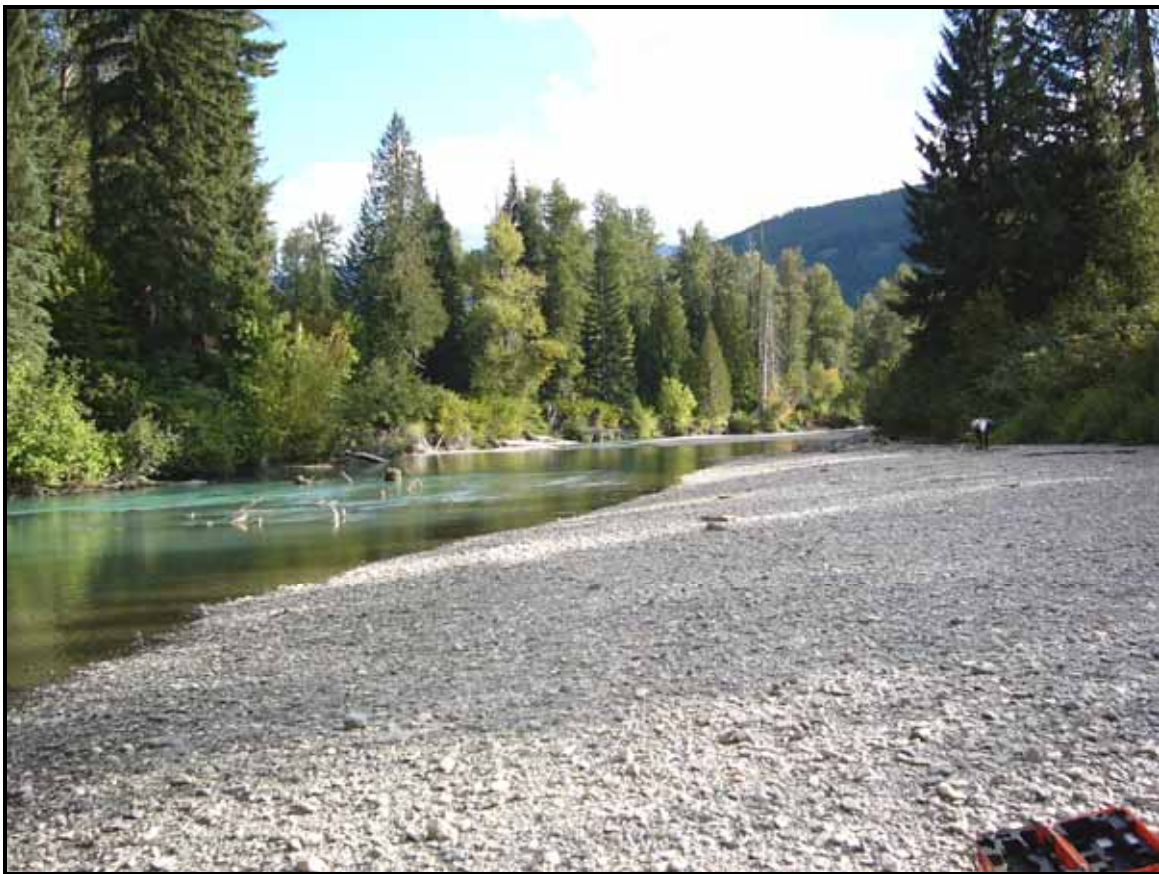
Figure 11. White Upper, looking downstream.

with some mid-channel bars. In other words, the only difference in deposition pattern relates to how well the side- or mid-channel bars connect to the banks, which is a matter of degree. Both patterns generally indicate excess sediment. Bank stability at CS1 was rated higher than at the reference reach, indicating more stable banks at CS1 than at White Upper. However, the BEHI results were somewhat contradictory, indicating the erosion hazard at CS1 is higher than at White Upper. Figures 11 and 12 are photographs of Icicle CS1 and White Upper cross-sections.

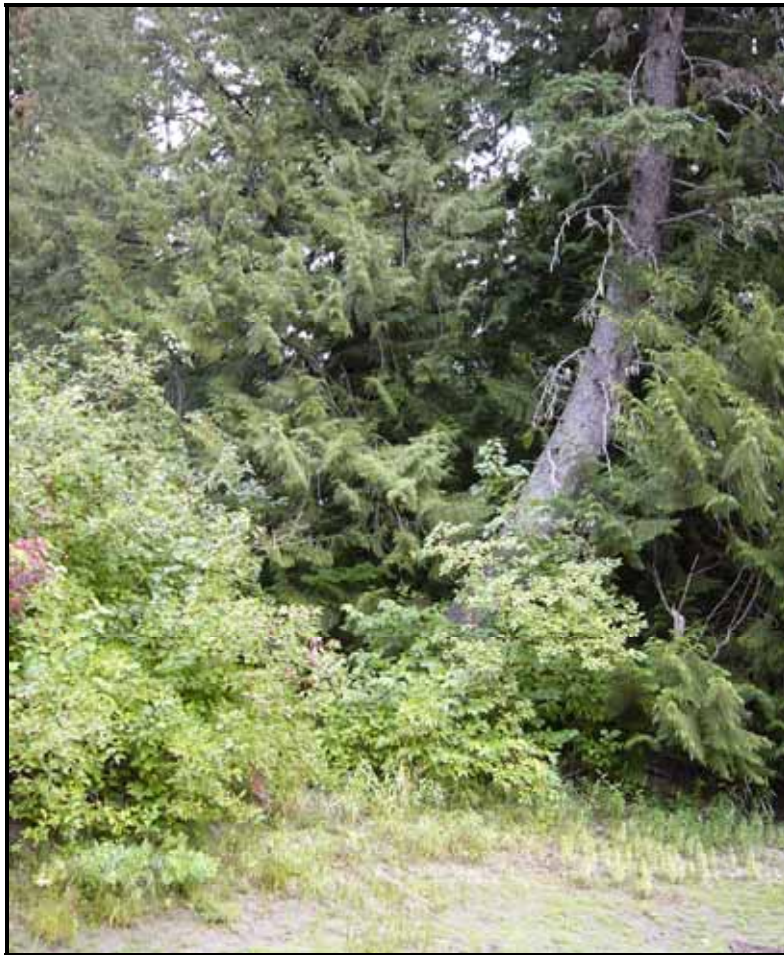
Figure 18. Lower White, vegetation on left (looking downstream) bank.

Figures 18 and 19 are photographs of White Lower and Icicle CS4 cross-sections.
