GNN Project No.: 217-854

Subject: MEMO: Review of Revised Expansion Plans
Proposed Mission Ridge Ski Resort Expansion Project
Chelan County, Washington

RECONNAISSANCE-LEVEL EVALUATION OF GEOLOGIC HAZARDS REPORT

**PROPOSED MISSION RIDGE SKI RESORT EXPANSION PROJECT
THE VILLAGE AT MISSION RIDGE
CHELAN COUNTY, WASHINGTON**

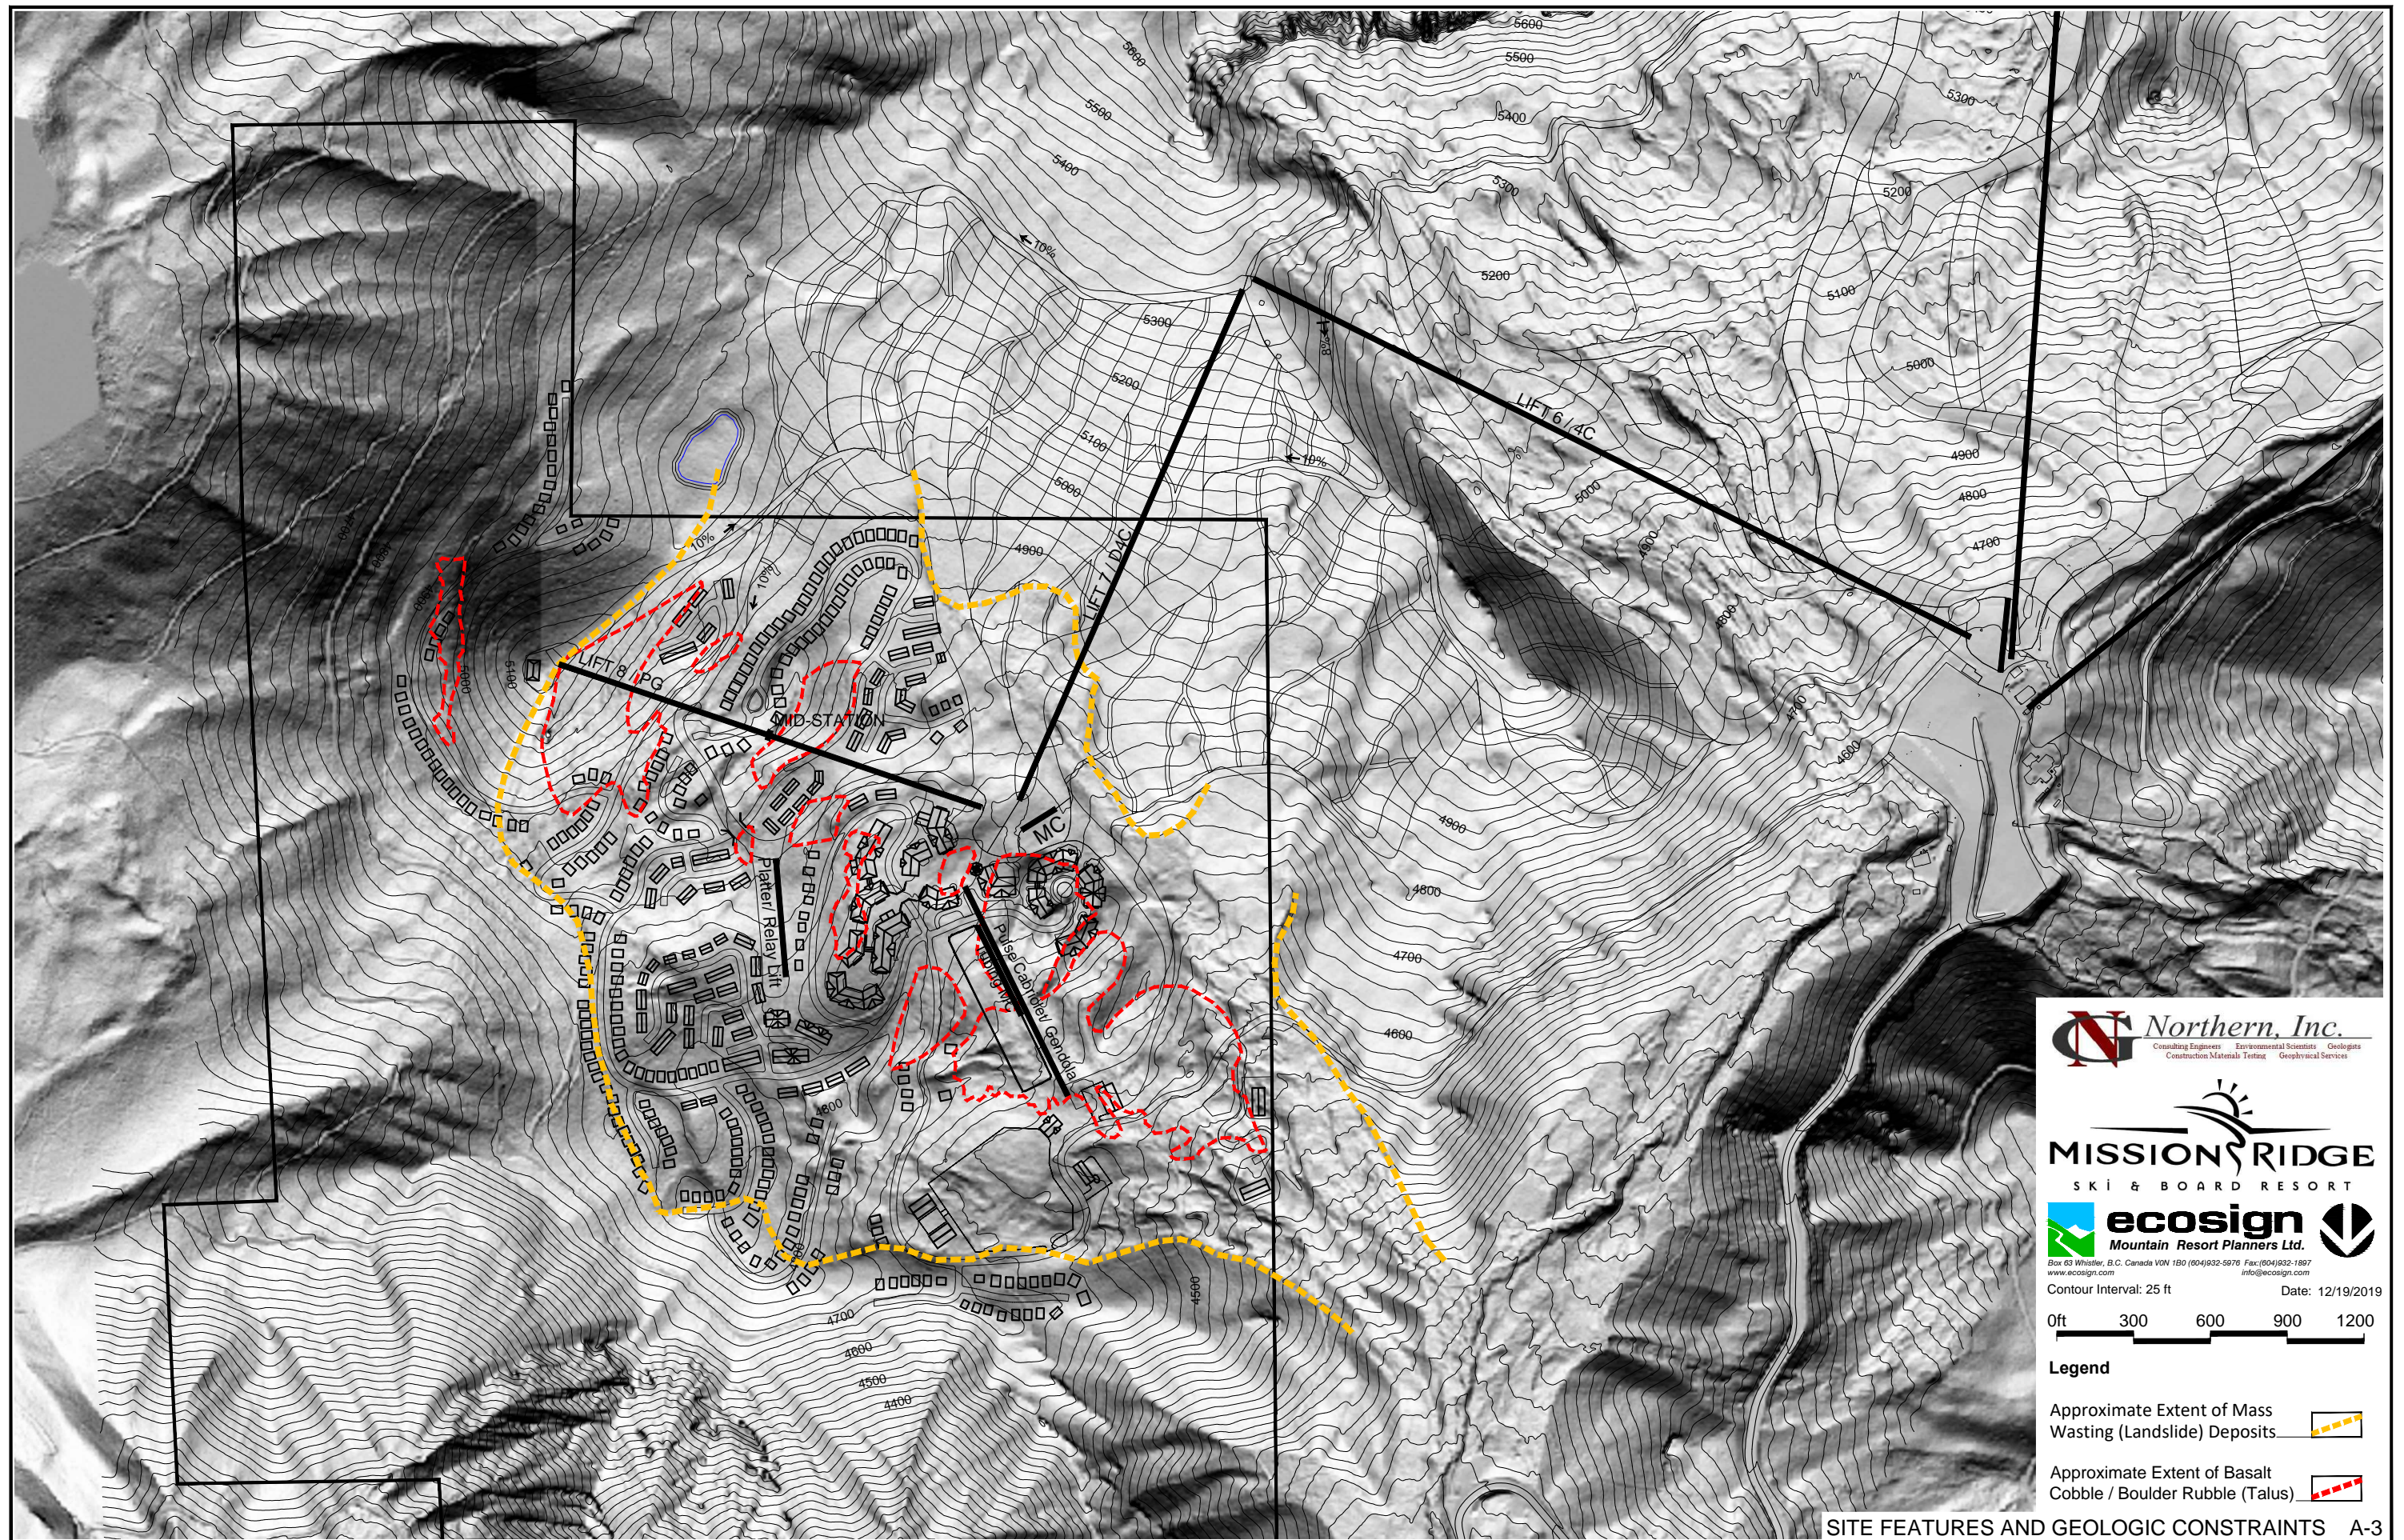
Attachment: Site Features and Geologic Constraints (A-3)

The attached *Site Features and Geologic Constraints* map shows revised reconnaissance-level boundaries of the noted mass wasting and talus deposits based on a site-specific digital elevation model (DEM) surface not available at the time of the referenced report. Therefore, the attached map supersedes Figure No. 2 of the referenced report.

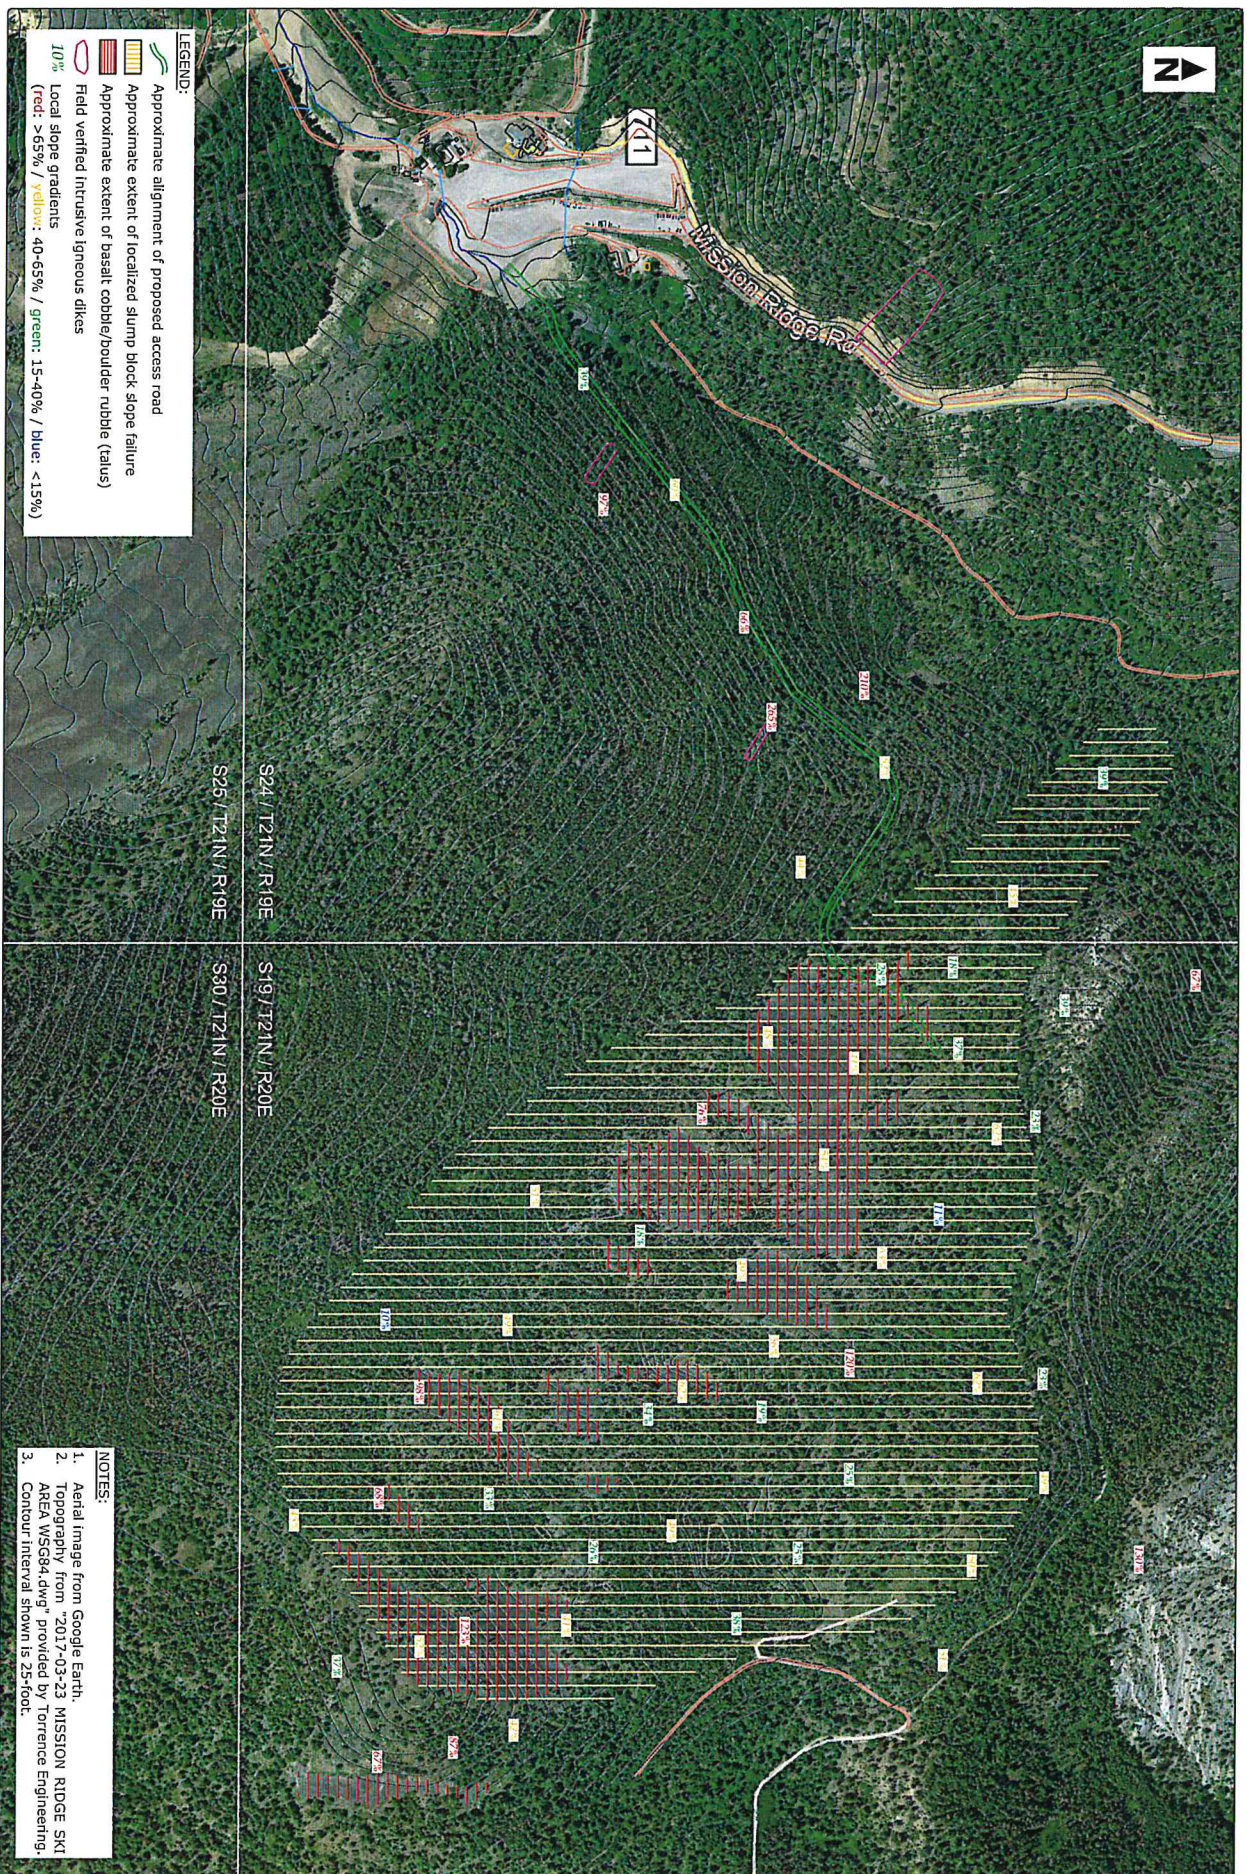
The ±140-acre site of the proposed Village at Mission Ridge expansion project is located southwest of the City of Wenatchee in Chelan County, Washington. The entire subject site is mapped within areas defined by Chelan County as Geologically Hazardous Areas due to the risk from landslides and erosion hazards (see Figures 4 & 5).

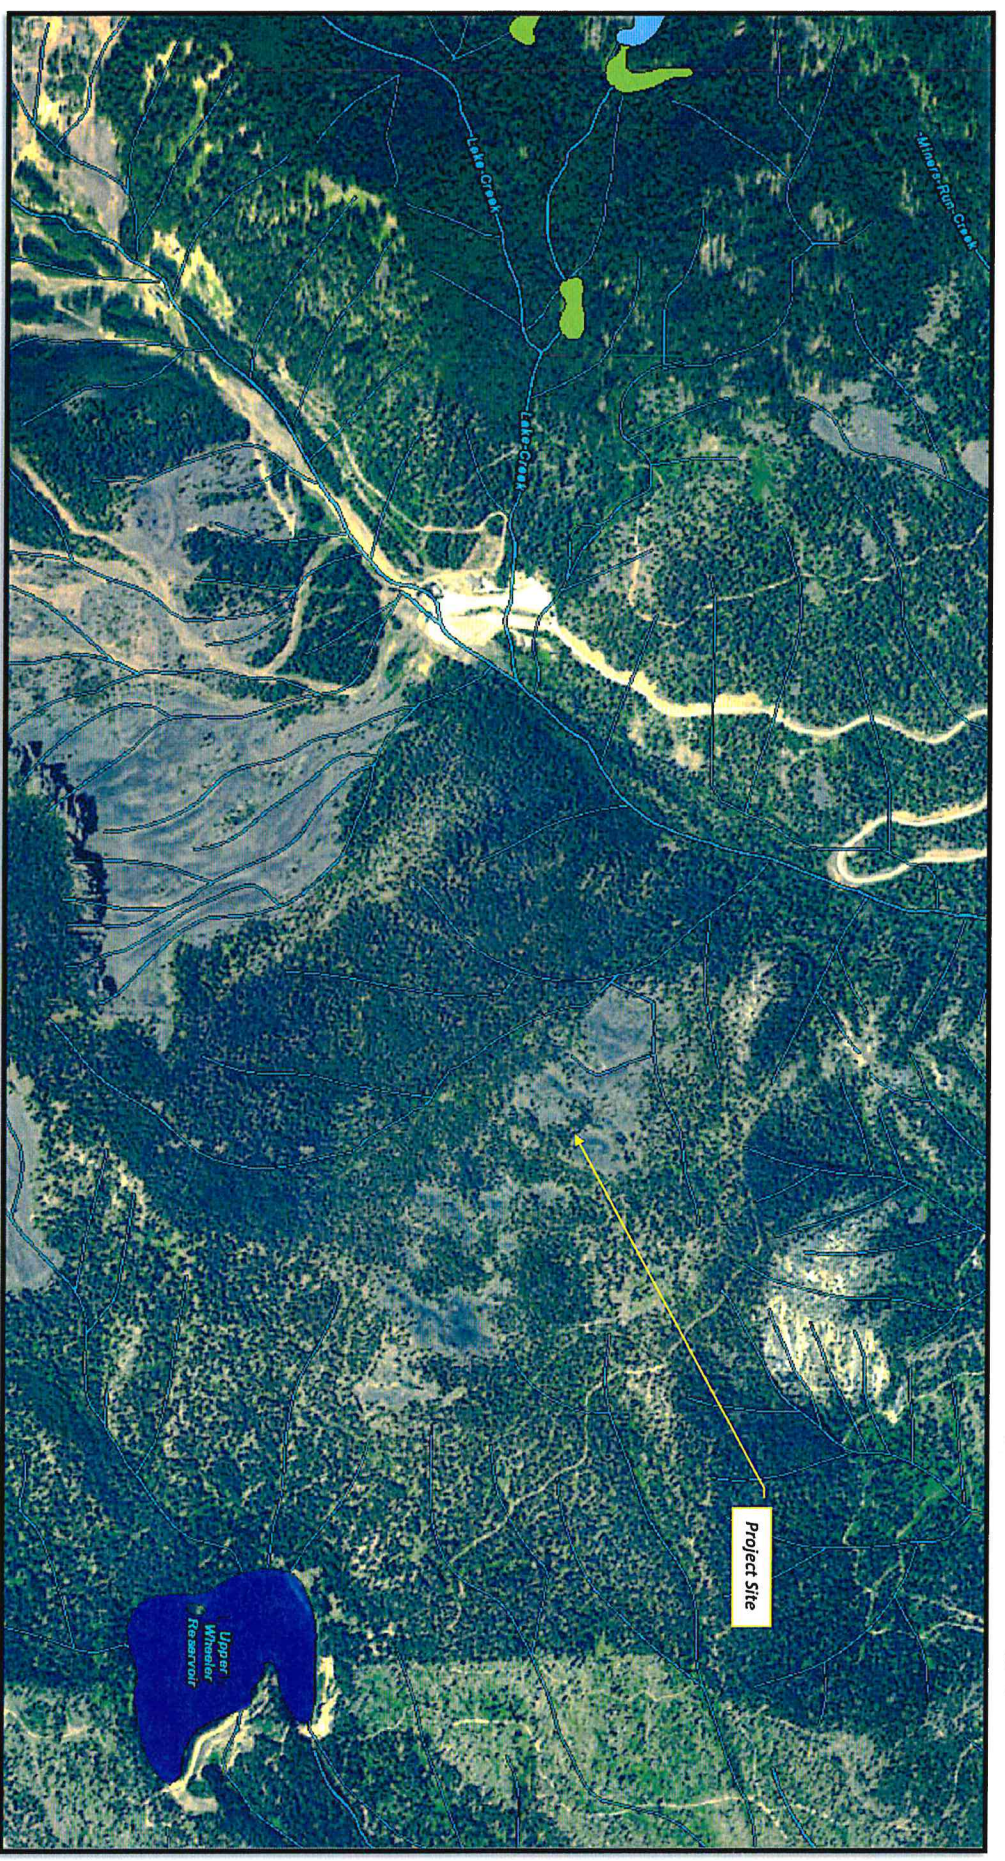
U.S. FISH & WILDLIFE – NATIONAL WETLANDS INVENTORY MAP (FIGURE 6)
Village at Mission Ridge
Chelan County, Washington

A number of smaller unnamed drainages/intermittent-streams are mapped across the project site (see Figure 6), however the watershed area associated with the noted drainages is relatively small. While no indications of onsite seeps or springs were observed during our site reconnaissance,
