Wenatchee River Whitewater Park Feasibility Study Chelan County, Washington

PREPARED FOR: Chelan County Natural Resource Department 411 Washington St. Suite 201, Wenatchee, WA 98801

Mason Lacy, PE and Mike Harvey Recreation Engineering & Planning Inc. 485 Arapahoe Ave, Boulder, CO 80302

DATE: August 3, 2021

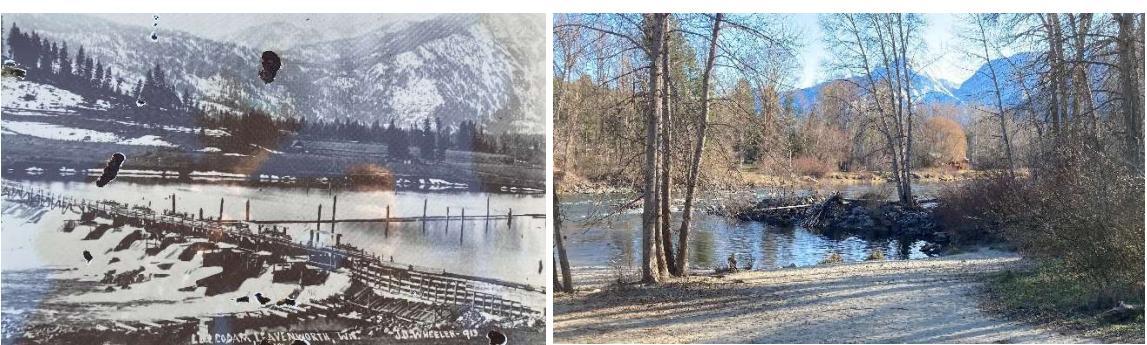
Figure 15. The remaining riprap dam can be clearly seen today on the river left bank (right photo). A historic photo of the dam from the same vantage point is shown in the left photo. *Left image source: Wenatchee National Forest*

REP engineers measured approximately 2ft of hydraulic drop across the dam structure during the site visit (flow of 2,400cfs at the Peshastin gage). This was estimated from upstream of the dam to the pool downstream of Barn Beach using a hand level. The amount of hydraulic drop at a site is affected by constrictions upstream and downstream, and will change with the amount of flow in the river. From the LWRA bathymetric LiDAR data, it was estimated the riverbed drops between 2ft to 4ft from upstream of the dam to the downstream controlling section.

Most high-performance whitewater features require 1.5 to 2ft of drop. Possible instream improvements could include deflectors, boulders and other elements to create eddies and more hydraulic complexity. Based on our field measurements, we estimate up to one high-performance feature could be created, with possibly an additional beginner feature that could also provide downstream tailwater control. Additional hydraulic measurements and modeling would be necessary during the design phase to confirm the amount of drop available at a variety of flows.

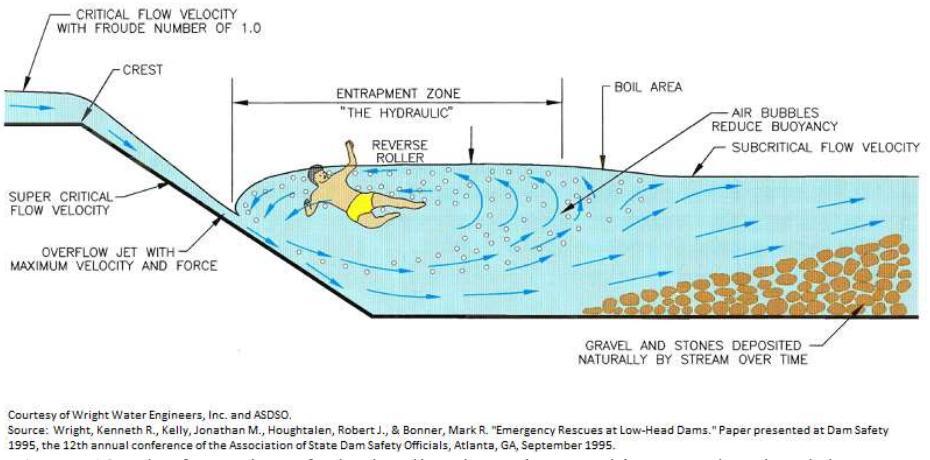
Figure 18. The formation of a hydraulic "drowning machine" at a low head dam. *Source: Wright Water Engineers*

The hydraulic formed at the Dryden Dam is a classic low-head dam hydraulic scenario. The American Whitewater description of the run calls the hydraulic "a guaranteed drowning machine". There has been at least one documented drowning at the site, and unfortunately it is rarely documented whether a drowning was associated with a dam. The documented case occurred in 2016, and the American Whitewater accident description is attached to this report. The victim was on a commercial raft trip and wearing a PFD.

Without a change in the right bank broodstock collection facility, recreational improvements can still be made to the weir. At a minimum, safety improvements should be considered to address the public safety hazard. REP has designed many similar dam safety retrofits, and are confident that the weir could be modified to allow safe downstream passage by rafts and other river users, while still maintaining at the existing uses of the dam including attraction flow for the fishway, diversion of water for irrigation,

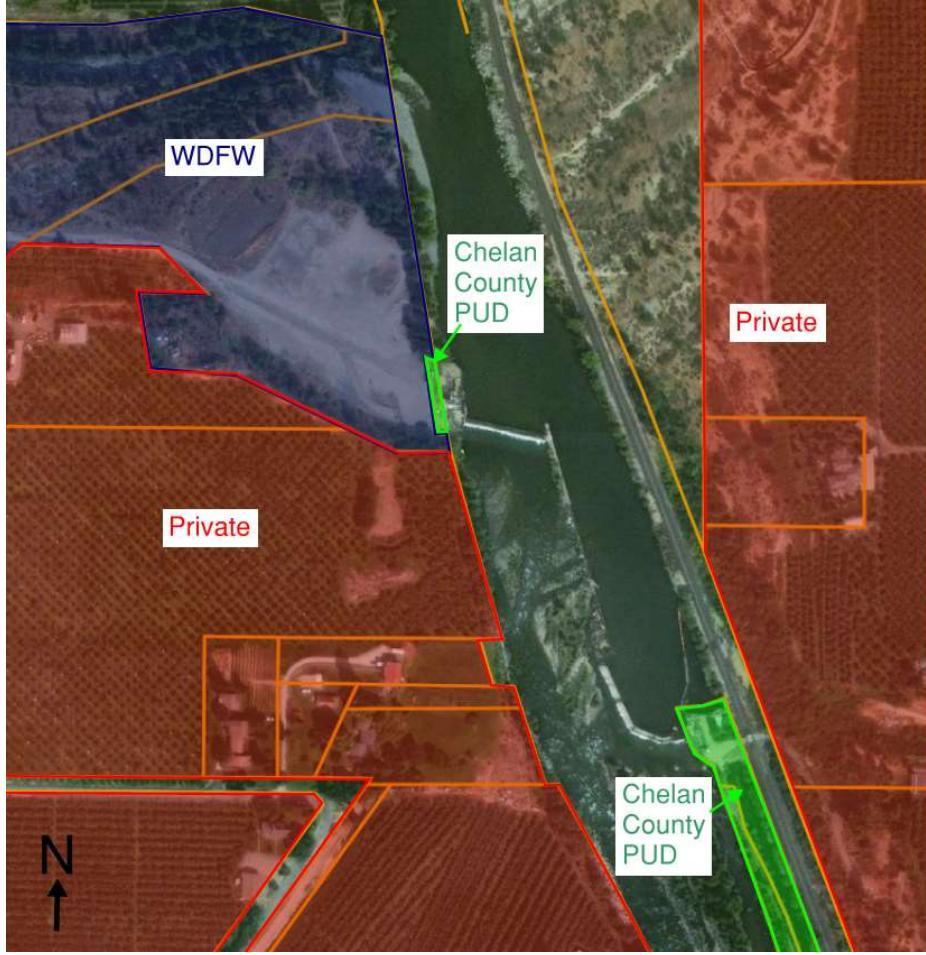
The only public access at the site is on the property owned by WDFW. Any improvements designed with bank access in mind, such as "park and play" whitewater features, would need to extend upstream from the existing dam to avoid access issues on the private land immediately downstream. Alternatively, if a portion of the riverside private property could be purchased or a public access easement obtained, some improvements could extend downstream.

Figure 21. Land ownership at the Dryden Dam site.

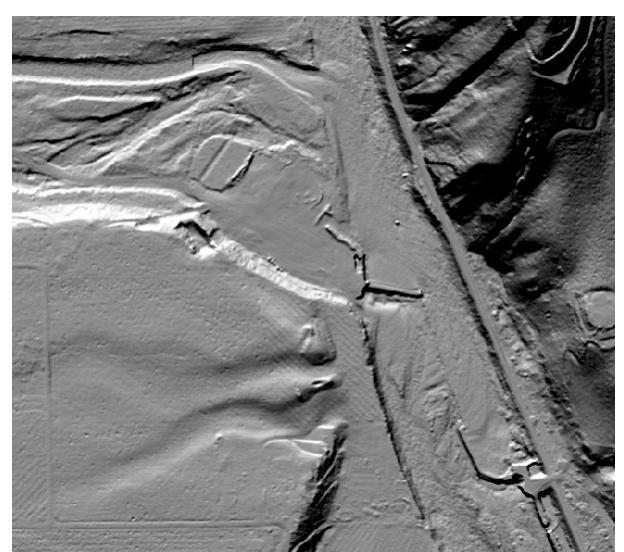
Figure 22. Dryden Dam and Peshastin Creek upstream can be seen in the hillshade from the LWRA LiDAR data.

There is sufficient hydraulic drop at the dam for a whitewater park, and the gradient picks up downstream of the dam. The channel is locked in by the dam and railroad, without signs of significant recent deposition or erosion.

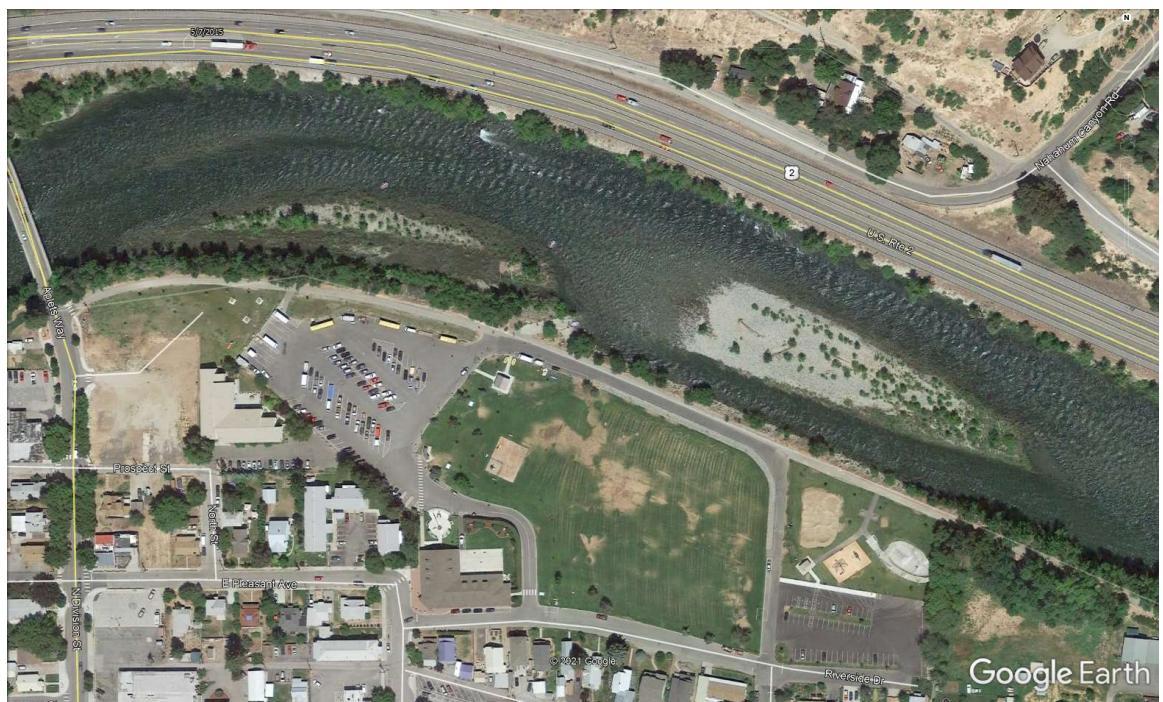
Figure 25. An aerial view of Cashmere Riverfront Park and the Wenatchee River. *Image source: Google Earth, image date 7/1/2017*

There is hydraulic gradient at the site, extensive public property bounding the river right bank, and developed park infrastructure including parking, restrooms, and a boat ramp. The site is located adjacent to downtown Cashmere, making this site intriguing for locals as well as for drawing more visitors into the downtown community. Estimated from the LWRA bathymetric LiDAR, the riverbed drops between 3ft-5ft across the length of the park.

However, the location of the site on a large bend in the river makes a whitewater park located along the right bank of the river nearly impossible. The thalweg is located along the left bank as the current flows around the outside of the bend, and significant deposition occurs at a large point bar adjacent to the park. This has caused issues with use of the boat ramp at low flows, as access to the ramp dries up with the water concentrated along the left bank. The area has been dredged previously to help mitigate the issue, but sediment deposits again along the right bank during high flows.
