Table 6: Potential Project Areas Identified by the Nason Roads Assessment

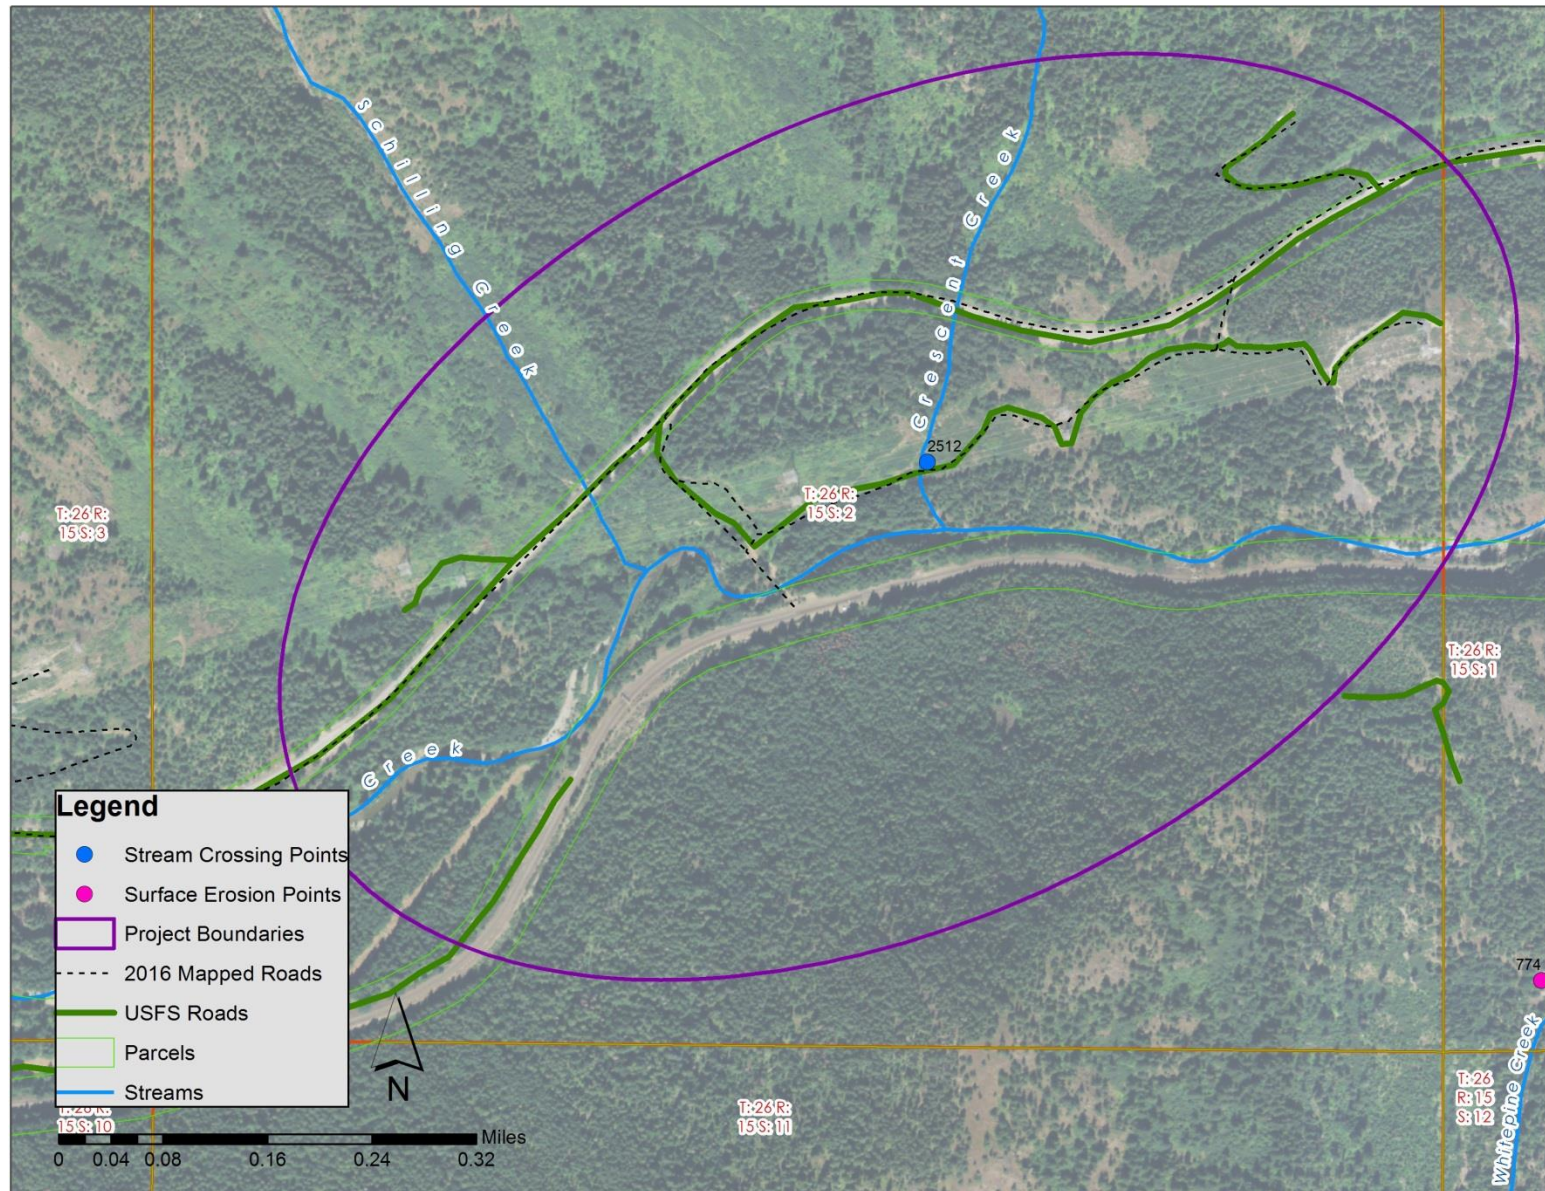
Project 23: Location of Project Area 23 overlaid on 2013 aerial photo. No field data was collected here, however, it was included as a project area due to modeling results
