Re: Mission Ridge Hydrogeology for Plan Revision

MEMORANDUM

To: Mr. Larry Scrivanich PO Box 2174 Woodenville, WA 98072
 From: Gene St.Godard, P.G., L.Hg., CWRE Water & Natural Resource Group, INC. Spokane, WA
 Date: March 26th, 2018
 Re: Mission Ridge Expansion Preliminary Hydro Review Project No: 077-001 – Mission Ridge

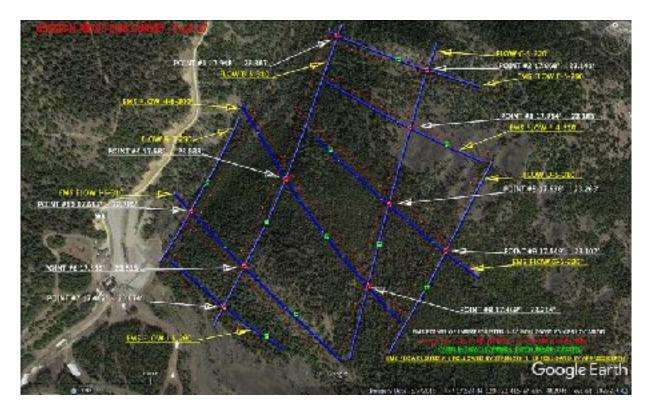
West Area

The EMS results are listed below. The blue flow lines indicate good signals which could hold the potential for water. The red flows indicate very little likelihood of containing significant water. The blue crossing points of the lines were of extreme interest as they are most likely to contain the largest volumes of water.

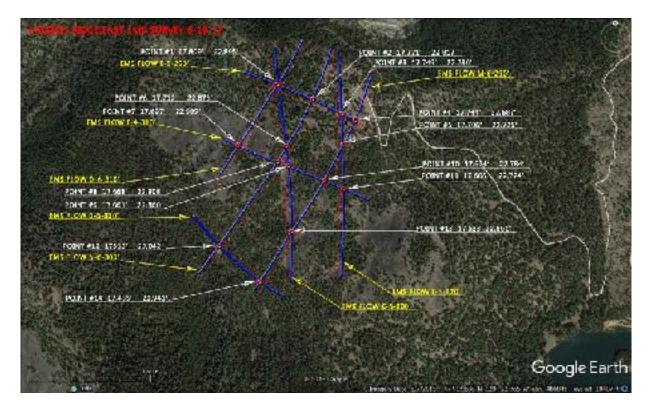
The EMS and VLF were in total agreement and the points determined to be the most likely to produce the best water were at points #4, #5, #6 from the East Area. We anticipate a maximum drilling depth at this point of about 450 feet*.

We recommend drilling at points #4, #5, #6 in the East Area to a depth of 450 feet*. The drilling order should be point #4 (Due to the strong flow of M-6 and the additional fracturing in that area), #6 (Due to Very Good signals in that area), then #5 (Due to the Very Good signals) in the East Area.
