# Historic Property Report

Resource Name: Monitor Bridge

Property ID: 1465

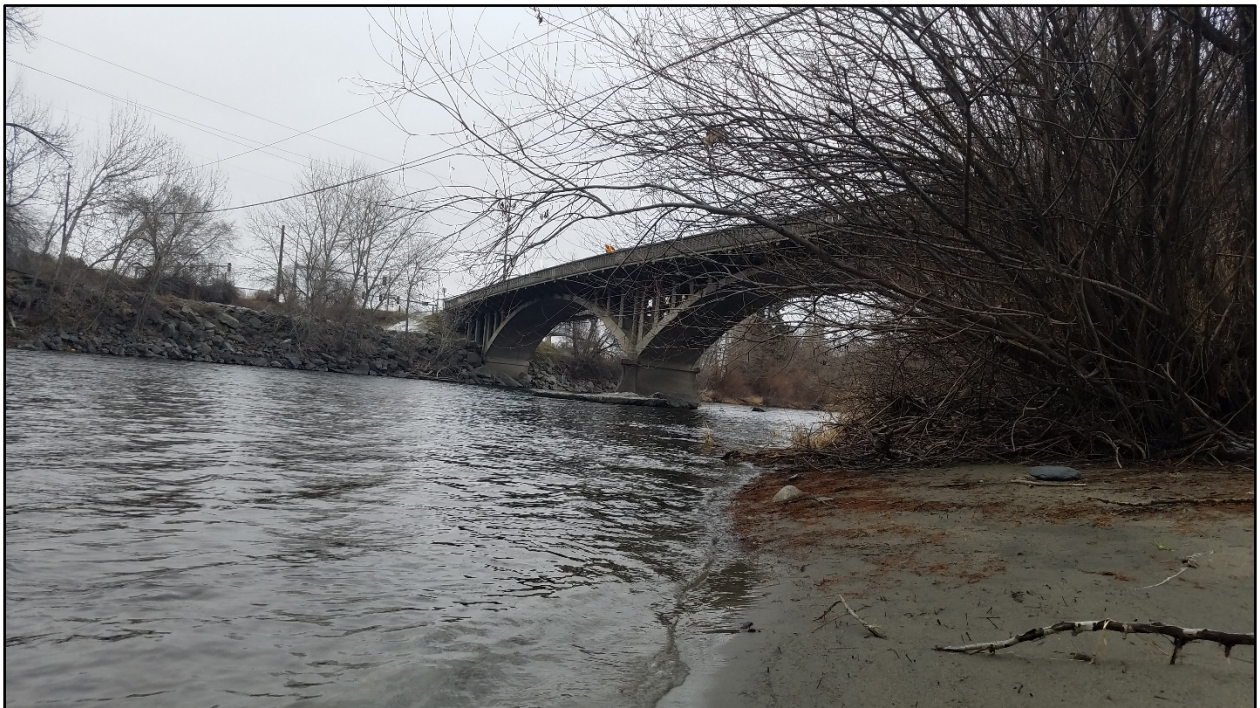
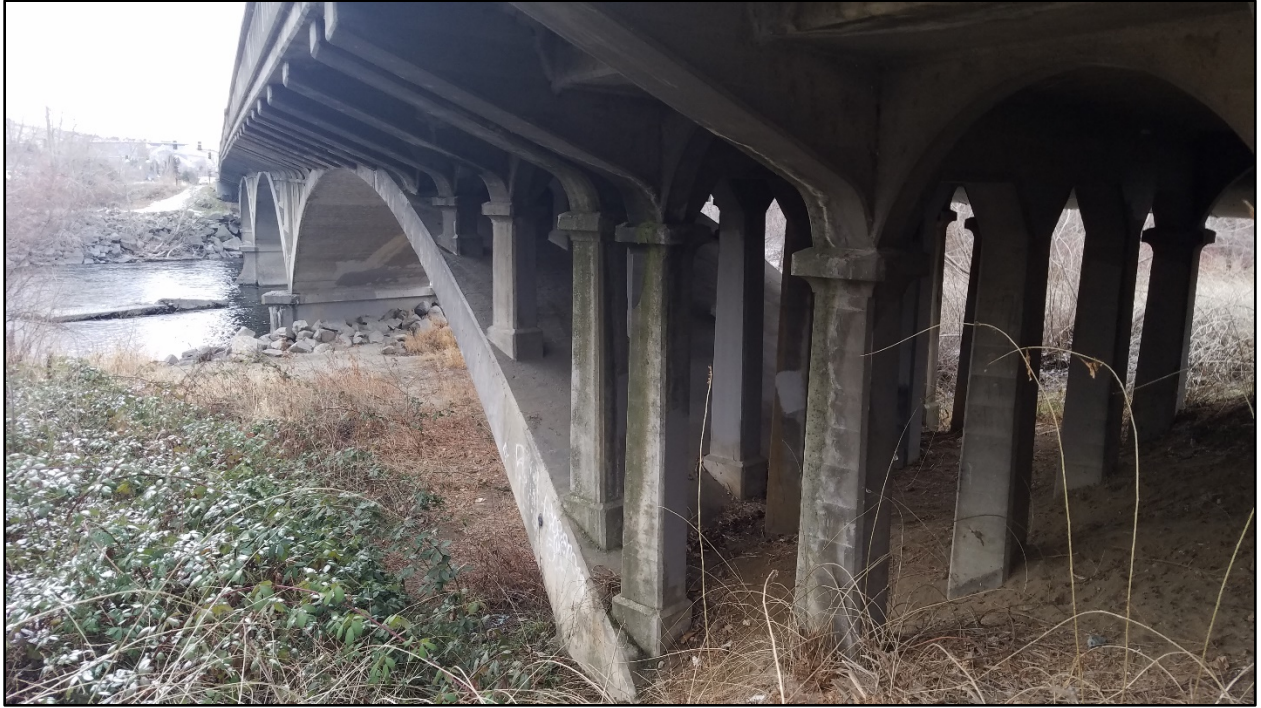
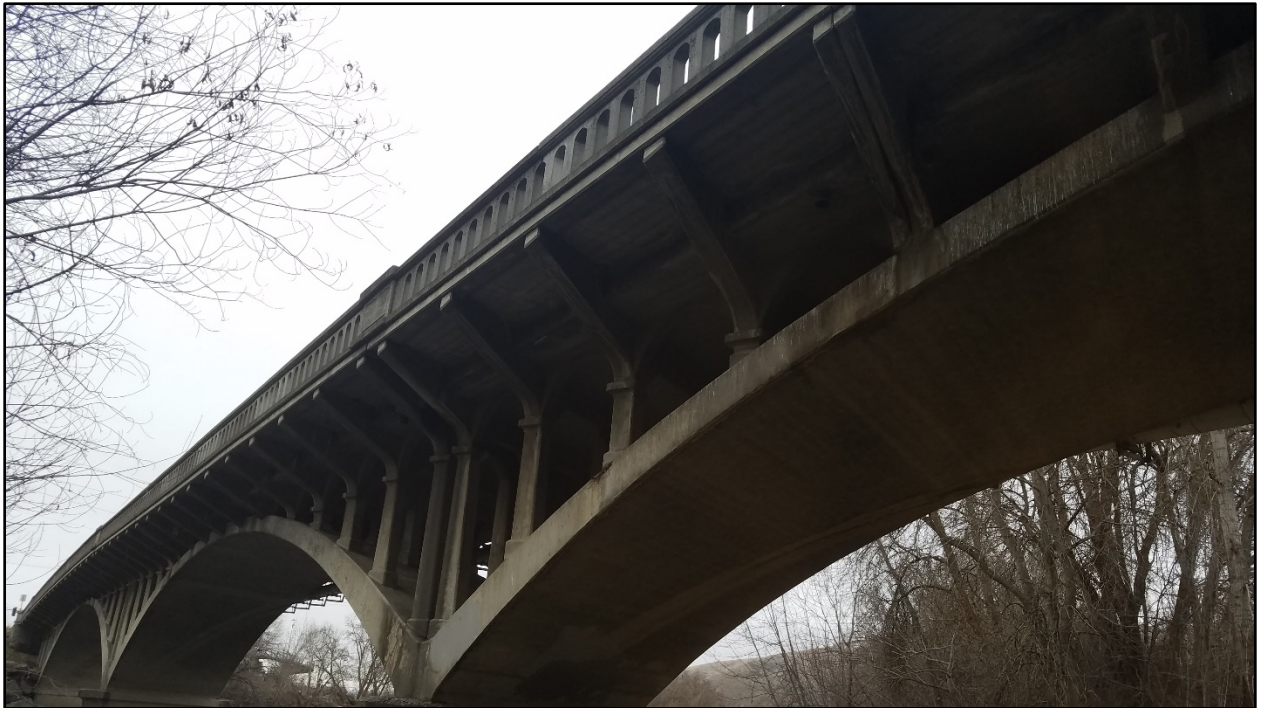
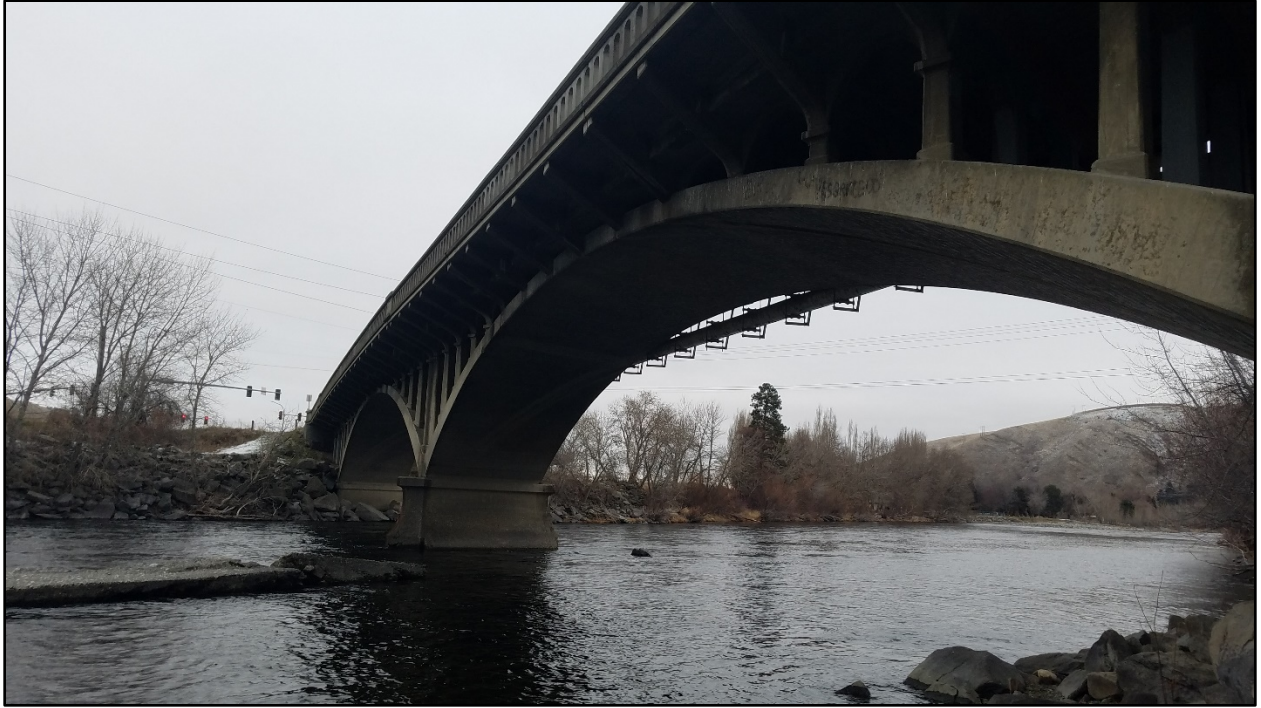
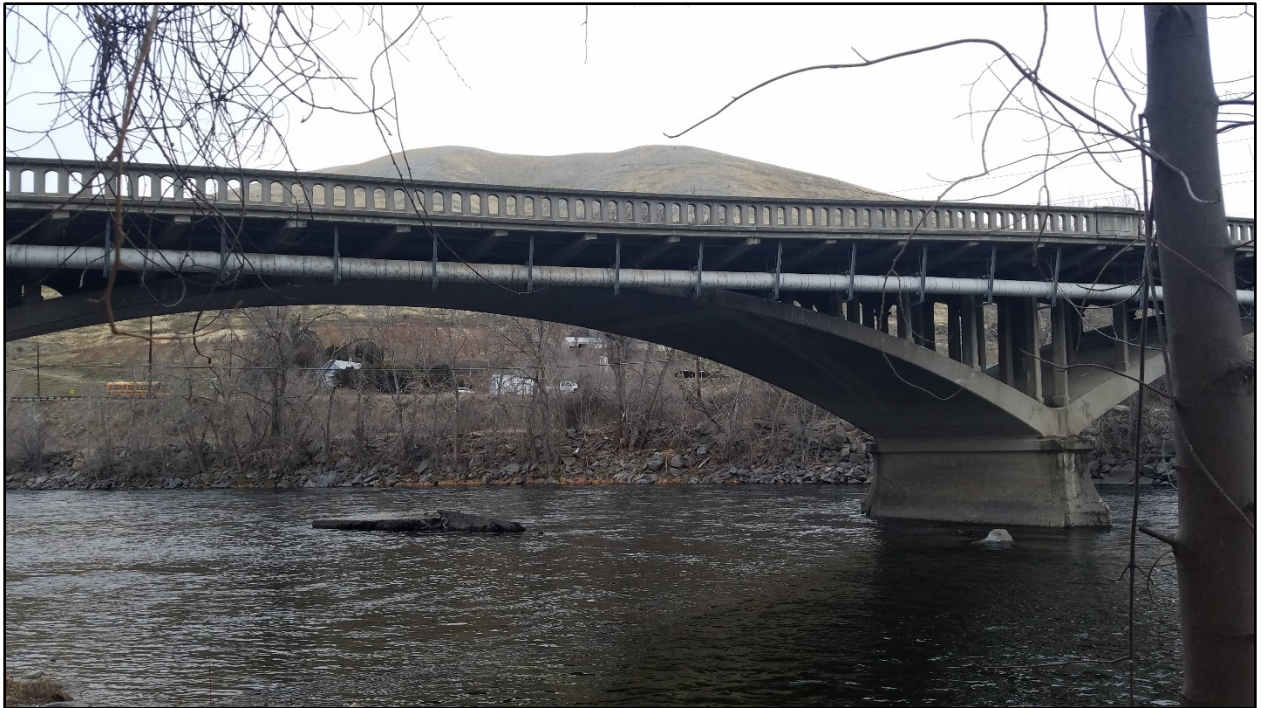
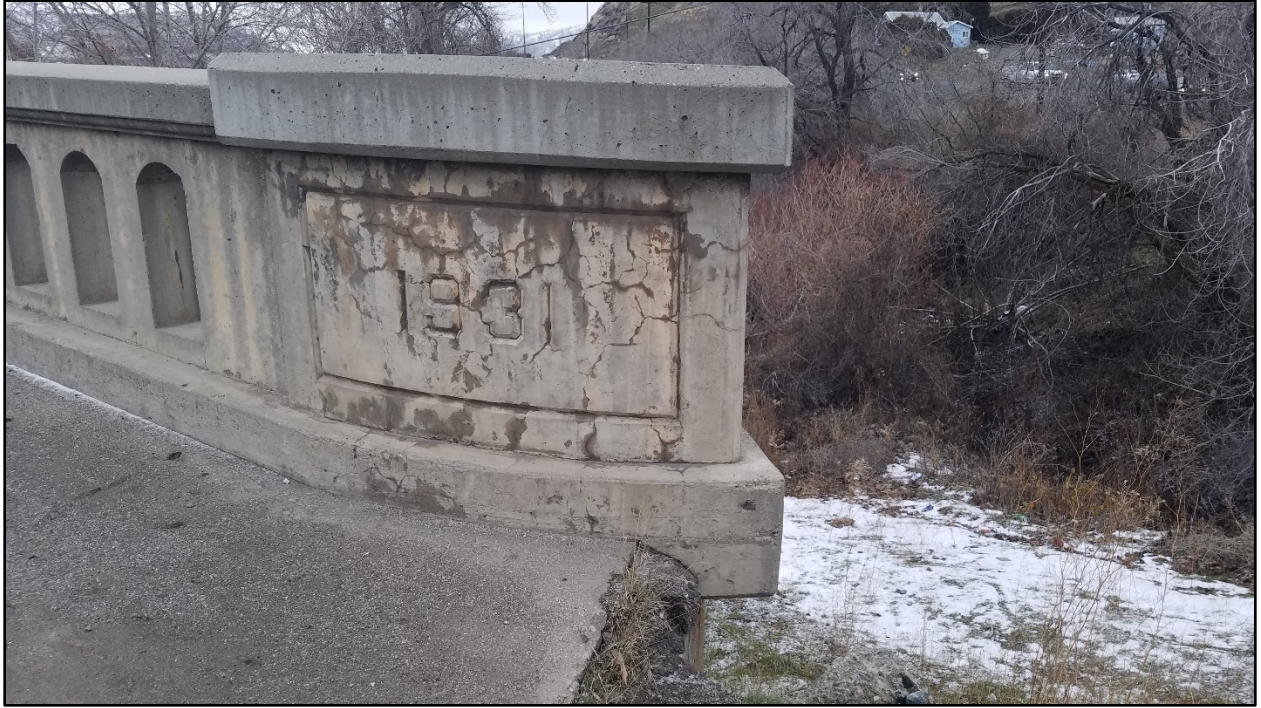
Although in good condition, the structure is listed as functionally obsolete due to the narrow two-lane deck. Aside from evidence of concrete spalling among the rails and some areas of its spandrel columns and ribs, the structure retains an adequate degree of integrity of location, materials, workmanship, design, feeling, setting, and association.

The Monitor Bridge carries two lanes of traffic 357-feet over the Wenatchee River into the unincorporated town of Monitor. Located in Southeastern Chelan County, its 20-ft. wide deck is abutted by two 4-ft. wide elevated concrete sidewalks that run the length of the bridge. The original concrete balustrade railings are present on its west and east elevations. The bridge is comprised of three arch spans measuring 131-ft., 121-ft., and 105-ft., with two approach spans measuring 36-ft. and 22-ft. respectively.

The date of its construction (1930) is embossed in both concrete rail end. Its multi-span design consists of three monolithic arch spans that support four rows of ten square spandrel columns with brackets on top. Six brackets are set directly attached to the arch ribs and support the cantilevered sidewalks. Minor haunches connect each spandrel column and horizontal concrete

caps connect each column while acting as floor beams. Both approach spans are supported by four rows of four columns on its east end and three sets of four columns on its west end. Two monolithic piers founded on piles, one instream pier and one located on the west river bank, support the bridge. Two massive abutments on the east end are also founded on piles. A utility pipe is suspended from its south side.
